**Boone Historic Preservation Commission  
Meeting Minutes  
October 29, 2018  
3:00 p.m.**

**Discussion of Draft Historic Preservation Design Guidelines and Handbook**

# ***Design Guidelines For Commercial Properties***

***Guidelines for Commercial Historic Landmarks  
and Commercial Properties within the Downtown Boone Historic District***

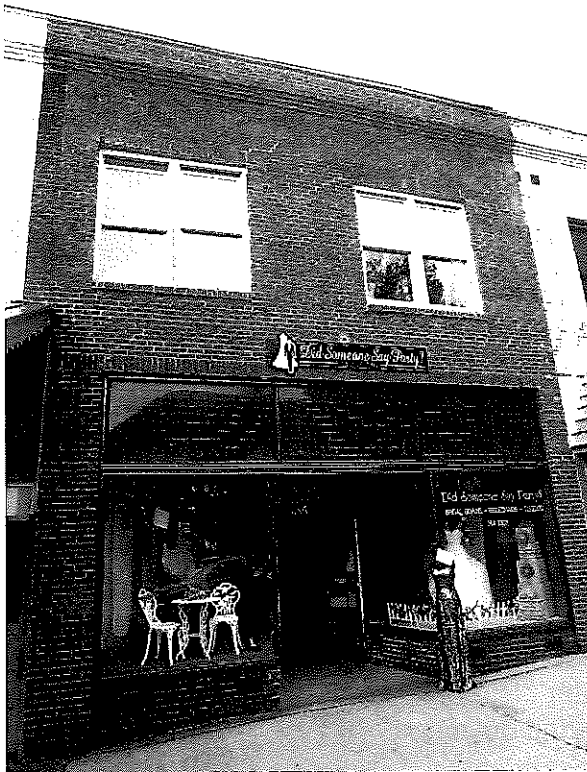
This West King Street building is an outstanding example of successful façade restoration and preservation that uncovered numerous original storefront details, including the clerestory windows above the shop windows and entrance. Photo courtesy of Eric Plaag, 2013.

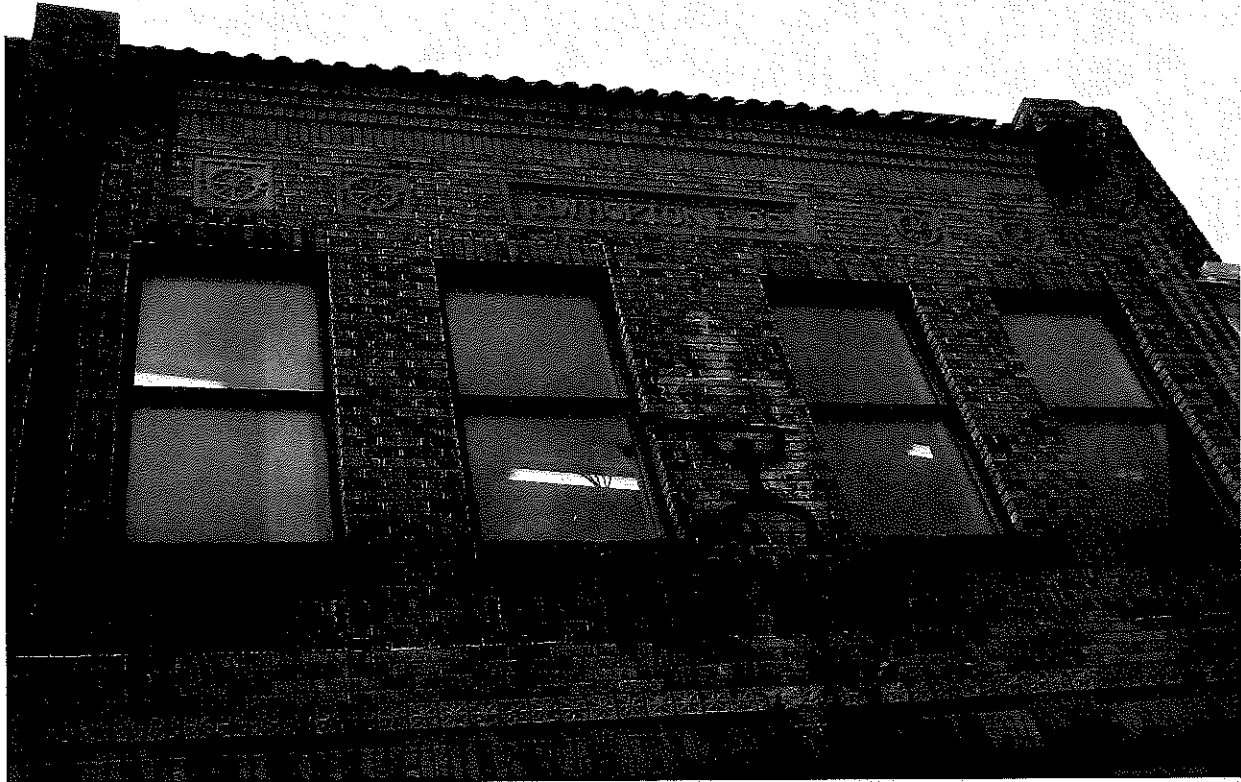
This building on West King Street is an example of both "good" and "bad" preservation decisions. While much of the original brick detailing, corbelling, and ornamentation of the façade has been preserved, this upper façade's windows were replaced, with modern materials and the prominent, ornate cartouche that once appeared between these windows has been removed in favor of modern signage. As of 2018, this building is undergoing another rehabilitation. Photo courtesy of Eric Plaag, 2013.

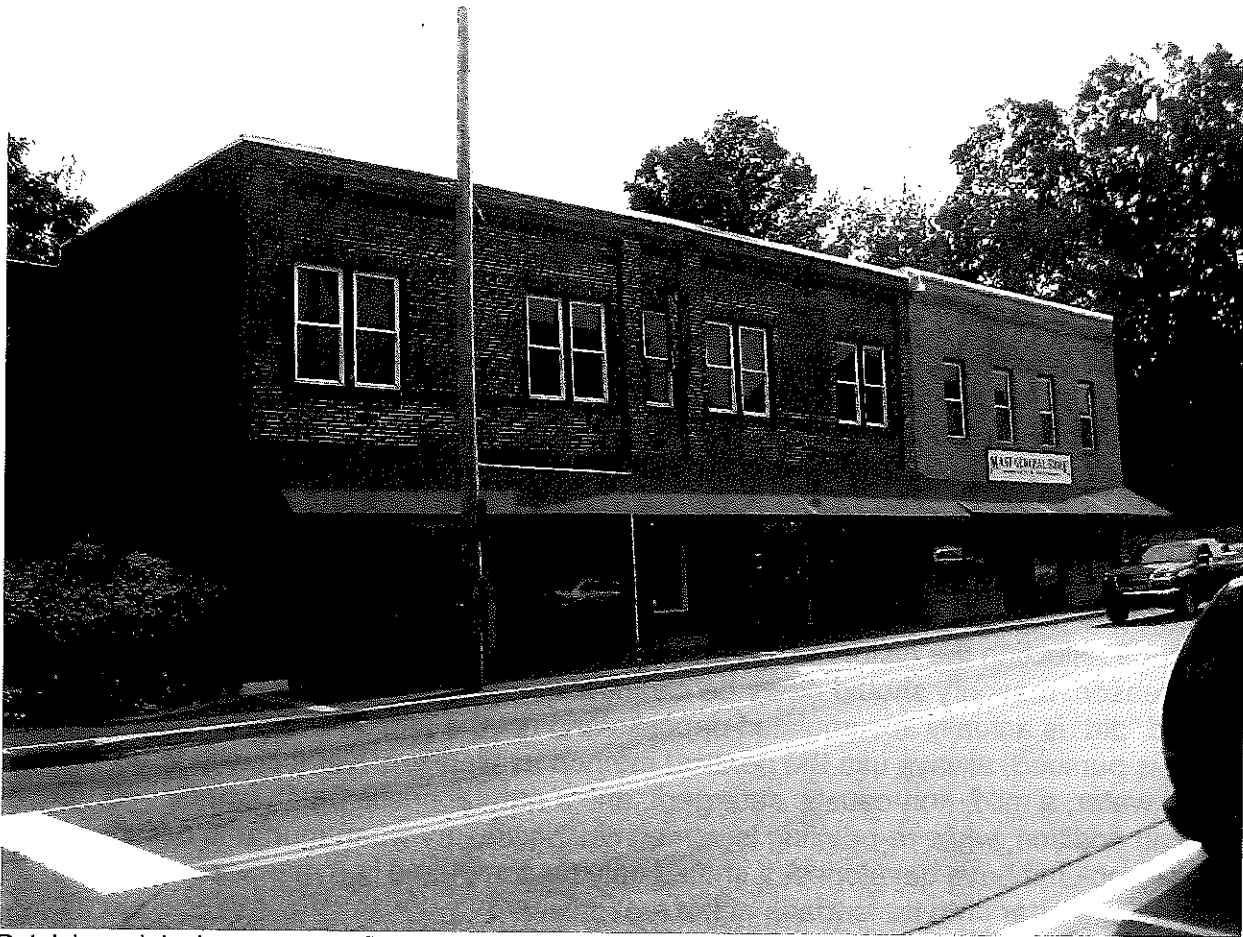
Retaining original masonry configurations, patterns, and detailing is essential to preserving the architectural character of Boone's historic districts. Photo courtesy of Eric Plaag, 2013.

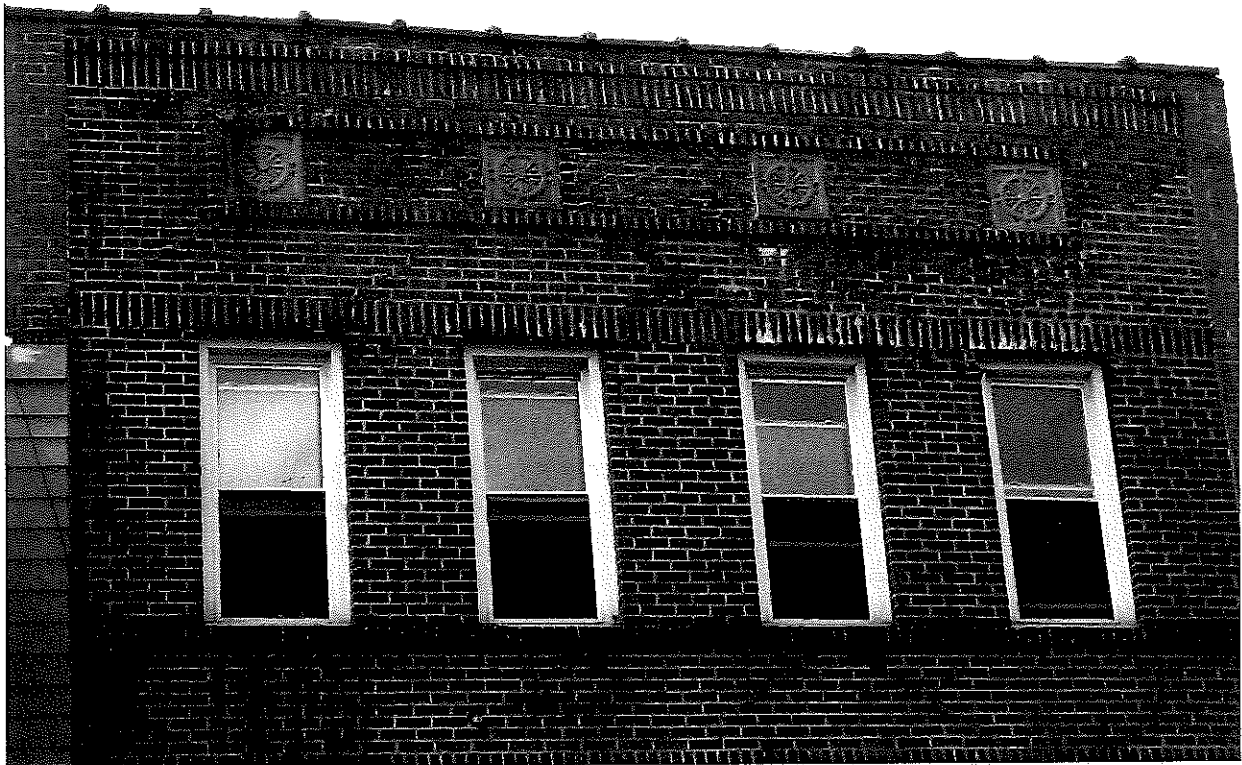
This West King Street property has suffered from poor attempts at re-pointing the masonry between the roofline and upper story windows. Photo courtesy of Eric Plaag, 2013.

- 4.3 Re-pointing of masonry should also be completed using materials that duplicate the existing mortar in appearance, texture, and color. Colored sands or mineral-pigmented mortar can be used to achieve a match with the existing mortar. Portland cement should be avoided in mortar, as it may produce a mortar that is stronger than the surrounding masonry, potentially causing the masonry to crumble.
- 4.4 Unless there is a specific reason for using waterproof or water-repellent coatings (e.g., brick that has previously been sandblasted, creating a porosity problem), these treatments should be avoided, as they can accelerate deterioration of historic masonry.
- 4.5 When repairing or replacing masonry or mortar, take care to maintain the alignment, bond pattern, joint spacing, color, texture, and size of the original masonry.

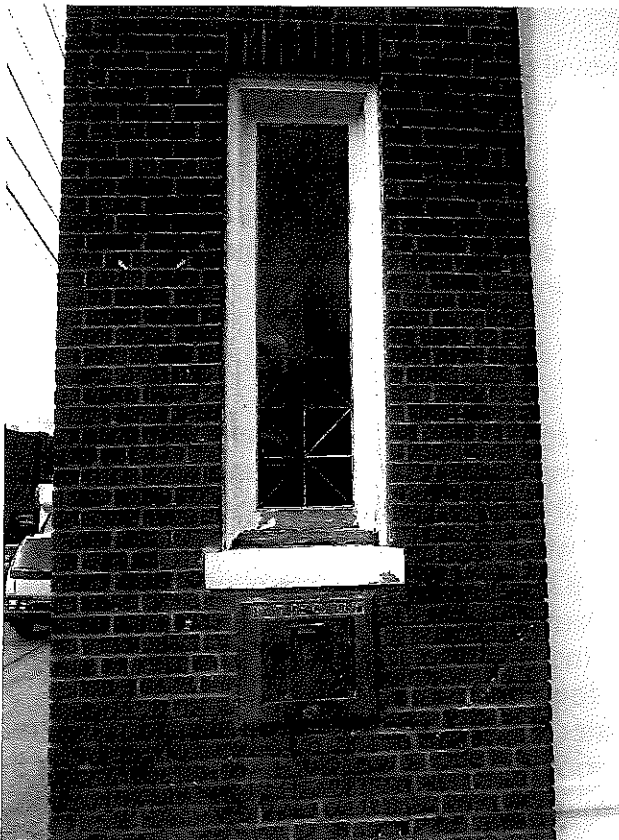
Historic window patterns, like those found here on the Watauga County Bank building, should always be

repaired and preserved rather than replaced. Architectural flourishes, like the night depository door below the window, which is no longer used, should be retained, as they help tell the story of an historic property's function and importance to the community. Photo courtesy of Eric Plaag, 2013.

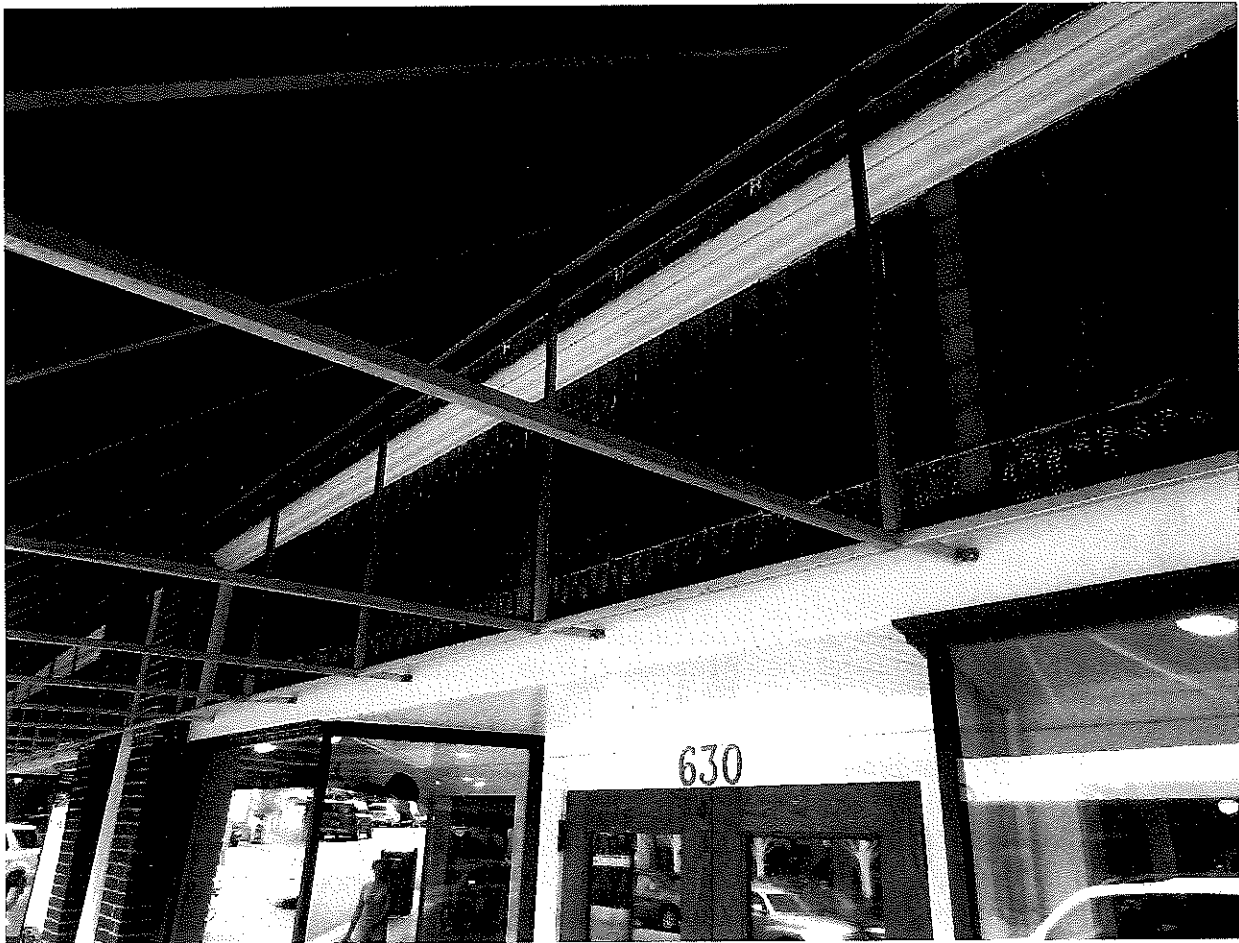
Original clerestory windows, like these found on one West King Street property, contain elaborate details that contribute to the character, appearance, and integrity of the downtown historic district. Photo courtesy of Eric Plaag, 2013.

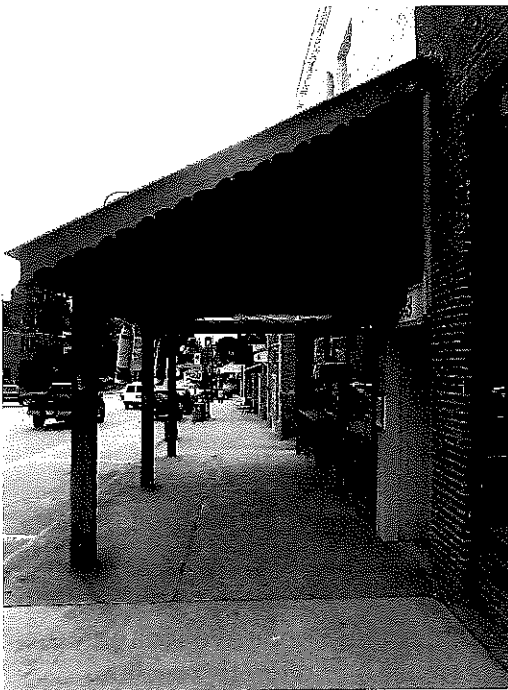
Shed roof porticoes like this one on West King Street attempt to create a "mountain village" appearance but are not historically appropriate to the Downtown Boone's historic districts and damage the integrity of the district. Photo courtesy of Eric Plaag, 2013.

- 6.10 Awnings, porches, shed roof porticoes, and arcades that attempt to create a "mountain village" appearance or that are not historically accurate to Boone's downtown historic context only work to damage the integrity and appearance of the district. Property owners whose buildings possess such features should endeavor to remove them and restore the façade of their property to its historic appearance. They should never be incorporated into additions or new construction within the Downtown Boone historic districts.

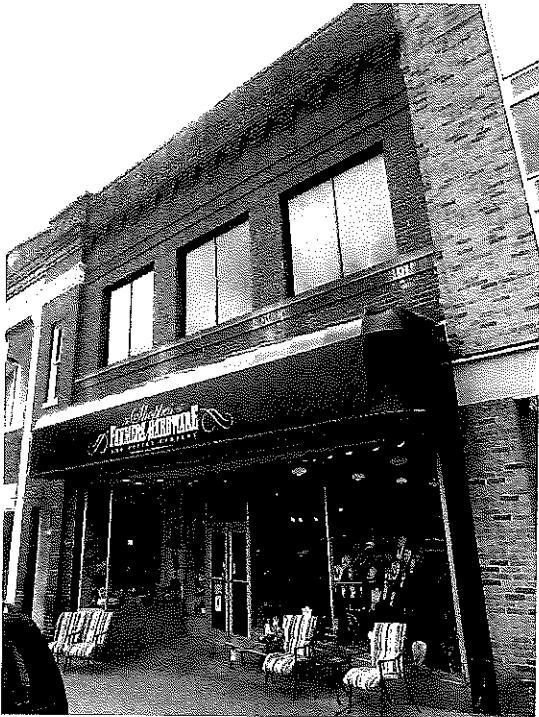
Awnings should be historically appropriate to the buildings they are attached to, and they should never obscure historic architectural features. This awning on West King Street, for example, is stylistically inappropriate to the building and almost entirely covers the structural glass that was once visible above this storefront. Photo courtesy of Eric Plaag, 2013.

- 6.11 Awnings on properties in the historic district should always be historically appropriate in accordance with available photographic and historic documentation, and they should never obscure vital architectural components of the original building. For example, properties that historically possessed flat awnings anchored by cables or steel rods should retain these kinds of awnings. In cases where they have been removed, and particularly in cases where they have been replaced with modern, sloped awnings, property owners should endeavor to remove the modern feature and restore the original awning configuration with appropriate materials based on historic documentation. Sloped awnings should be composed of canvas or acrylic. Metal awnings are never appropriate, except for historic properties erected after World War II that historically had metal awnings at the time of their construction.
