# Historic Preservation Commission

**IV. Case Z06278-112122 - Mast Store - COA**

## MAST STORE, INC. – Western Façade repair

### Request

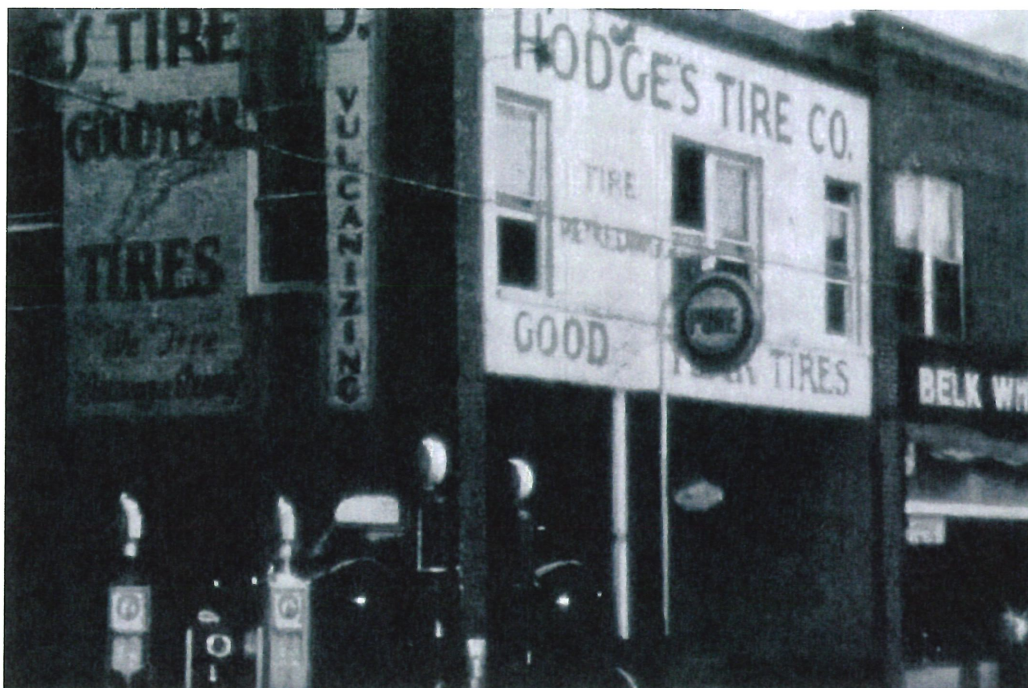
Screenshot from the 1936 H. Lee Waters film of Boone showing the Boone Garage, occupied by the Hodges Tire Company, with its south facade aligned with the south facade of the Jones Building to the east. Image courtesy of the Pilar Fotta Collection, Digital Watauga Project.

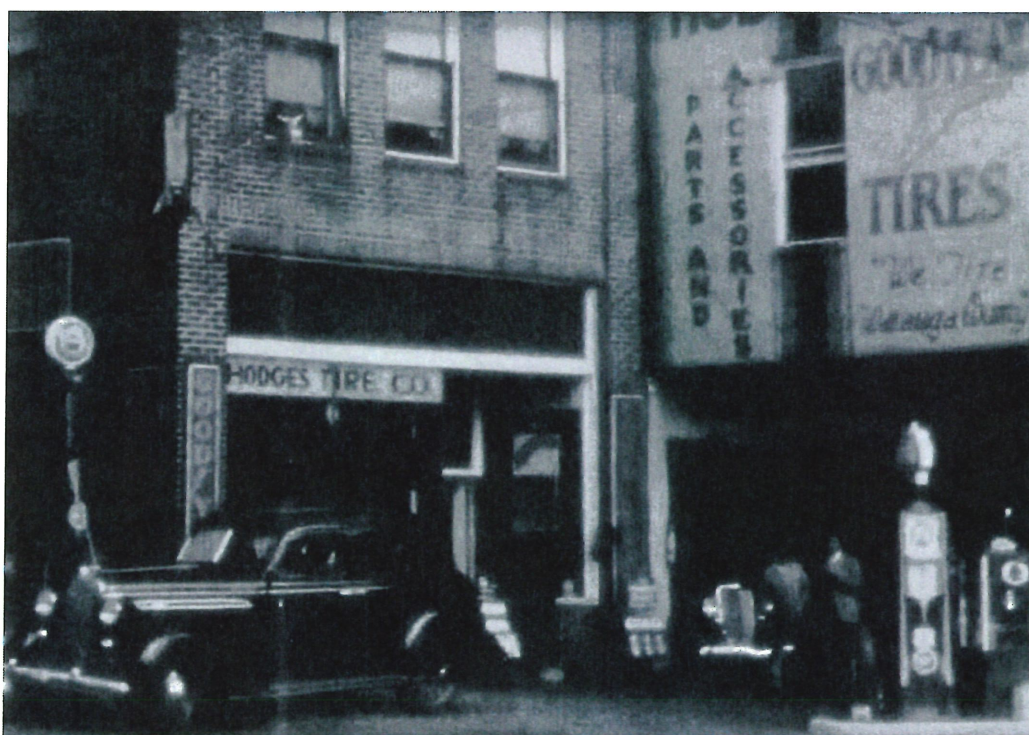
Screenshot from the 1936 H. Lee Waters film of Boone showing the west and south elevations of the W. R. Winkler Tire Company Building at left, with the west wall of the Boone Garage at right. Image courtesy of the Pilar Fotta Collection, Digital Watauga Project.

Sometime shortly before July 1938, the Hodges Tire Company removed the second-floor overhang and the garage bays of the Boone Garage building, trimming back the building footprint to a position slightly forward of the Winkler Tire Company Building to the west. They also covered the new façade with a native stone veneer that protruded forward of the Winkler Tire Company Building. This change is visible in a photograph that ran that month in the *Watauga Democrat* on July 7, 1938. Unfortunately, that photograph is framed in a manner that does not show us the west wall of the Jones Building. We do know, however, that Rufus Colvard bought the Winkler Tire Company Building and the Boone Garage in 1940, then added the Jones Building through transactions in 1941 and 1943. Guy Hunt, who began operating Hunt's Department Store in the Jones Building

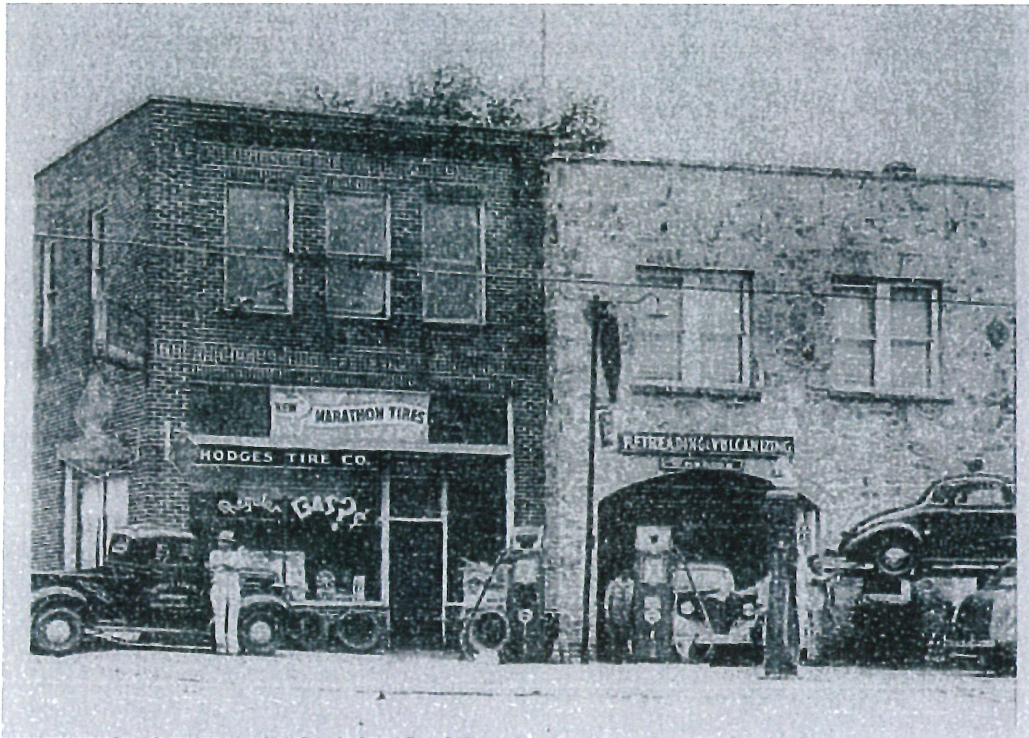
Hodges Tire Company advertisement image, *Watauga Democrat*, July 7, 1938, with the Winkler Tire Company building at left and the cut-back Boone Garage with its new stone veneer at right. Image courtesy of DigitalNC.com.

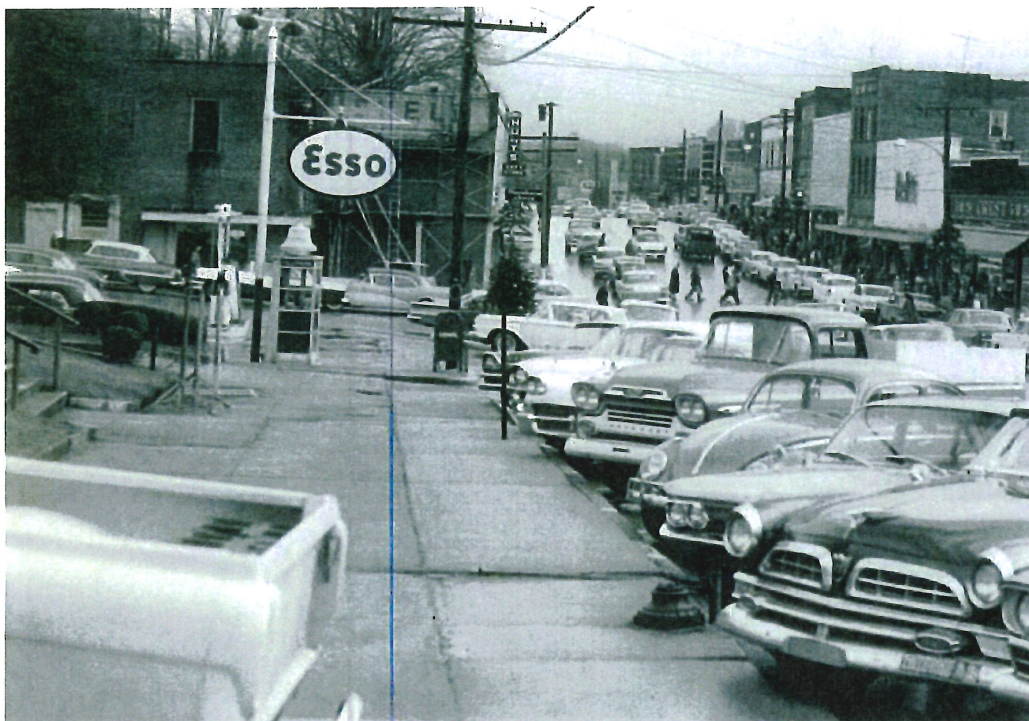
Detail crop from a circa 1960-62 image taken around Christmas showing the installation of a brick veneer wall on the Boone Garage remnant and the west wall of the Jones Building. Image courtesy of the Paul Armfield Coffey Collection, Digital Watauga Project.

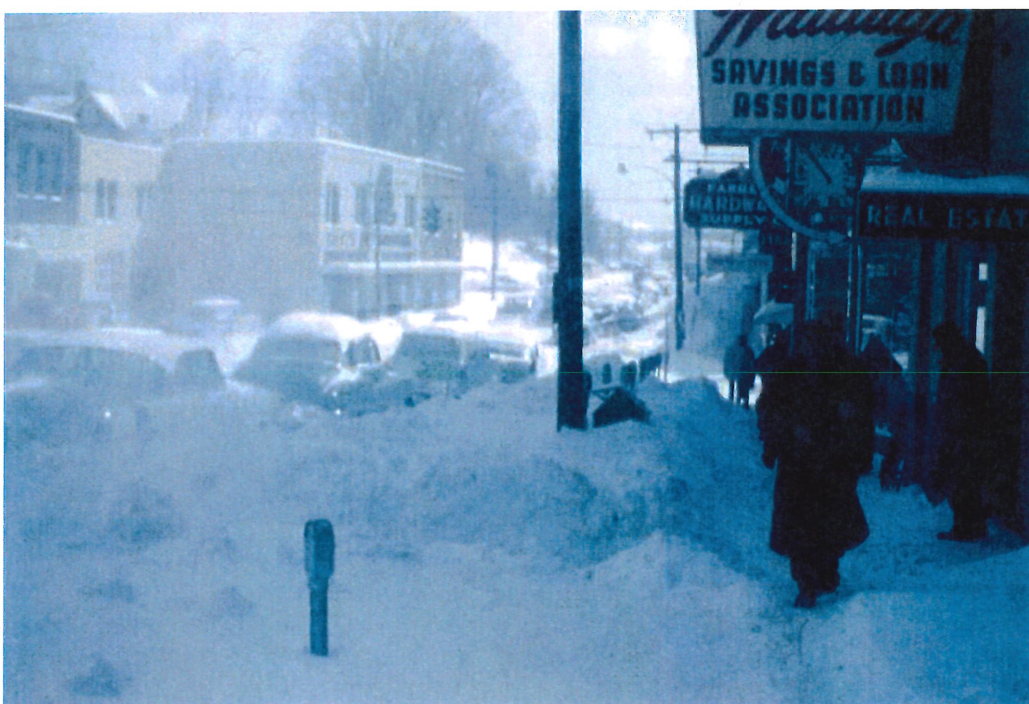
March 1960 image taken during the 1960 Blizzard (with a March 1960 processing date). We initially thought this image showed the brick veneer installed on the west wall of the Jones Building and the south elevation of the Boone Garage remnant, but we now believe this represents a painting over or re-application of stucco on both buildings. Image courtesy of the John Ward Family Collection, Digital Watauga Project.

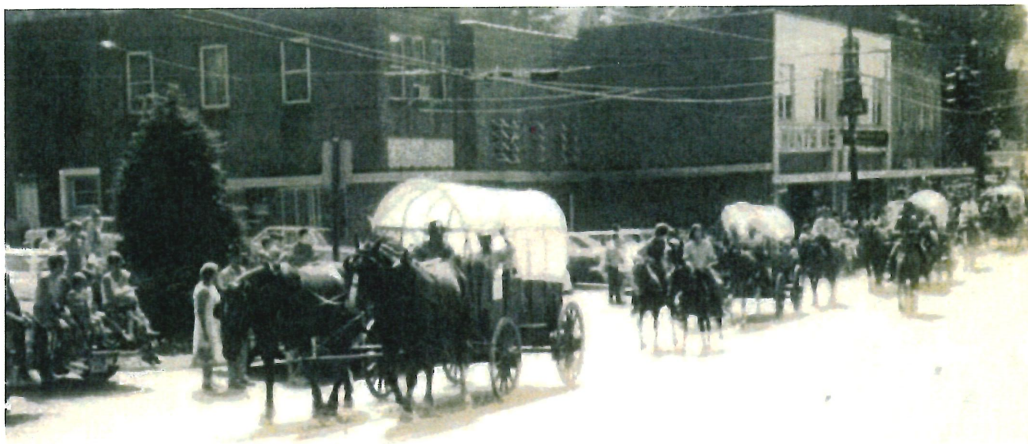
This image of the July 1963 Wagon Train parade shows the Boone Garage remnant and the west wall of the Jones Building following installation of the brick veneer. Image courtesy of the Historic Boone Collection, Digital Watauga Project.

We also know that Colvard installed a brick veneer treatment over the Boone Garage remnant and the west wall of the Jones Building sometime between March 1960 and July 1963. One image (reproduced below) shows this work being completed during December, given that Christmas decorations are visible on the street poles. We know that the work could not have been completed earlier than December 1957 because of the Tweetsie Railroad bumper sticker on the car in the foreground (Tweetsie opened in July 1957). And we know that the brick veneer work was completed before the July 1963 Wagon Train, based on an image (also below) of the wagon train passing by the building. We initially misread the color in the 1960 Blizzard image below as representing brick, but we now believe that this represents a painting over (and possibly a re-application) of the stucco that was covered a short time later by the pre-1963 brick veneer. It is this pre-1963 veneer wall that was in danger of collapse at the time of the 2015 Downtown Boone architectural survey and that was ultimately removed under an emergency public safety order from the Town of Boone in 2022. We should note, too, that we did not have the benefit of observing the actual removal of the veneer walls on the west wall of the Jones Building and the south wall of the Boone Garage remnant. Any photo documentation of that work may confirm our conclusions outlined below.

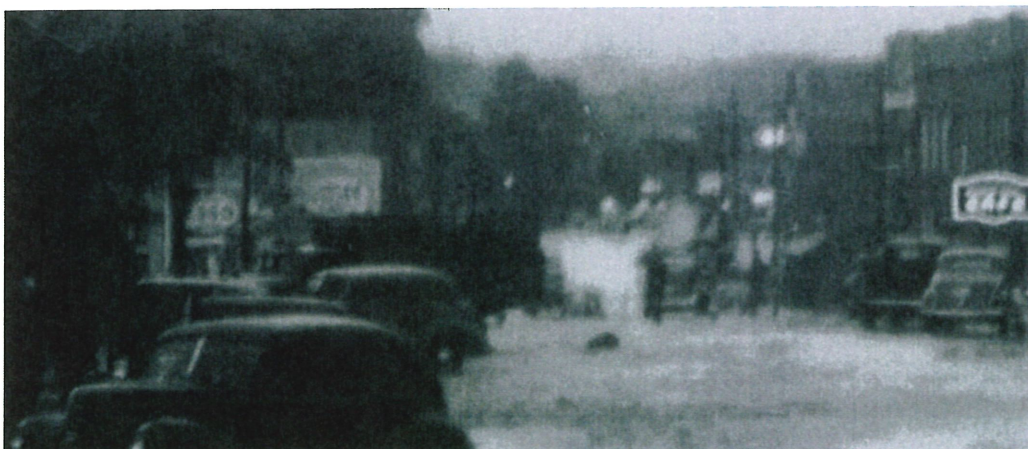
The "Shell" lettering at the top of the west wall of the Jones Building can be seen in this detail crop of flooding on King Street during the August 1940 flood. Image courtesy of the David P. Wyke Collection, Digital Watauga Project.

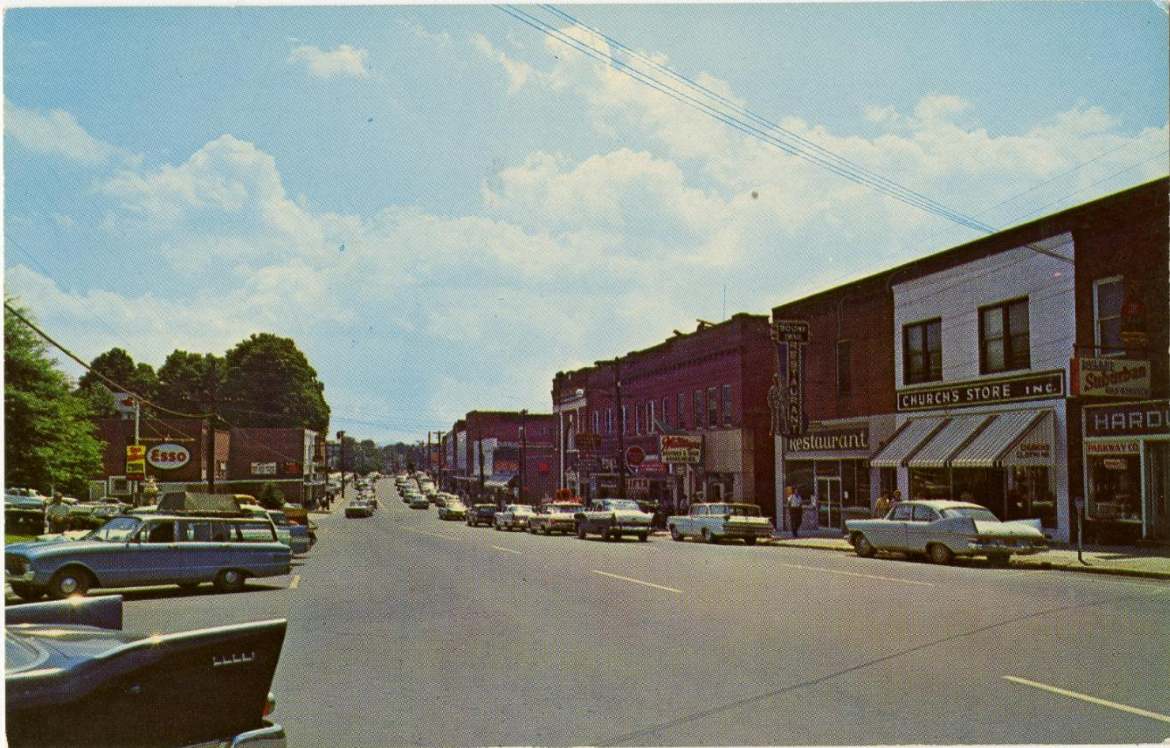
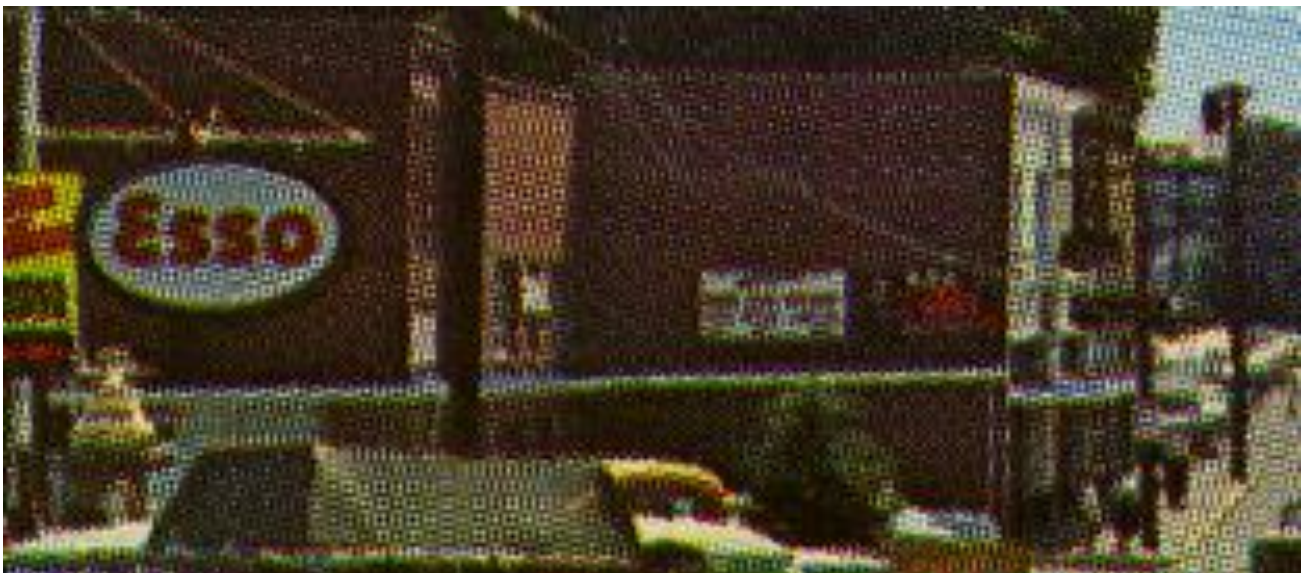
Figure 1. W. M. Cline Co., "Downtown Boone Street Scene Postcard," Digital Watauga, accessed January 3, 2023, <https://digitalwatauga.org/items/show/20690>.

- [Ann-Lar-01-013-a](#) Shows the building in question in the distance, circa 1963. A small advertisement can be seen painted on the wall above the small eave. Unknown text.

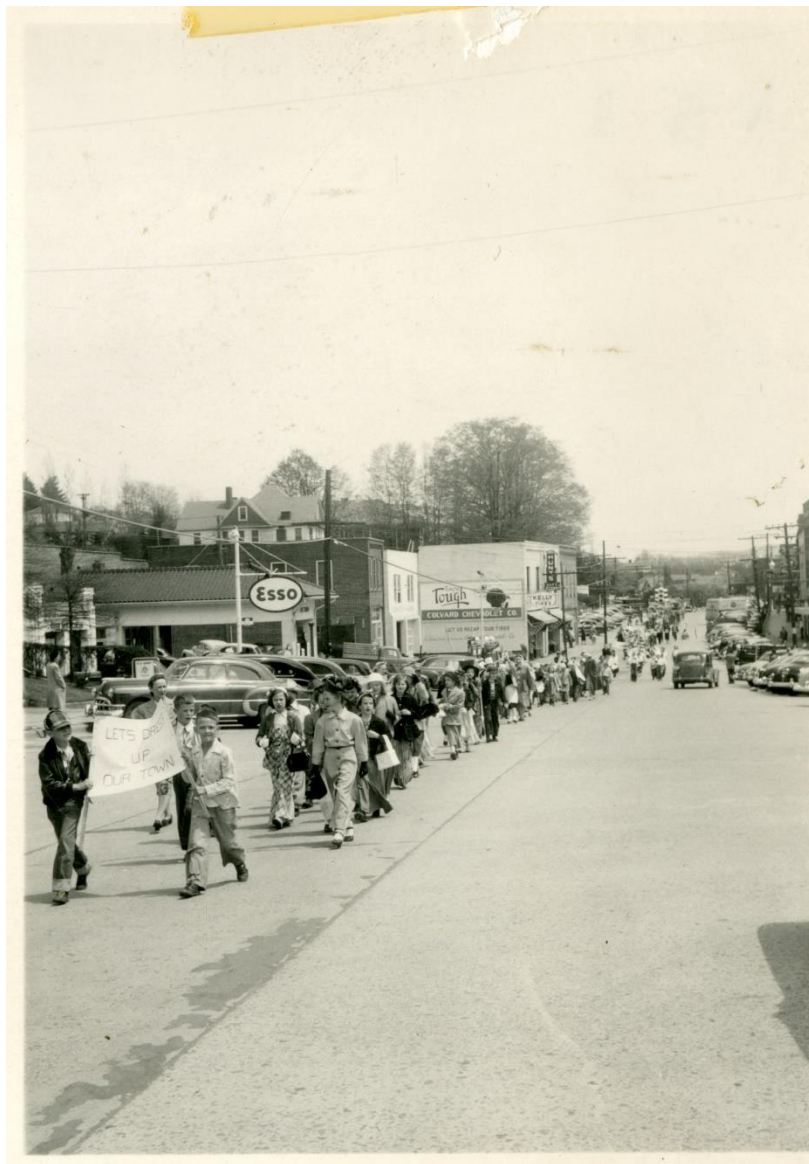
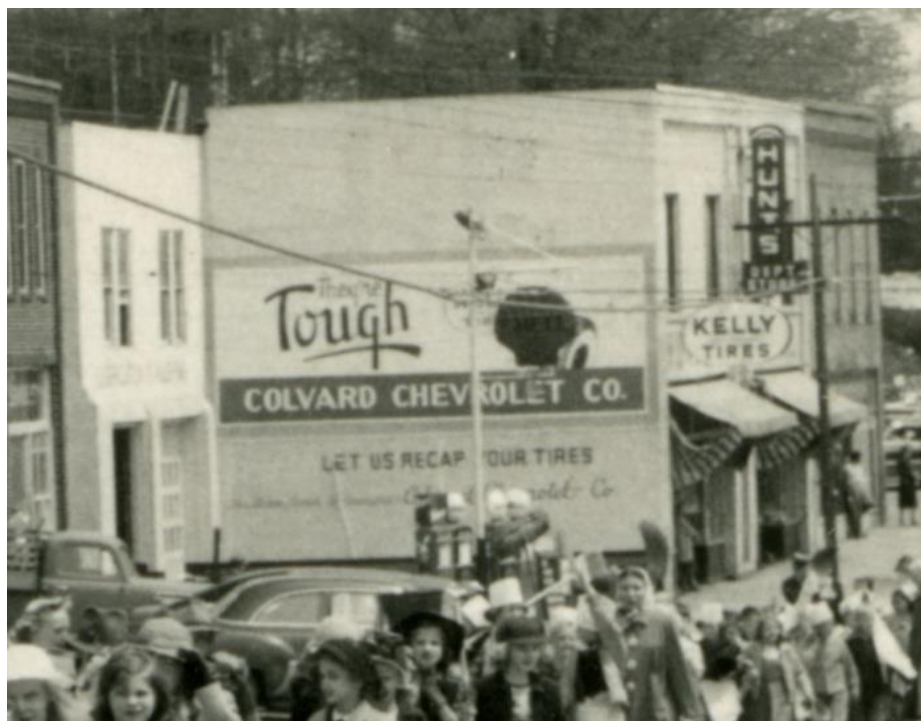
Figure 2. Unknown, "Children in 1952 Spring Clean Up Parade," Digital Watauga, accessed January 3, 2023, <https://digitalwatauga.org/items/show/644>

- [Con-Sta-01-002](#) Shows the West elevation of the building in question. In this image an advertisement for Colvard Chevrolet Co. can be seen. "Let us recap your tires" is written below the main ad.

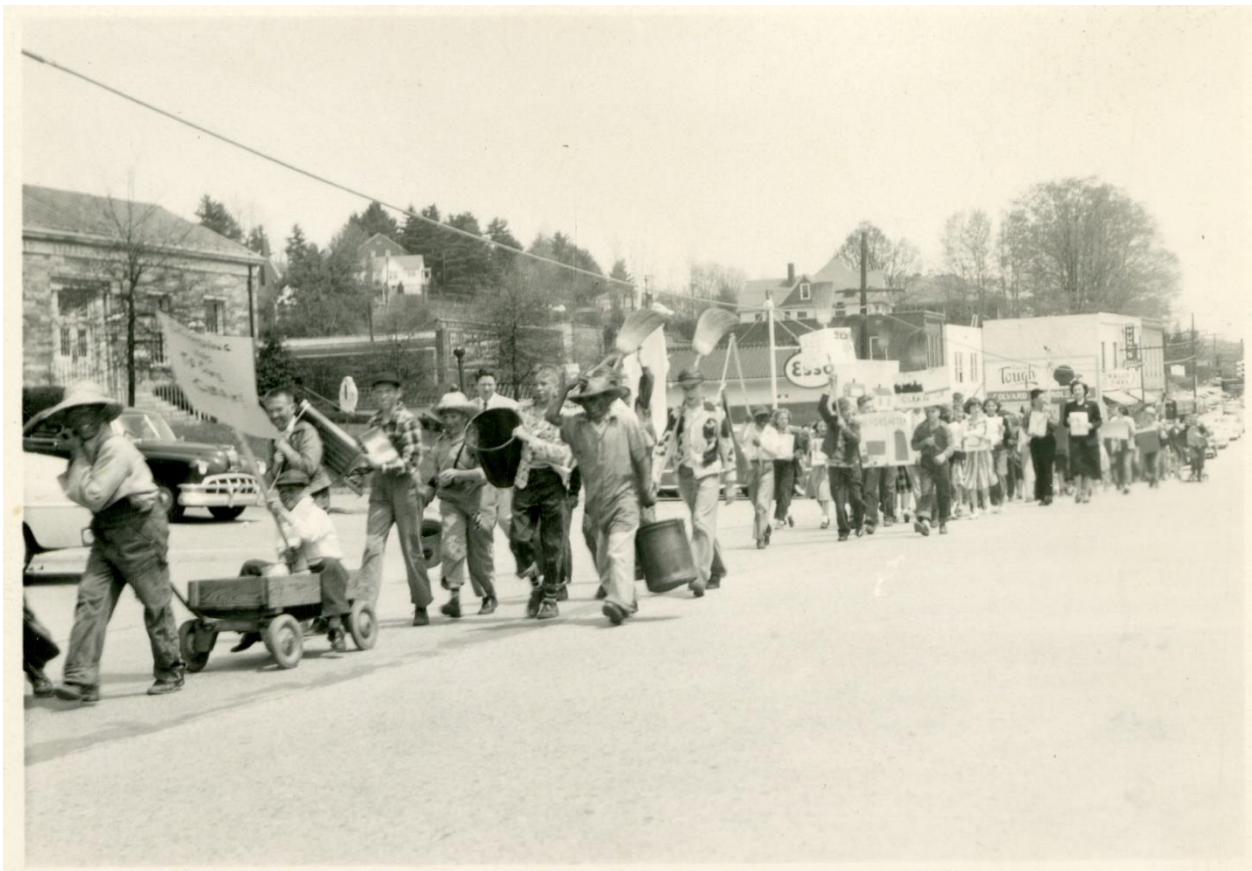
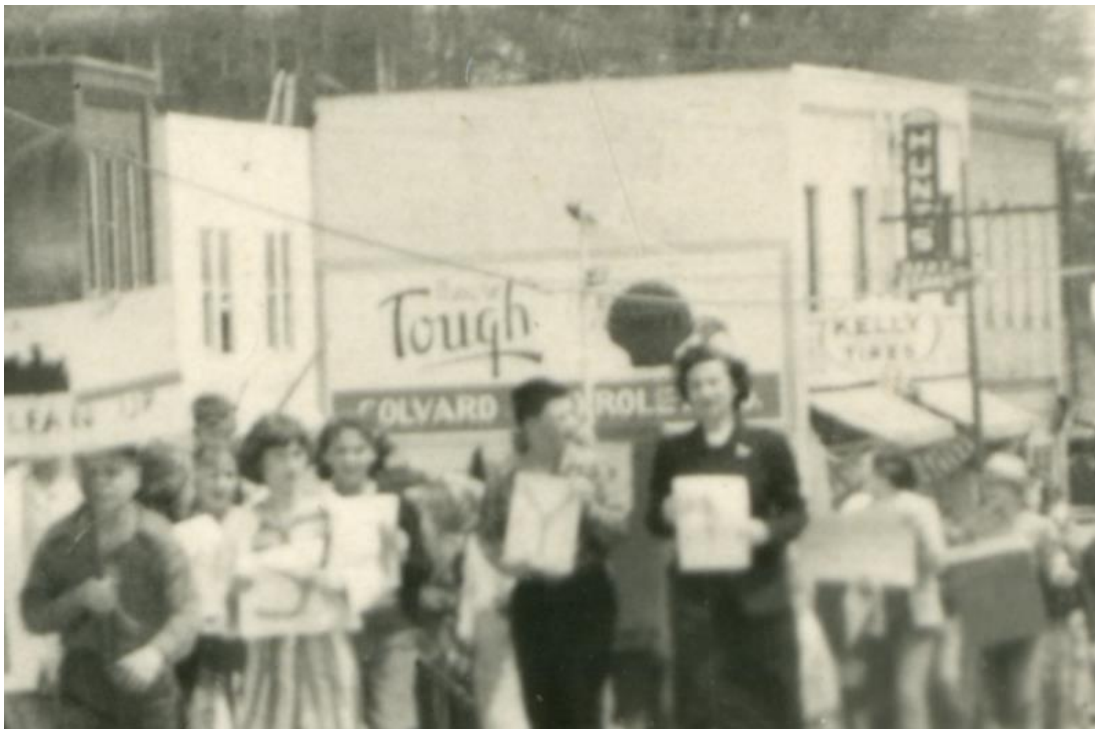
Figure 3. Unknown, "Westbound Spring Clean Up Parade," Digital Watauga, accessed January 3, 2023, <https://digitalwatauga.org/items/show/6451>.

- [Con-Sta-01-008](#) Features an image from a 1952 Spring parade and an advertisement can be seen for Shell and Colvard Chevrolet Co.

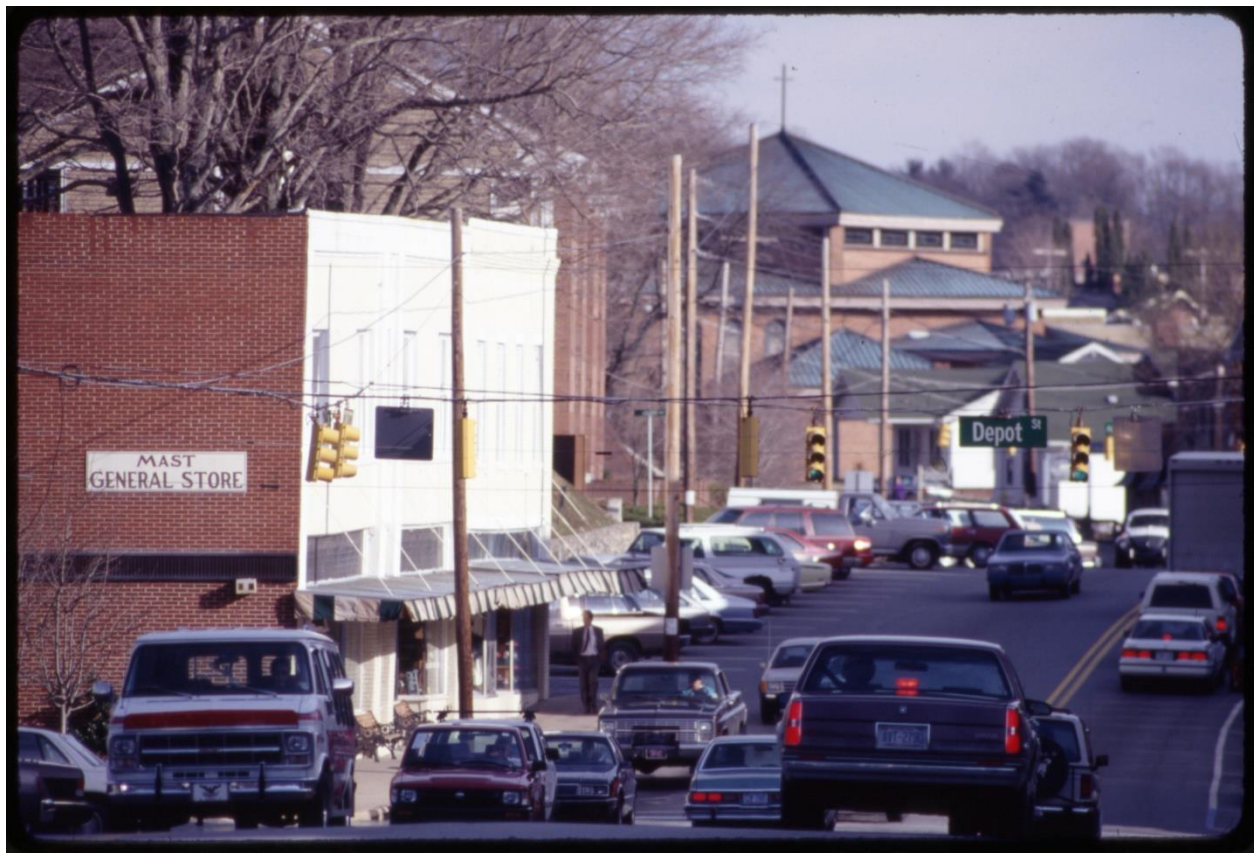
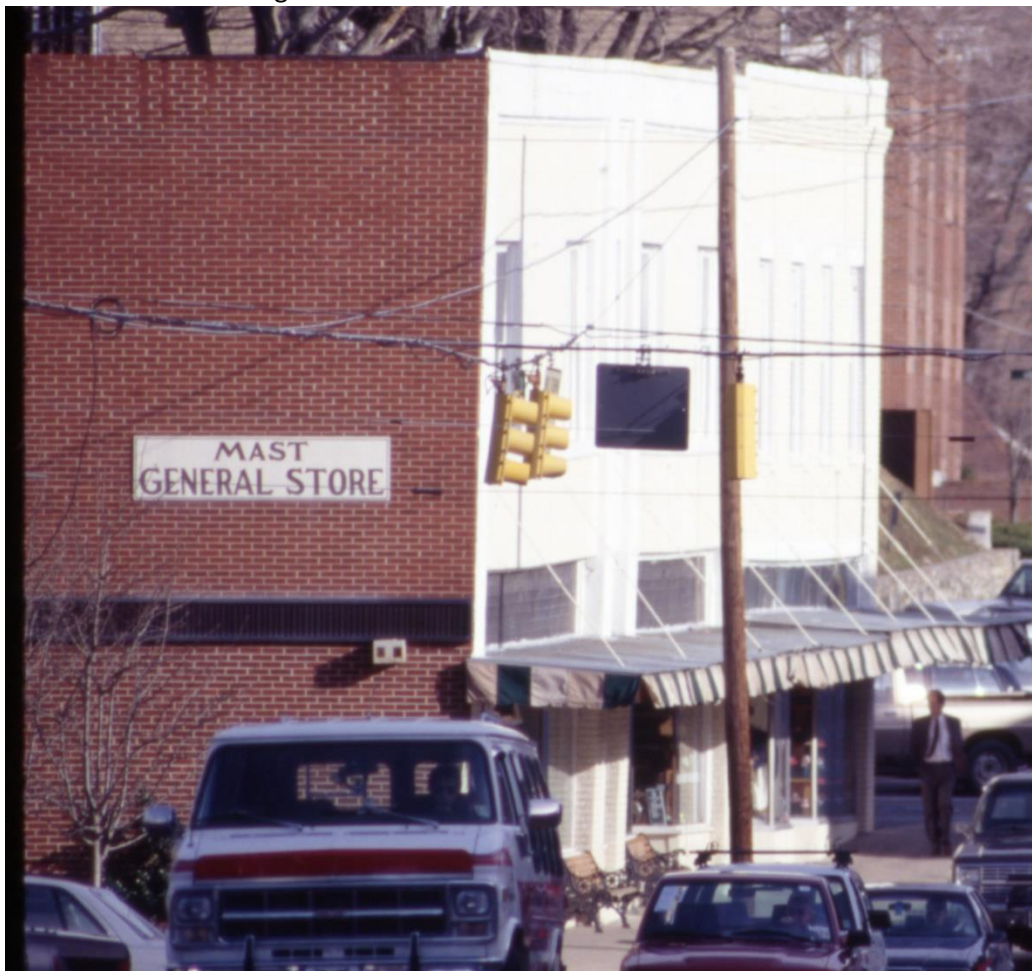
Figure 4. Unknown, "West King Street, Including Mast General Store, Downtown Boone, 1990s," Digital Watauga, accessed January 3, 2023, <https://digitalwatauga.org/items/show/7092>.

- [Dow-Boo-01-128](#) Shows the West elevation of 630 W King St in the mid 1990s. Signage for Mast General Store is fixed on the corner of the building.

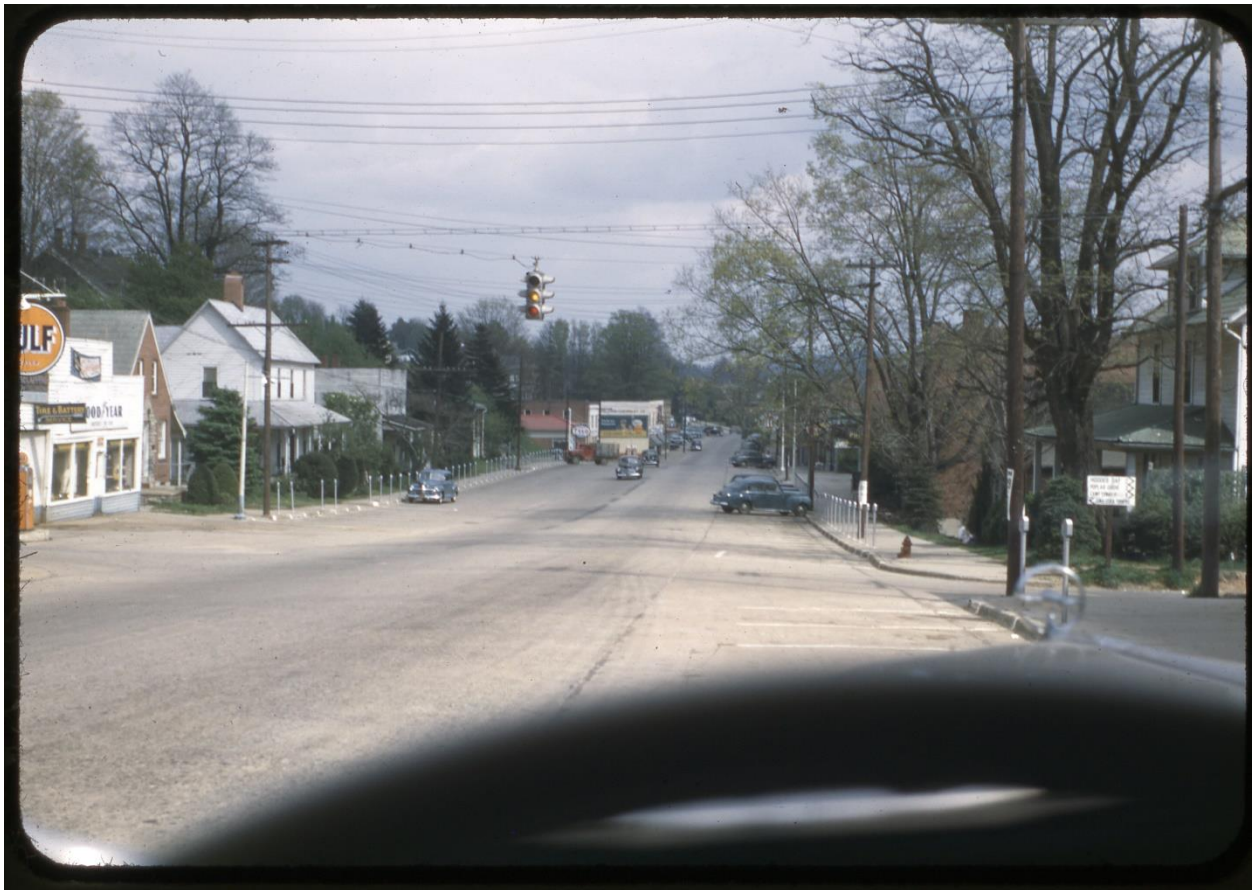
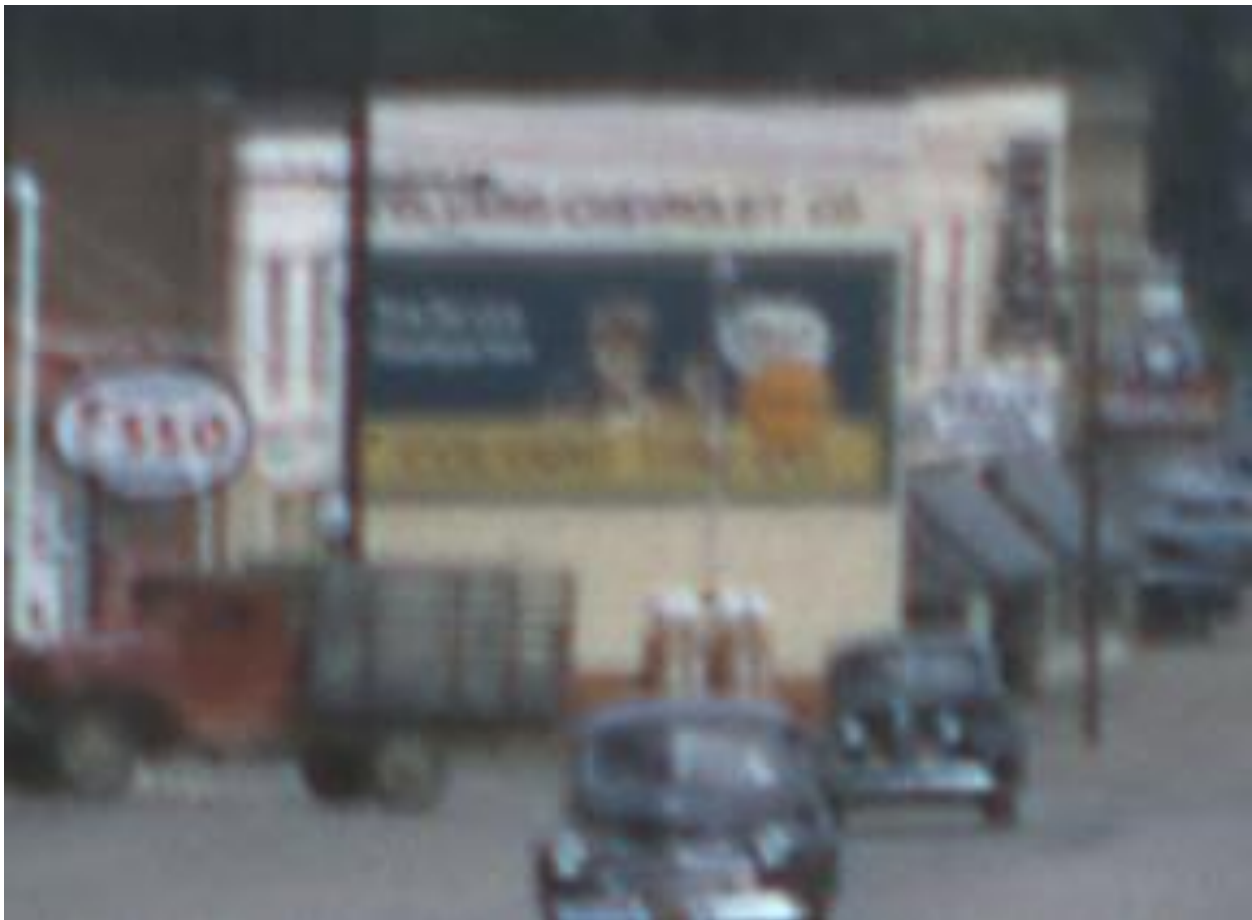
Figure 6. E. T. Glenn , "Downtown Boone Side Roads," Digital Watauga, accessed January 3, 2023, <http://digitalwatauga.org/items/show/27828>.

- [Etl-Gle-01-163](#) Shows the west elevation of the building with a Colvard Tire Co. advertisement, this image is dated late 1950s, early 1960s.

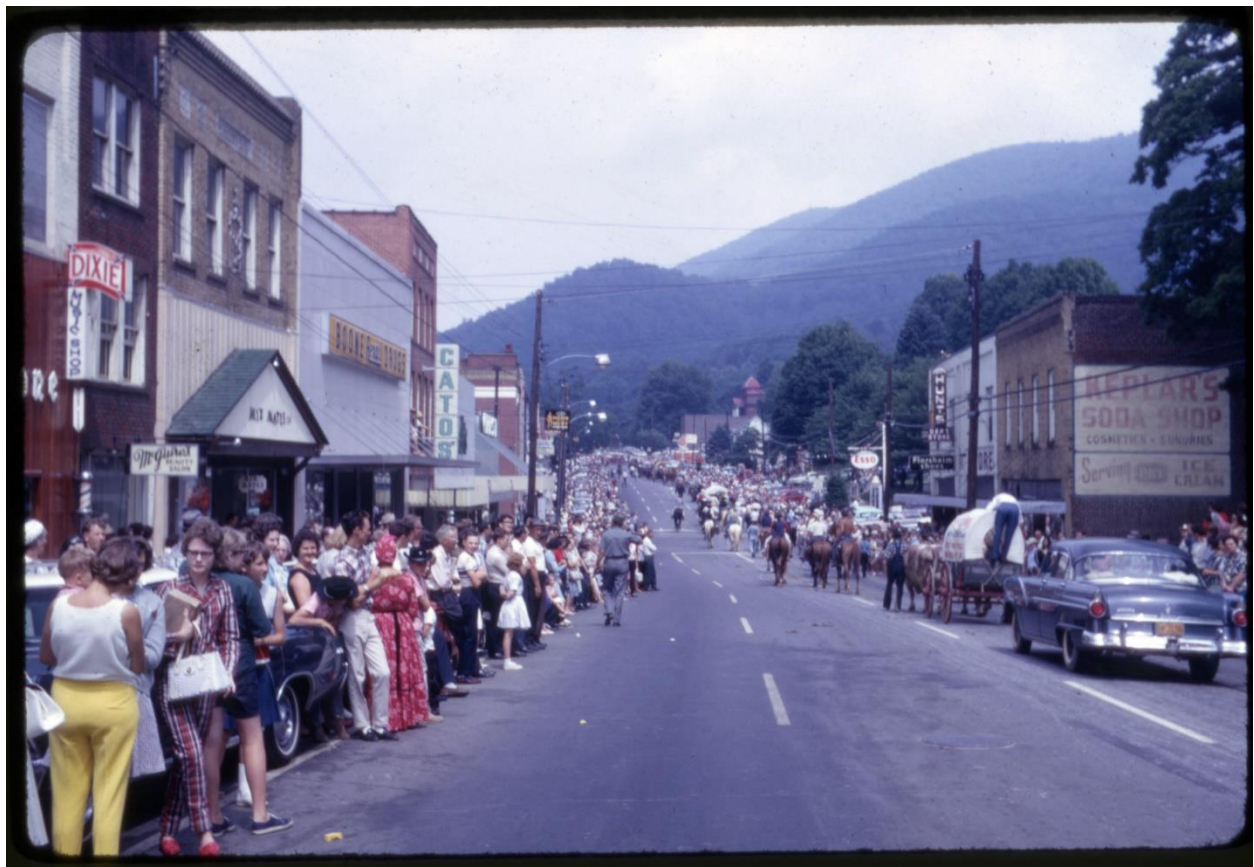
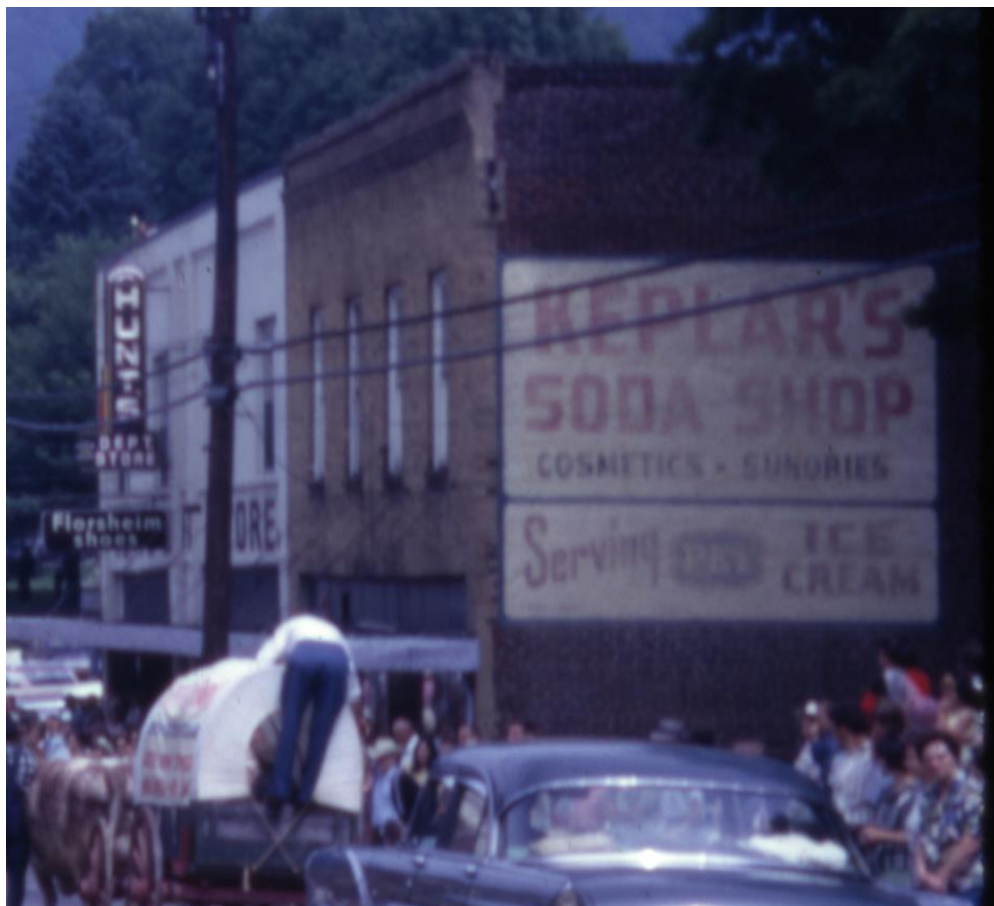
Figure 8. Harlan Ledford, "Crowd Watching Daniel Boone Wagon Train," Digital Watauga, accessed January 3, 2023, <https://digitalwatauga.org/items/show/9426>.

- [Har-Led-01-206](#) shows the South elevation (front) of the building in the late 1960s.

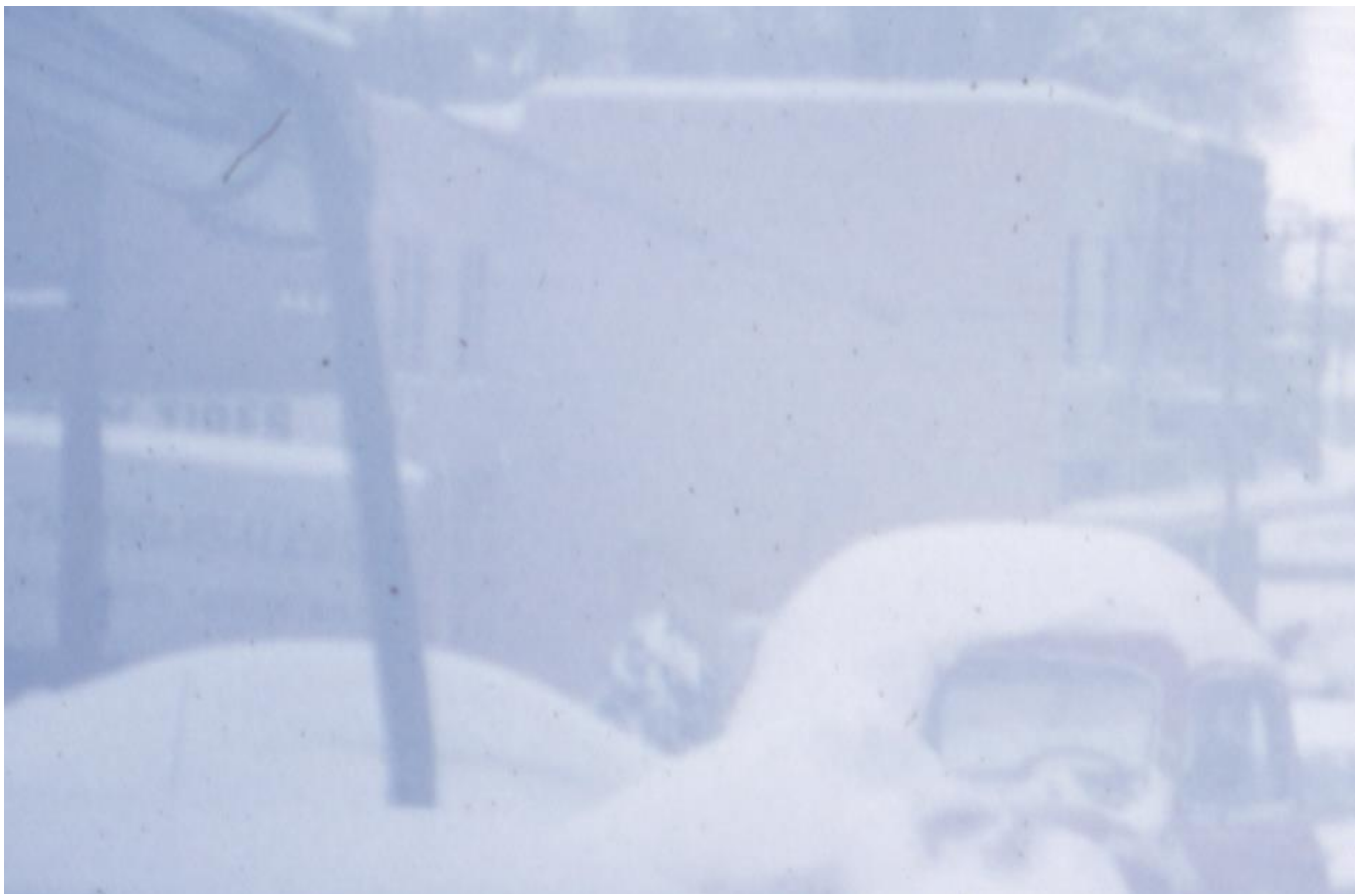
Figure 16. John Ward, "King Street Amid 1960 Blizzard," Digital Watauga, accessed January 3, 2023, <https://digitalwatauga.org/items/show/19940>.

- [Joh-War-01-091](#) Shows the west elevation of the building during snowy season, 1960.

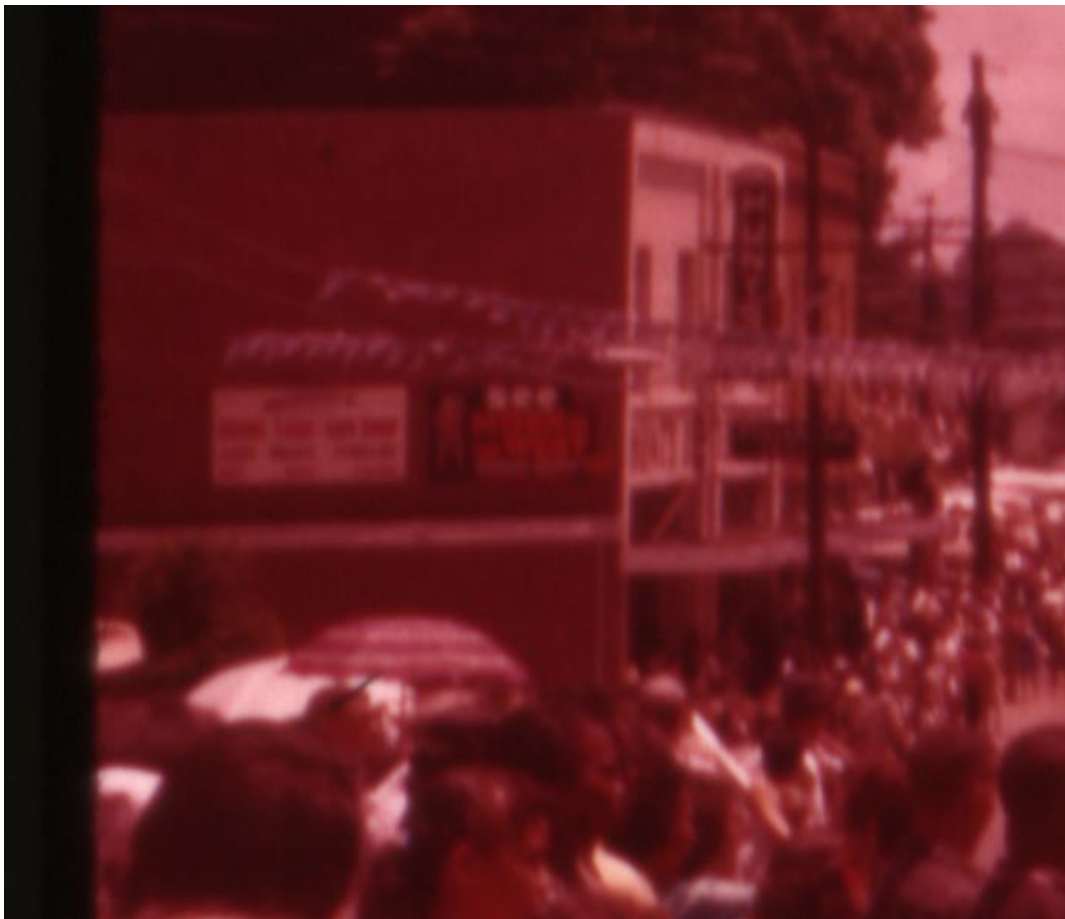
Figure 17. John Ward, "Carolina Charter Parade Float," Digital Watauga, accessed January 3, 2023, <https://digitalwatauga.org/items/show/19968>.

- [Joh-War-01-119](#) Shows the corner in question during a parade in 1963. Two advertisements can be seen on the wall. Circa early 1960s. Compare the Ann-Lar-01-013-a image.

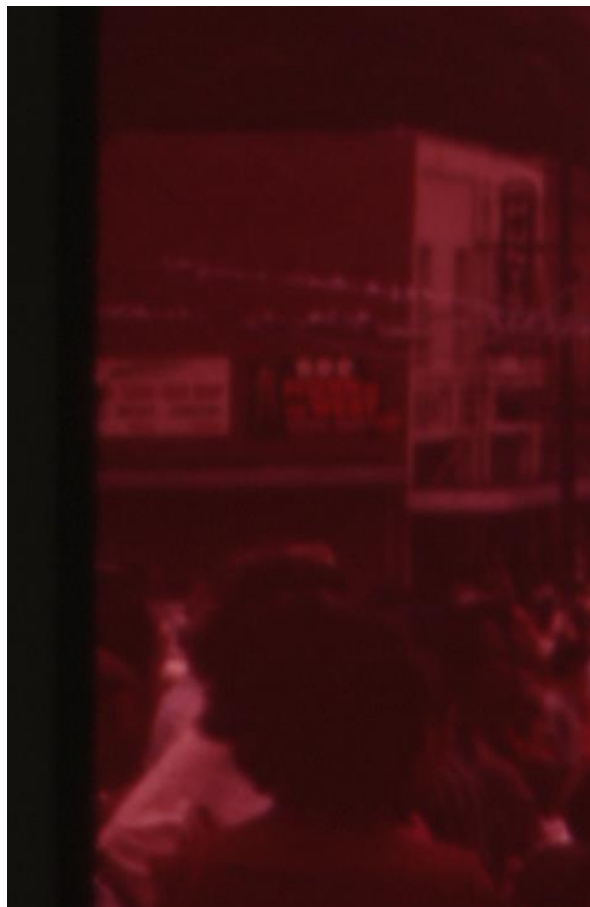
Figure 18. John Ward, "Vintage Cars Driving Down King Street," Digital Watauga, accessed January 3, 2023, <https://digitalwatauga.org/items/show/19976>.

- [Joh-War-01-127](#) Shows the corner in question at a distance during a parade in 1963. Two advertisements can be seen on the wall. Circa early 1960s. Compare the Ann-Lar-01-013-a image

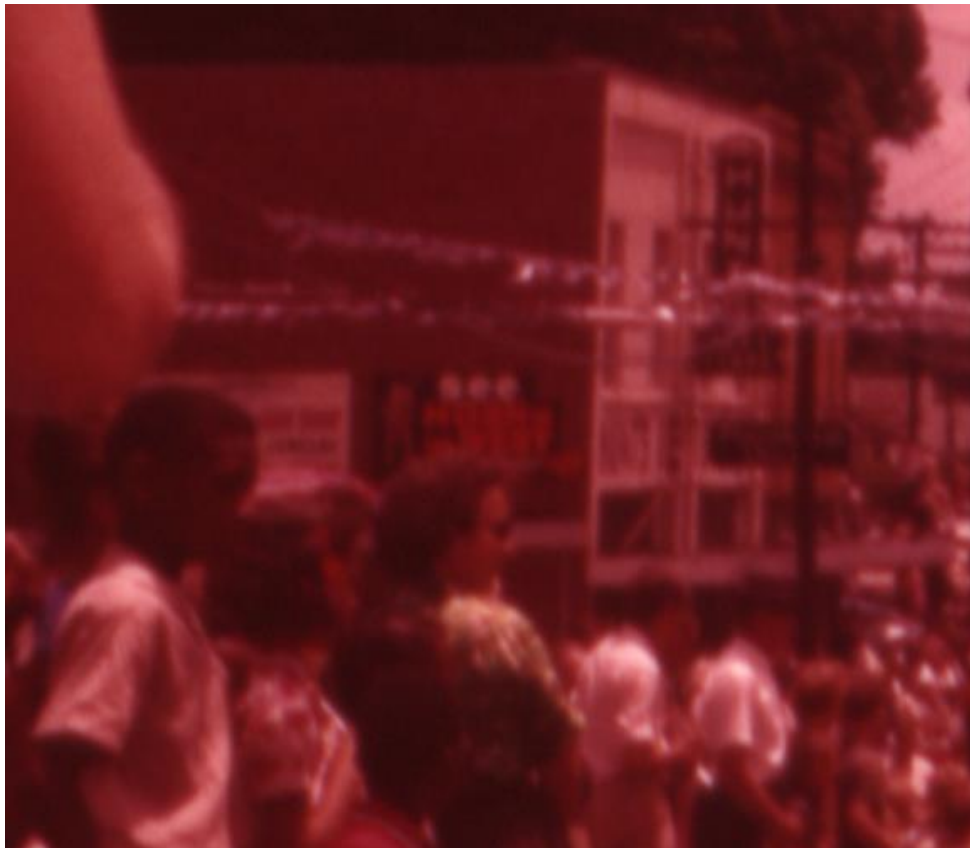
Figure 19. John Ward, "Oxen Pulling Covered Wagons," Digital Watauga, accessed January 3, 2023, <https://digitalwatauga.org/items/show/19977>.

- [Joh-War-01-128](#) Shows the corner in question at a distance during a parade in 1963. Two advertisements can be seen on the wall. Circa early 1960s. Compare the Ann-Lar-01-013-a image

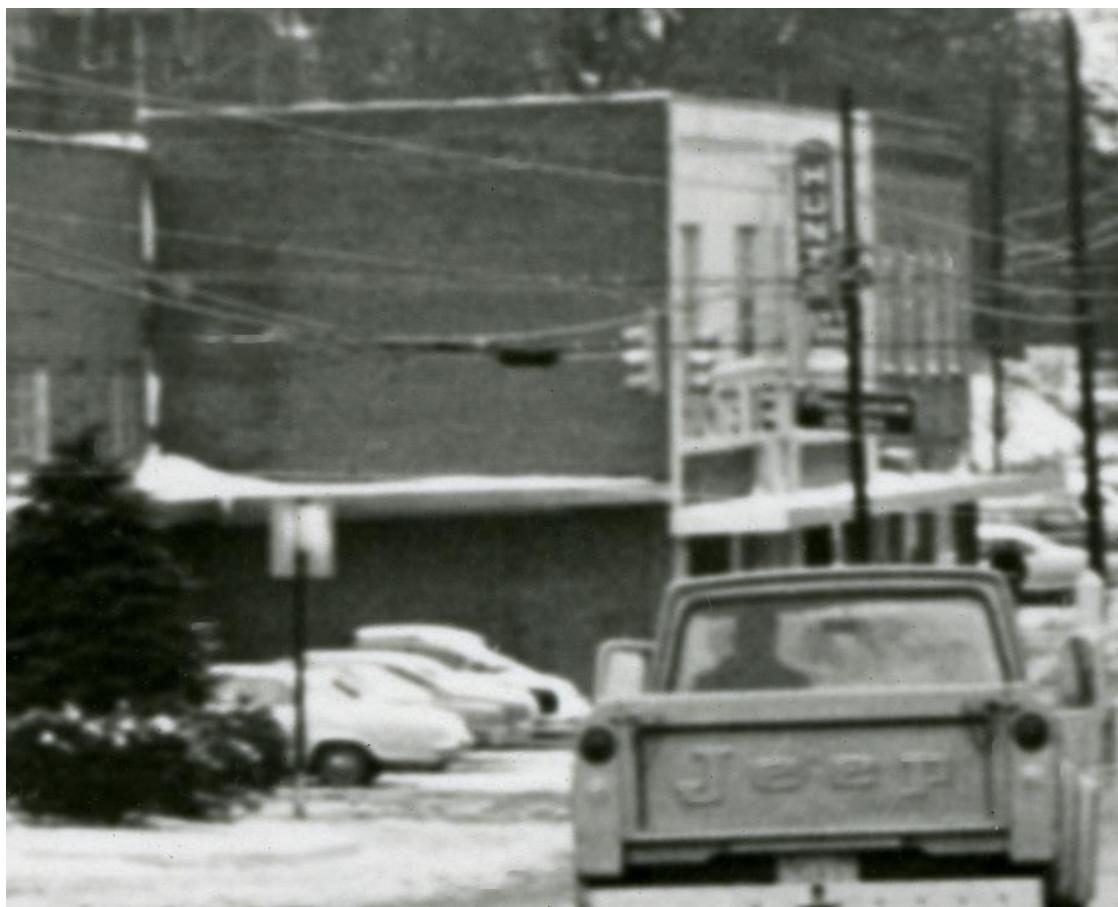
Figure 20. Image from the Paul Armfield Coffey Collection, courtesy of the Digital Watauga Project

- Arm-Cof-20-341 (Pal-Arm-20-341) Shows the corner in question with a small eave and no advertisements. Circa early 1950s.
