# Historic Preservation Commission

**IV. Case Z06278-112122 - Mast Store - COA**

## MAST STORE, INC. – Western Façade repair

### Request

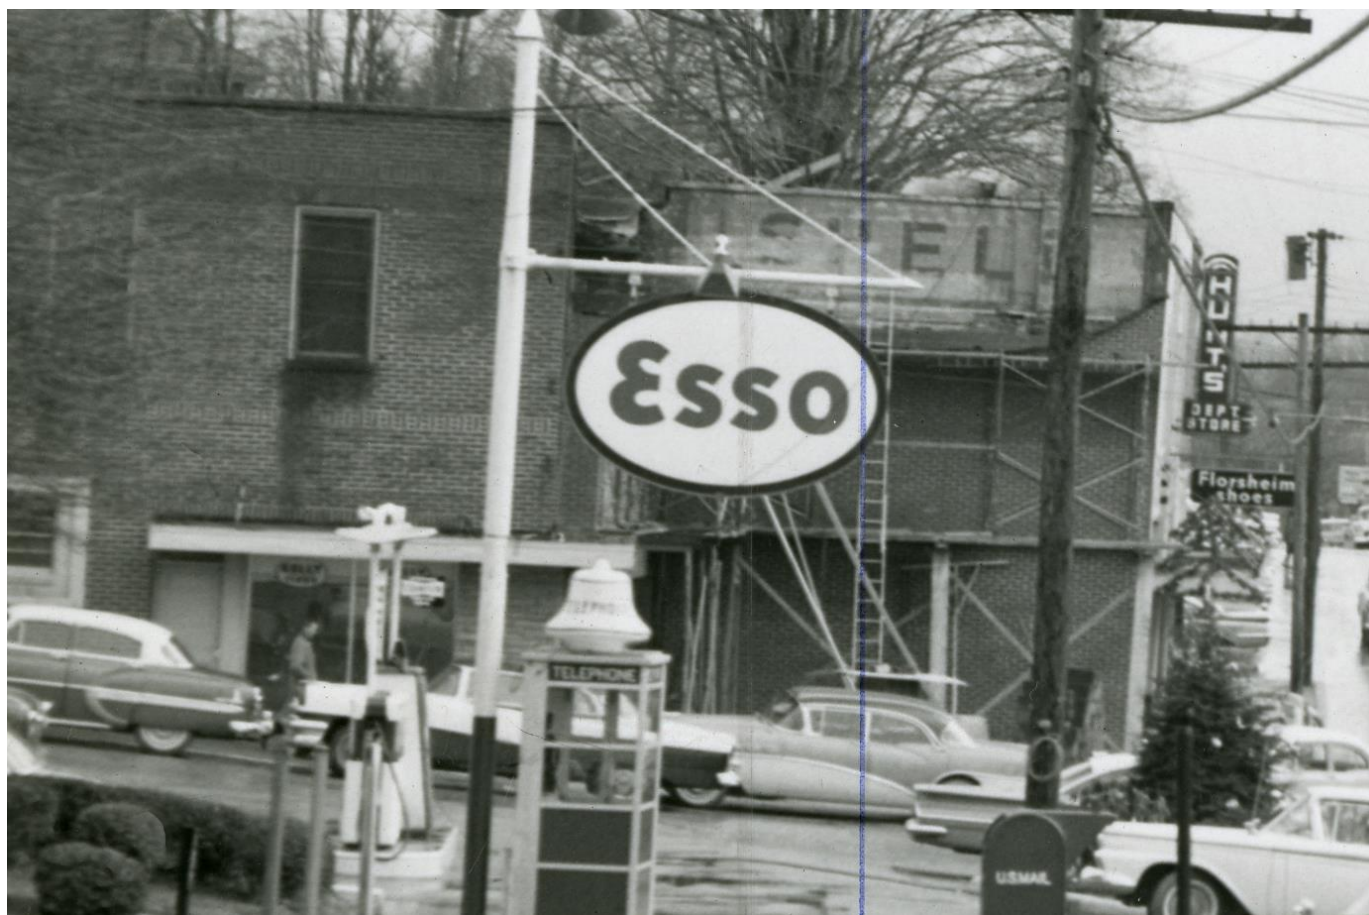
Figure 21. Image from the Paul Armfield Coffey Collection, courtesy of the Digital Watauga Project

- Arm-Cof-21-001 (Pal-Arm-21-001) Shows scaffolding and work being done to the West elevation of the building, a Shell advertisement can be seen. Circa mid 1950s.

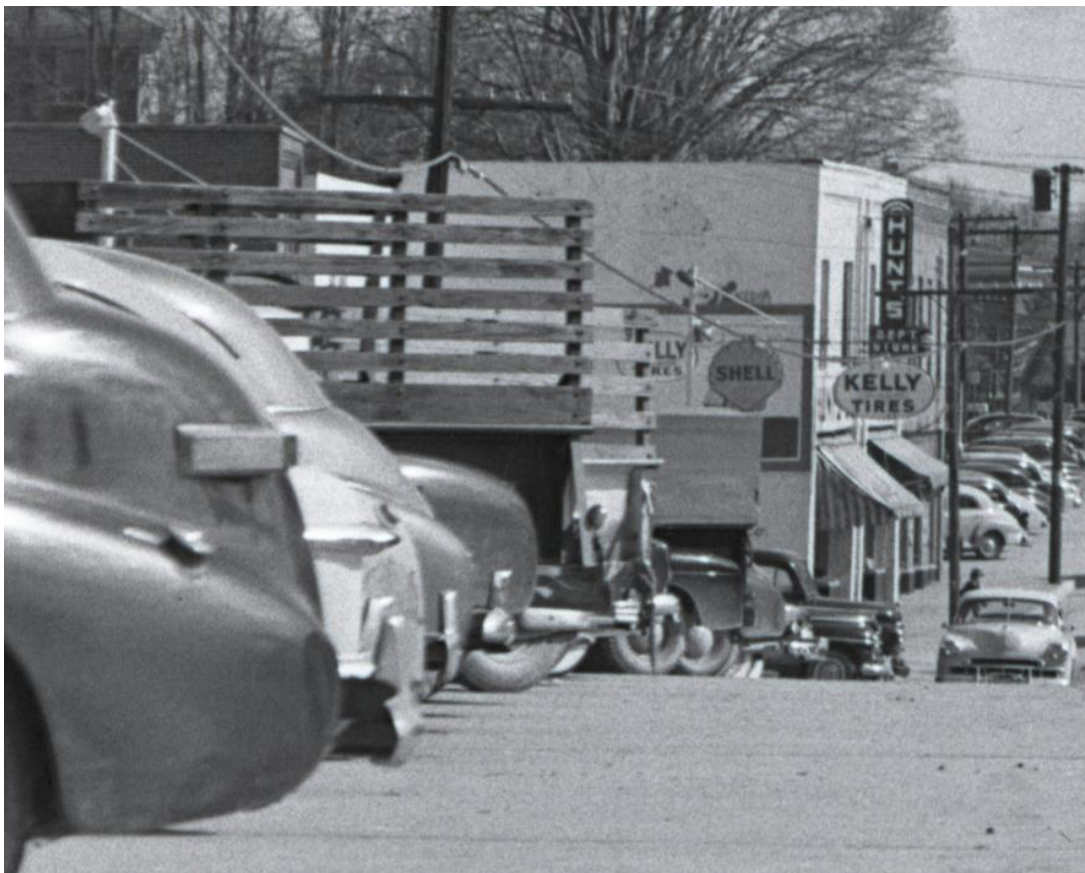
Figure 24. Palmer Blair, "Main Street of Boone in 1953," Digital Watauga, accessed January 3, 2023, <http://digitalwatauga.org/ite>

- [Pal-Bla-04-107](#) Shows the corner in question in 1953 with a Kelly's Tire/Shell advertisement on the wall.

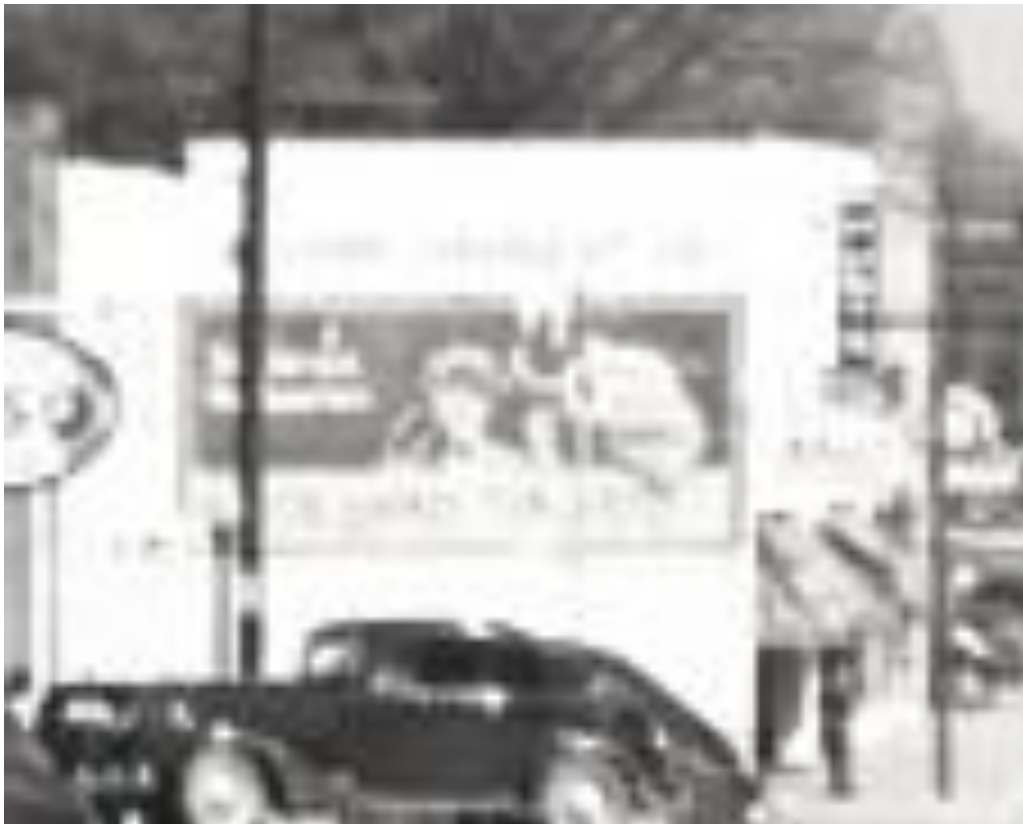
Figure 25. Palmer Blair, "King Street, 1949," Digital Watauga, accessed January 3, 2023, <https://digitalwatauga.org/items/show/3646>.

- [Pal-Bla-04-109](#) Shows the building in 1949, an advertisement can be seen painted on the side facing N. Depot. This image was originally scanned at a low resolution so zooming is difficult here.

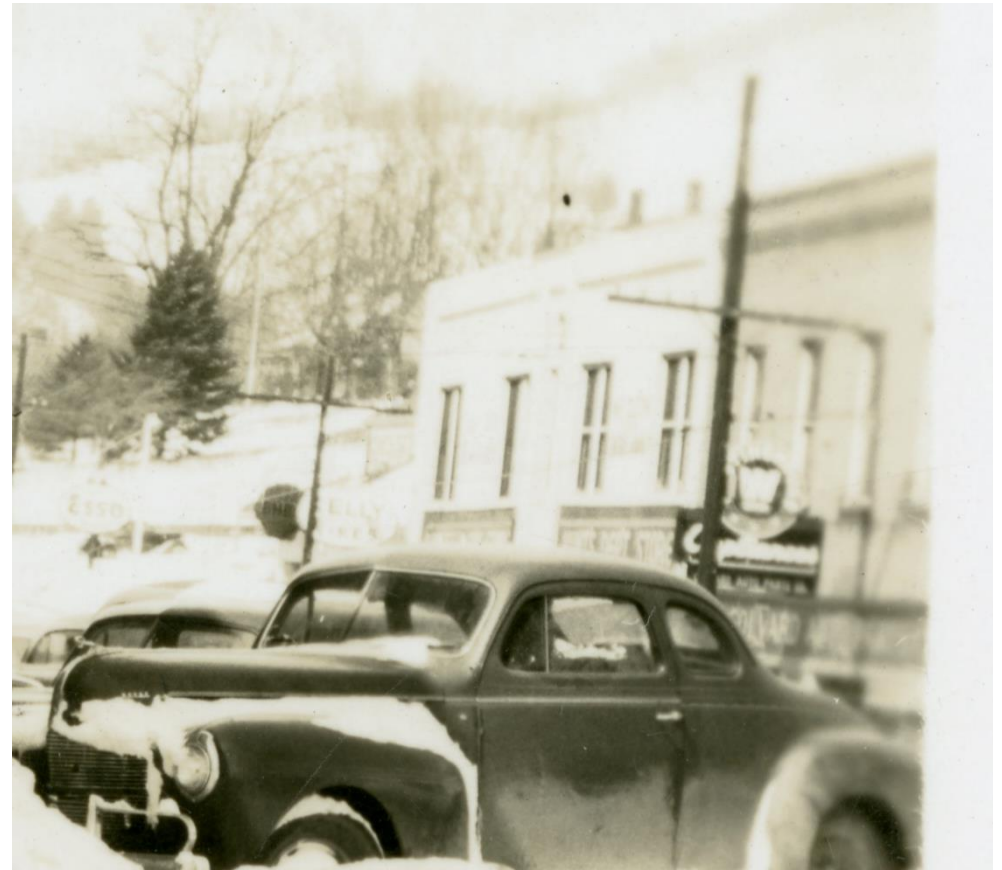
Figure 26. Palmer Blair, "Snow Scene on King Street, Boone, NC, Circa 1945," Digital Watauga, accessed January 3, 2023, <https://digitalwatauga.org/items/show/8275>.

- [Pal-Bla-05-033](#) Shows the front (south elevation) of the building around 1945.

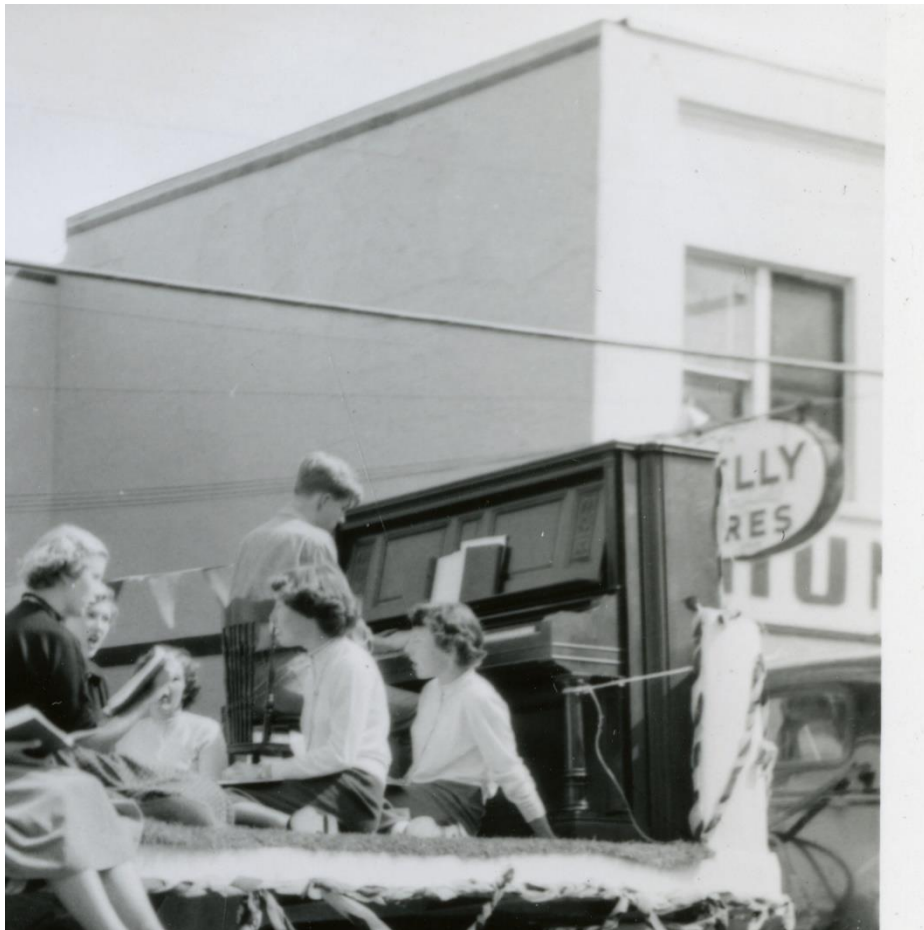
Figure 27. Paul Weston, "Float in Boone Parade, 1950s," Digital Watauga, accessed January 3, 2023, <https://digitalwatauga.org/items/show/6253>.

- [Par-Wes-02-027](#) This image shows a closer image of the corner of the building facing N. Depot in the 1950s without an advertisement on it.

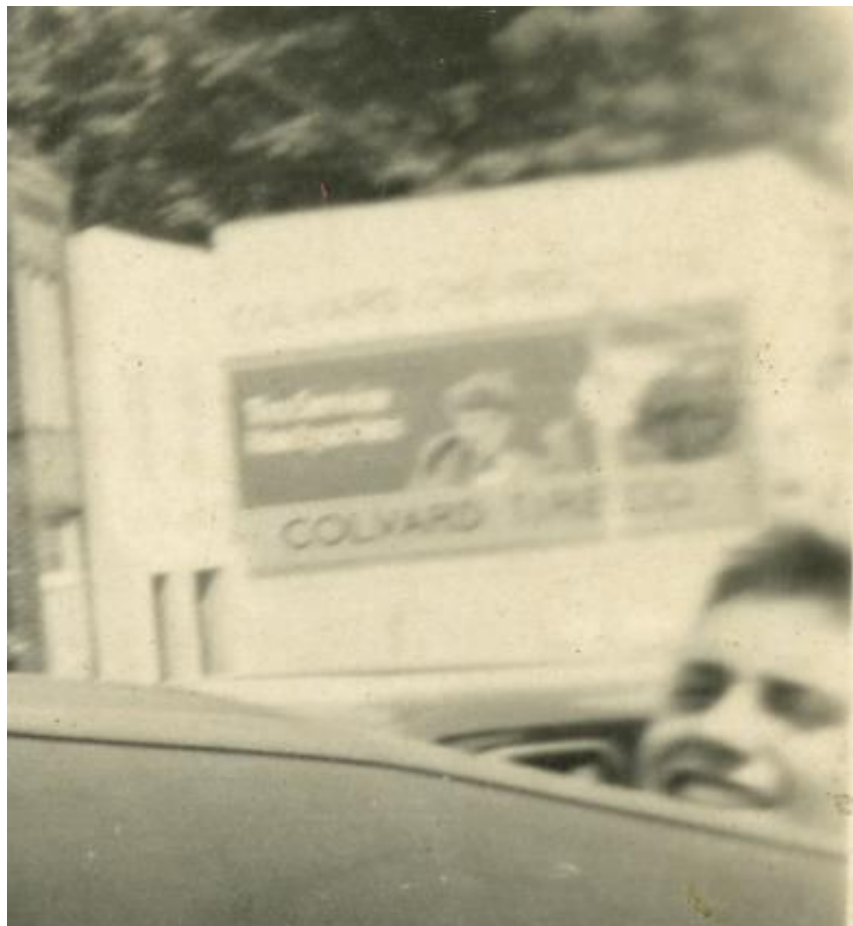
Figure 29. Unknown, "Couple Riding in Convertible Downtown Boone," Digital Watauga, accessed January 3, 2023, <https://digitalwatauga.org/items/show/14989>.

- [Wil-Nor-01-0187](#) This image shows the corner in question in the far right with an advertisement for Colvard Tire Co. This image is dated 1940-1950.
