# Historic Preservation Commission

Regular Meeting

Tuesday, June 11, 2024

**V. Case A24-0285 Qualls Block Renovation - Certificate of Appropriateness**

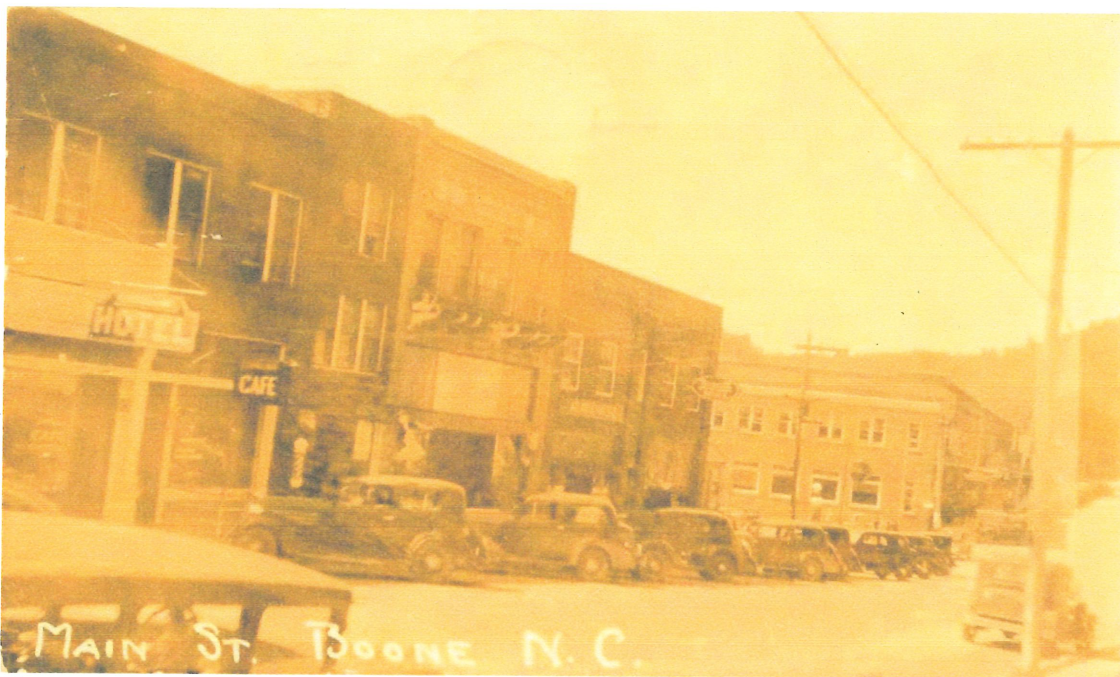
centered on the elevation. By 1937, the basement staircase and safety railing in front of the westernmost storefront had been added, possibly altering the adjacent shop window (where wood trim appears to be much thicker and the window appears to be set back slightly from the clerestory window trim). This image shows the dual entrance for the western half of the building, with the column between the two shop entrances.

The western half of the Qualls Block (left) as it appeared with its new portico circa 1937. Image courtesy of the Bobby Brendell Postcard Collection, Digital Watauga Project.

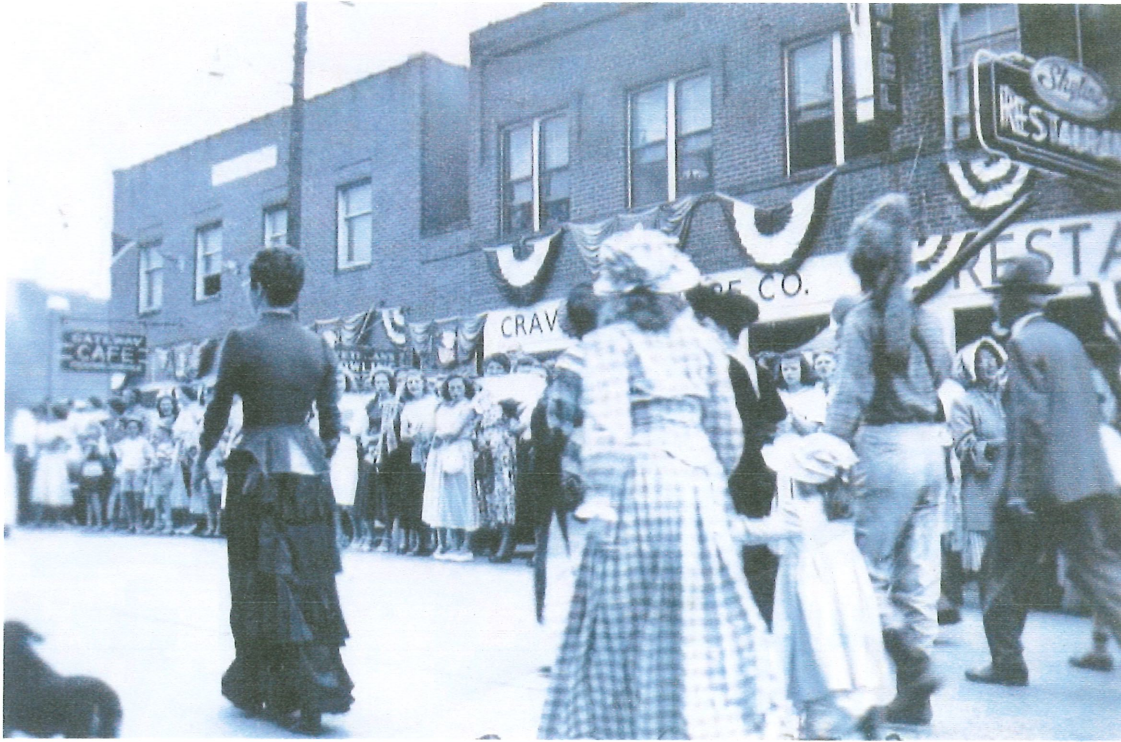
The eastern half of the Qualls Block is visible at center and right in this image from the July 1949 Watauga Centennial Parade. Note that the portico has been removed. Image courtesy of the Palmer Blair Collection, Digital Watauga Project.

*July 1949:* This image shows the upper portion of the eastern 60% of the Qualls Block. Note that the top of the structural glass frieze plate with "Craven Furniture Co." and "Restaurant" appears to align with the bottom of the lower rowlock course—the same alignment of the clerestory windows to the lower rowlock course in the 1923 and 1937 images. The former spacing of storefronts appears to have been abandoned, however, with the formerly centered entrance to the second-floor apartments apparently moved slightly to the east. Better evidence of this is visible in the next image from the 1952 fire. My speculation in the past has been that this alteration of the arrangement of the east storefronts occurred sometime around 1936, followed by the removal of the portico and the addition of the structural glass components circa 1944, when J. R. Craven acquired the building, or as late as 1948 following a series of other transactions. We have no known images that show the entire façade between 1923 and 1949 to verify this.

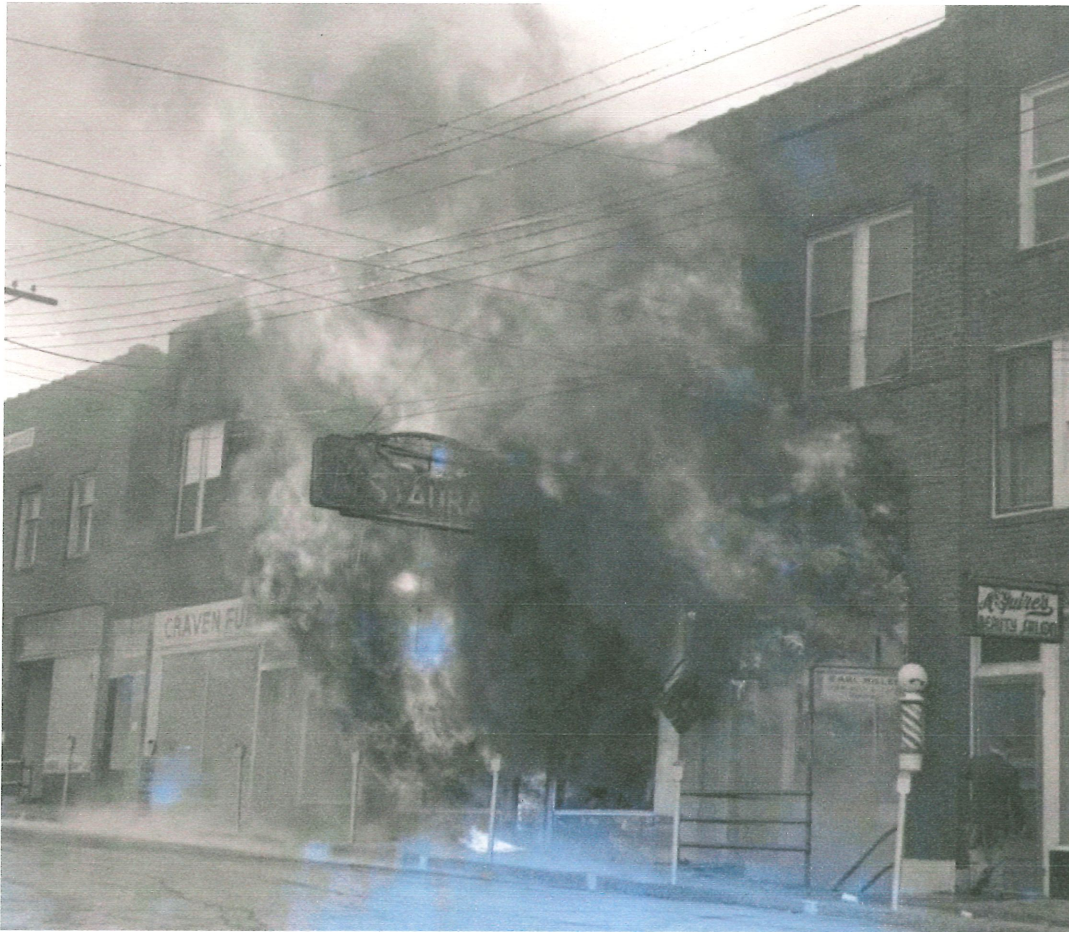
This image shows the Qualls Block during the devastating Christmas Day 1952 fire. Image courtesy of the Palmer Blair Collection, Digital Watauga Project.

*December 25, 1952:* This image shows the lower portion of the Qualls Block during the Christmas Day 1952 fire. The lower portion of the façade appears to be clad in structural glass panels (white up top, a dark color along the bulkheads). The eastern storefront contains a very slightly recessed, double-door entry with narrow transom and flanking aluminum frame shop windows (two east of the entry, one west). Just to the west of this storefront (at the fourth parking meter from left) was the entry to the second-floor stairwell, now moved beneath the third double window bay from the east on the second floor. This shift appears to have been part of the renovations that realigned the east storefronts—as early as 1935 or perhaps as late as 1944 (when Qualls sold the building to Craven) or 1948 (after a series of quick succession transactions beginning in 1945 had put the building in the hands of the Greene and Wilcox families). West of the second-floor door was the Skyline Restaurant, with its large, plate glass windows on either side of a central, single, recessed entry. Finally, at the west end of the block was the City Meat Market, with its single, recessed entry, as well as the basement staircase leading down to Earl Miller's watch and clock repair shop.

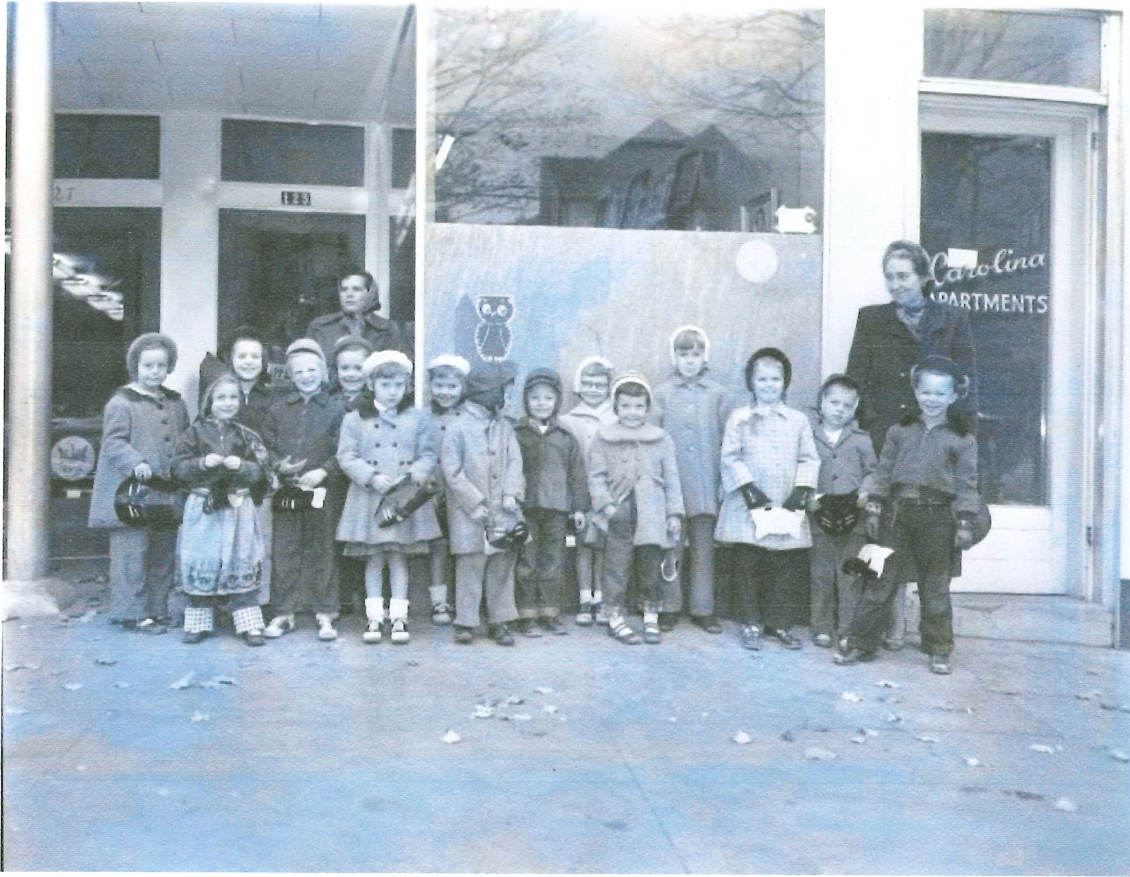
This October 31, 1954, image shows children gathered with their Halloween masks in front of Palmer Blair's studio in the Qualls Block. Image courtesy of the Palmer Blair Collection, Digital Watauga Project.

*October 31, 1954:* This image offers an excellent detail shot of most of the configuration of the eastern two shops with the common recessed entry, the metal pole, and the second-floor apartment entrance. Note the type of door present at that time on the second-floor entry.

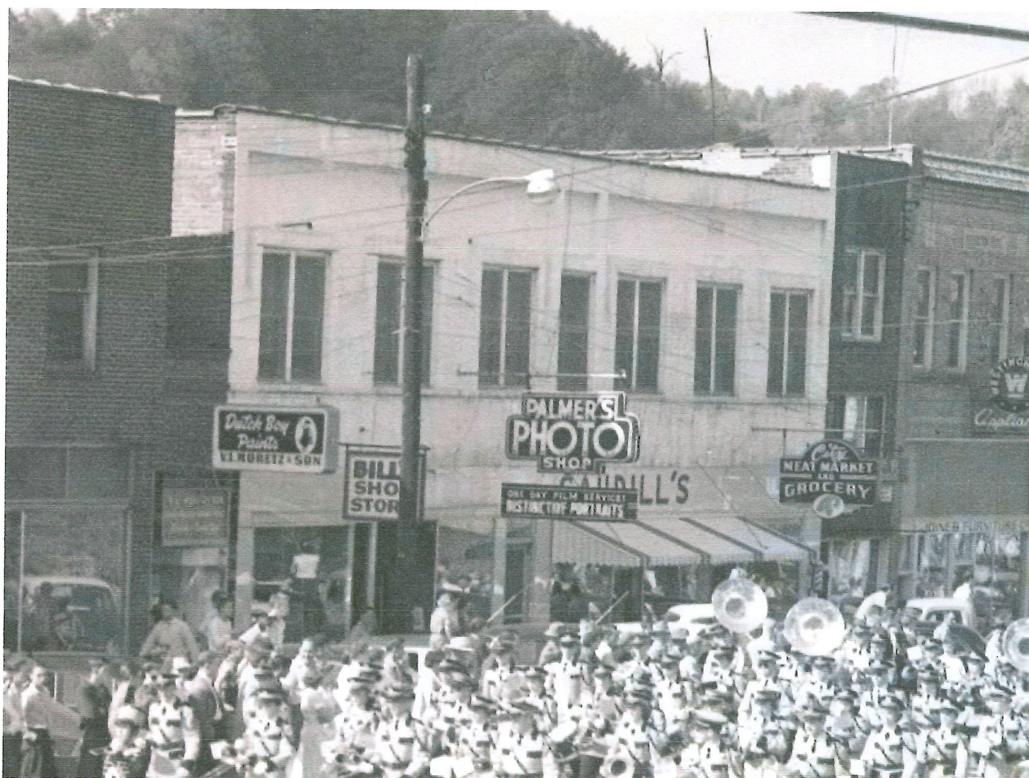
This image is believed to show the September 21, 1956, Appalachian High School Homecoming Parade passing in front of the Qualls Block. Image courtesy of the Palmer Blair Collection, Digital Watauga Project.

*September 21, 1956, and 1958:* These excellent, post-fire images show the changes resulting from the 1952 fire. Most obvious, of course, is the painting of the entire façade with white paint, almost certainly to obscure significant scorching damage to the brick. Also noteworthy is the replacement of the structural glass frieze plate above the first-floor shops with new glass that contained only the Caudill's store name. These images clearly illustrate that the structural glass not only covered the old clerestory window openings above the shopfronts but also extended down to sidewalk level along the obscured masonry portions surrounding storefront and door openings. The east storefront had also been altered into our present-day configuration, with two shops (Bill's Shoe Store and Palmer's Photo Shop) sharing a common recessed entryway leading to two separate doors, and a metal pole supporting the brick façade, cheated toward the easternmost shop windows. The second-floor staircase entry remained in its same location. The metal, cable-hung, scalloped awning over the Caudill's shop obscures some of the next storefront entry to the west, but it appears to be similar to what was there prior to the fire—two large shop windows flanking a centered entry that is slightly recessed (where two women appear to be seated in the 1956 image). West of this is the City Meat Market and Grocery space, with its recessed entry set at the east edge of the store and a large shop window set toward the west.

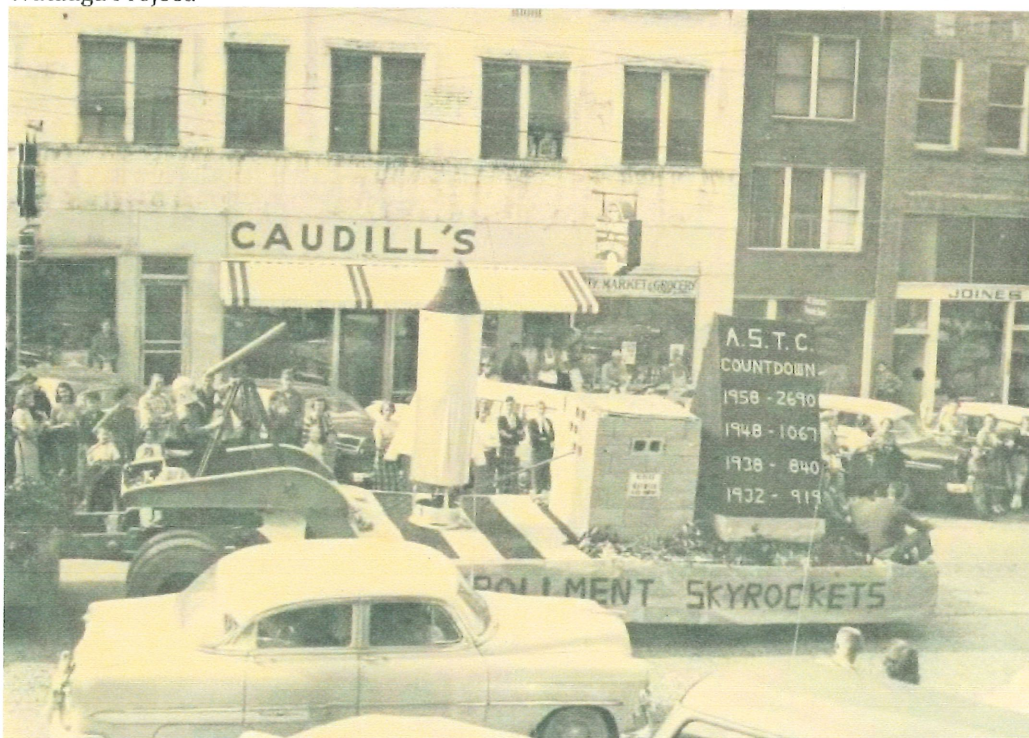
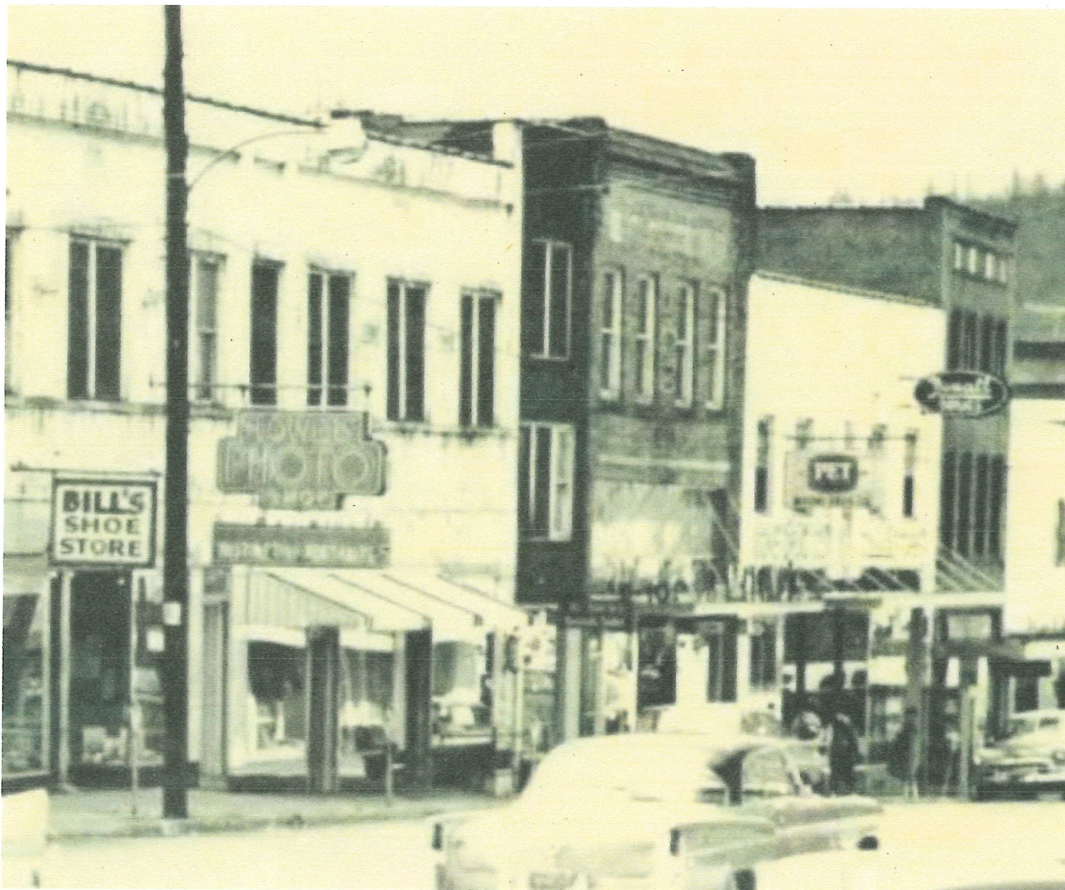
The Qualls Block as it appeared circa 1961. Image from the 1961 *Rhododendron*.

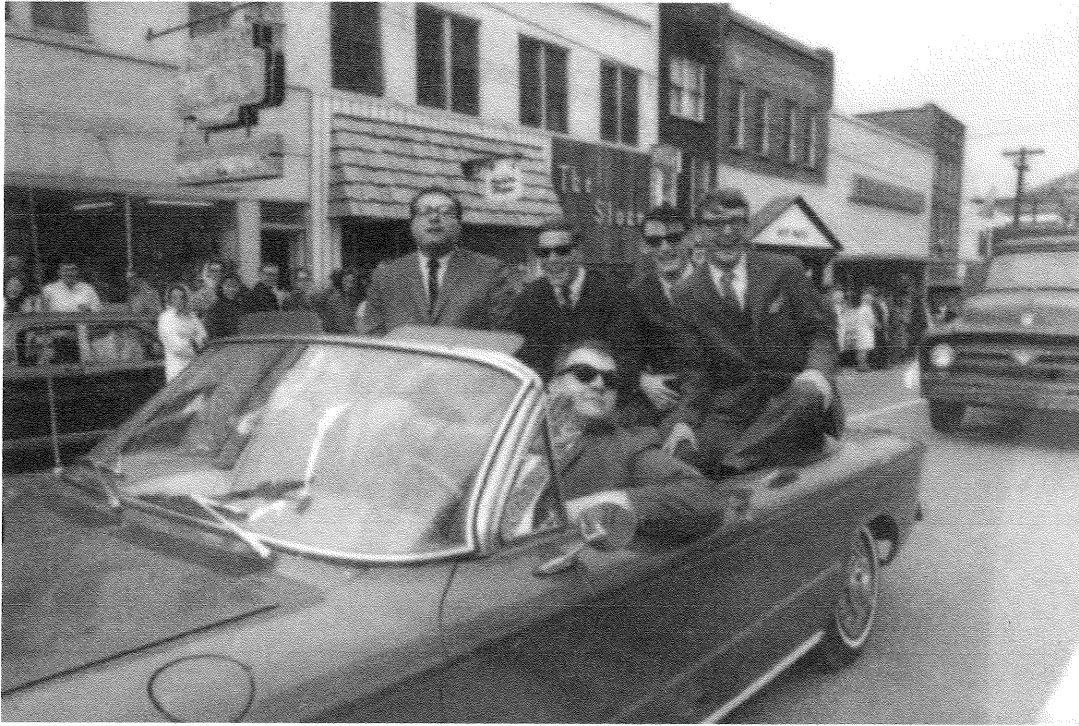
This image shows the configuration of three of the four storefronts in Fall 1965. Image courtesy of the Appalachian State University Historical Photos, ASU Digital Collections.

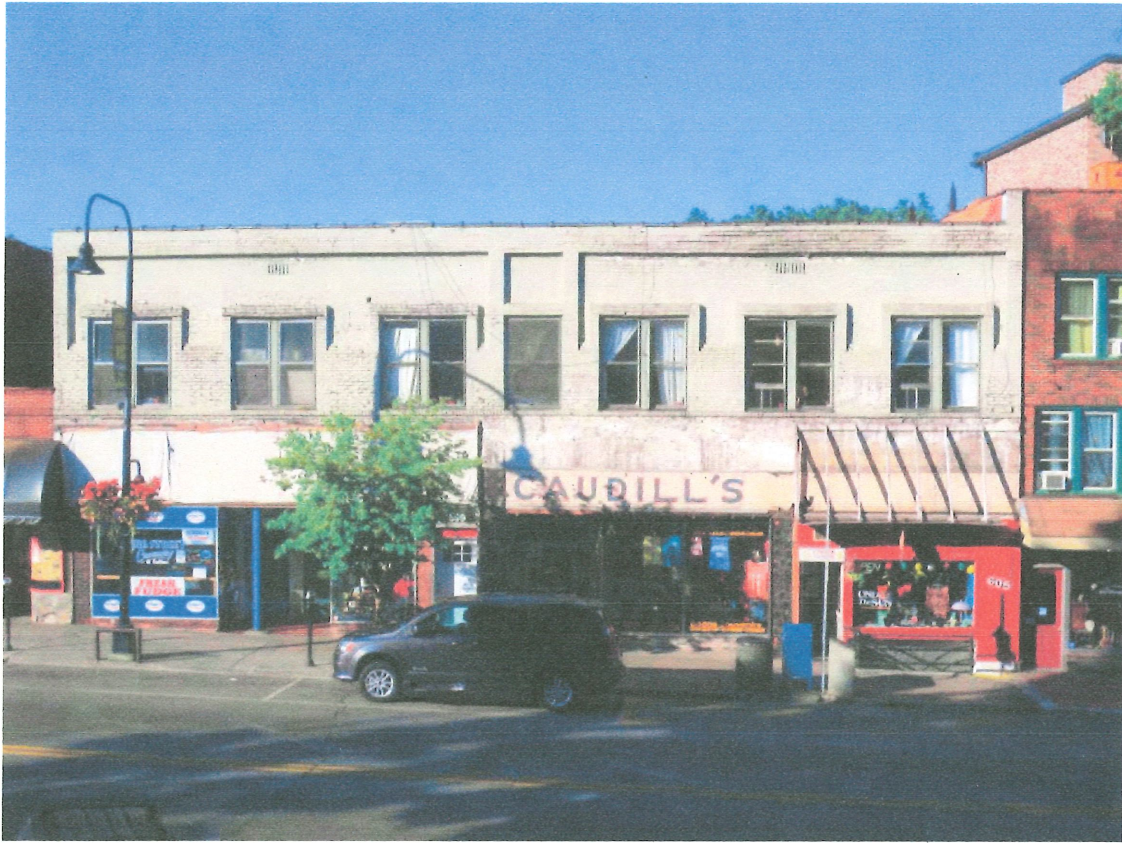
North elevation of the Qualls Block as it appeared on August 18, 2019. Image by Eric Plaag, Carolina Historical Consulting, LLC, for the Downtown Boone Historic Resources Survey Report.

1. As seen in the August 2019 image, most of the post-fire, mid-1950s structural glass signage and veneer treatment surrounding the storefronts was either badly damaged or has been removed. Mastic from the old structural glass application was still visible, adhered to the brick in the columns between the westernmost storefronts. The removal of a portion of the temporary covering over the east storefront in the later 2019 image revealed that the structural glass signage band above that storefront was also badly damaged, with portions missing altogether.

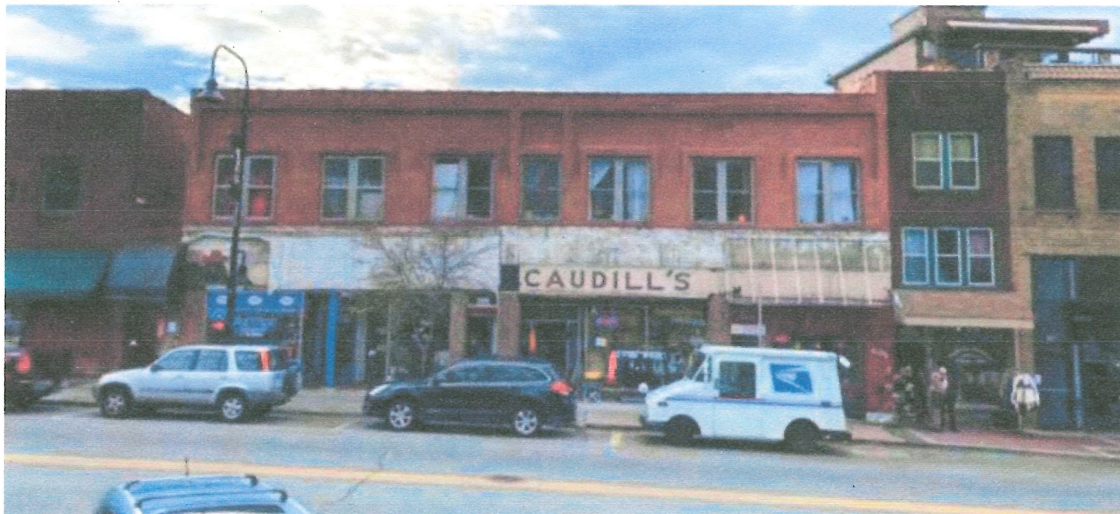
North elevation of the Qualls Block as it appeared in late 2019, after the upper façade had been painted but before the original upper façade windows had been replaced. Image provided by Will Clark, Trade Land Company LLC.

3. As seen in the later 2019 image, the brick stock on the columns surrounding the storefronts has been replaced or covered with a new brick veneer, presumably to achieve a more uniform appearance for the front of the building.

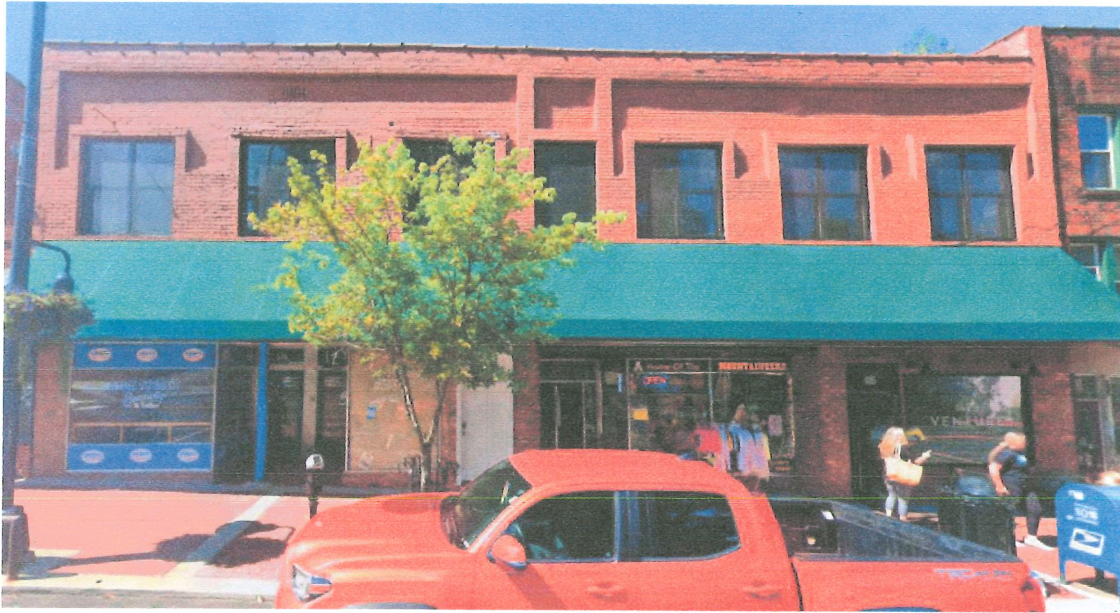
The north elevation of the Qualls Block as it appeared in August 2022, after renovation of the westernmost storefront for Venture Chocolate and replacement of the second-floor windows. Image courtesy of Google Streetview.

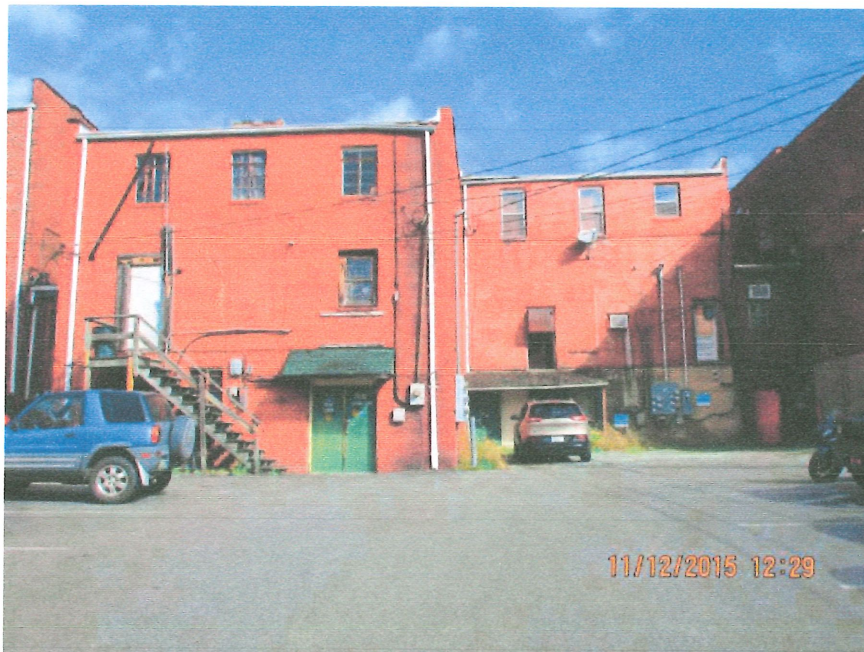
Rear (south) elevation of the Qualls Block as photographed on November 12, 2015, by Nicole Holladay for the Downtown Boone Historic Resources Survey.

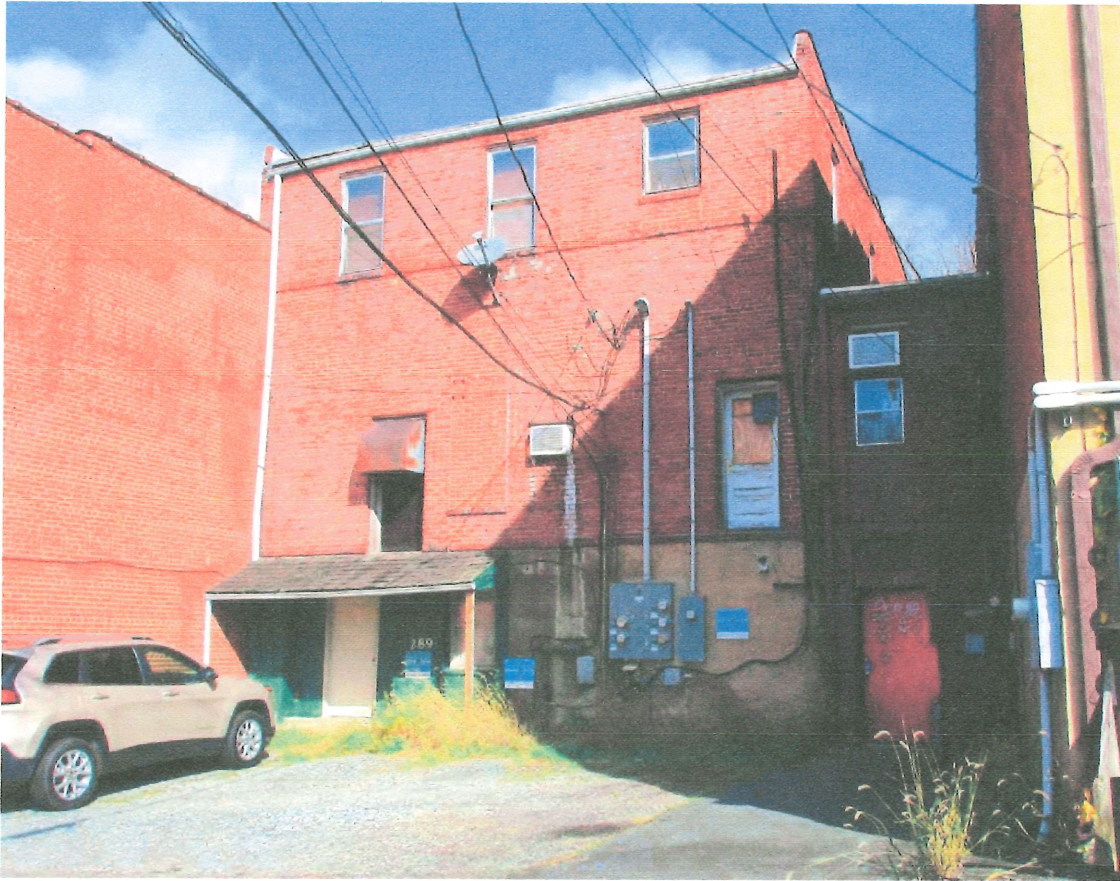
Side (east) elevation of rear of west half of Qualls Block (left) and rear (south) elevation of the east half of the Qualls Block (center) as photographed on November 12, 2015, by Nicole Holladay for the Downtown Boone Historic Resources Survey.

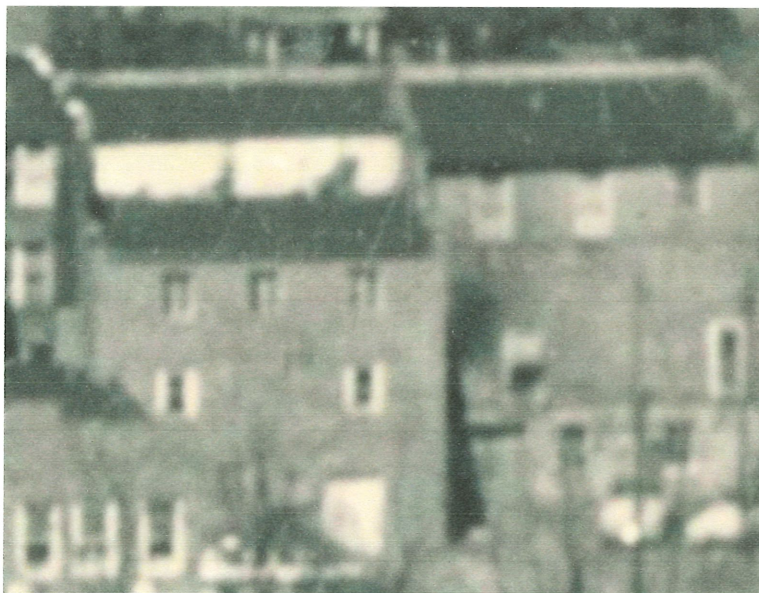
Detail crop showing the rear (south) elevation of the Qualls Block, circa 1960. Image courtesy of the Alfred and Daisy Adams Collection, Digital Watauga Project.

Regarding the proposed changes to the rear (south) elevation of the east half of Qualls Block, these changes attempt to make use of existing piercings in a tertiary elevation to accomplish the desired changes. Furthermore, this tertiary elevation has been so abused in the past by various architectural changes (including new piercings made outside the District's period of significance) as to effectively destroy any sense of the "original" or "historic" appearance of this elevation. In the case of the proposed changes to the side (east) elevation of the rear of the west half of the Qualls Block, this otherwise featureless, undistinguished elevation effectively functions as a tertiary elevation, given that it is not visible from any position other than at the rear of the Qualls Block as a whole. Accordingly, the proposed changes do not appear to violate Appendix D Commercial Standard 6.1, which reads in part, "It is never appropriate to introduce new features, such as vents, bays, windows, or door openings, in exterior walls if they diminish the historic character of the wall or damage historic materials." Indeed, Appendix D Commercial Standard 6.4 further instructs (in part), "On tertiary elevations not visible from the street, new door or window openings should be proportionate to existing ones and include matching design elements." As for the addition of the deck, walkway, and staircase at the rear of the Qualls Block, Appendix D Commercial Standard 8.8 reads,

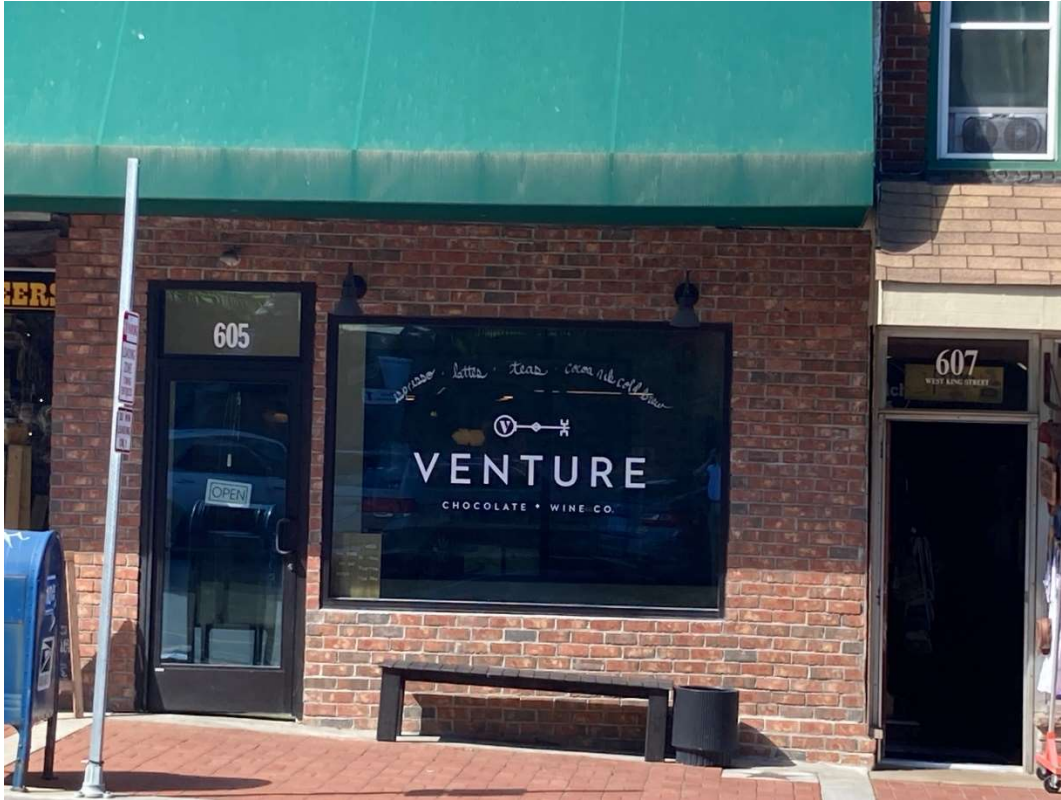
605 West King (similar design but smaller scale fixtures)

**Staff Note:** *To assist with your analysis, Staff visited other properties within the Historic District to find similar front façade light fixtures. Although no fixtures of the exact size and design of that on the subject parcel were found, a few similar fixtures are shown below. Photos were taken by Staff.*

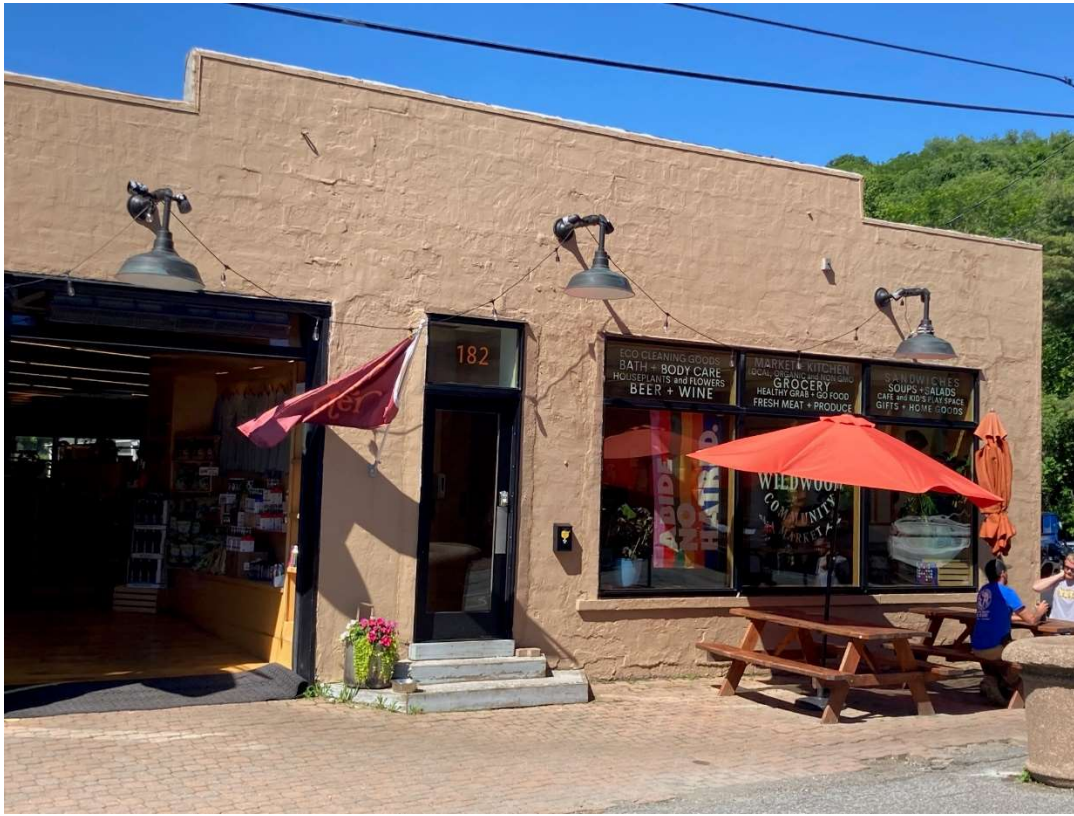
186 Howard Street (similar size and a somewhat similar but simpler design)

**Staff Note – As noted by the applicant in the Design Narrative, the light fixture is very similar in size and design to the Town of Boone street lights throughout the District.**
