**Town of Boone  
Planning Commission  
Special Meeting  
6:00 PM, Sep. 29, 2021  
WebEx, WebEx**

Part 1: Cases PL03370-112019 & PL05025-082321 B1 Downtown  
Expansion UDO  
Text and General Use Zoning Map Amendments Staff Report

Part 2: Cases PL05043-083121 & PL05063-090921 Downtown Boone  
Historic District  
Overlay UDO Text and General Use Zoning Map Amendments

## **TOWN OF BOONE DOWNTOWN PLANNING PROJECTS PREFACE**

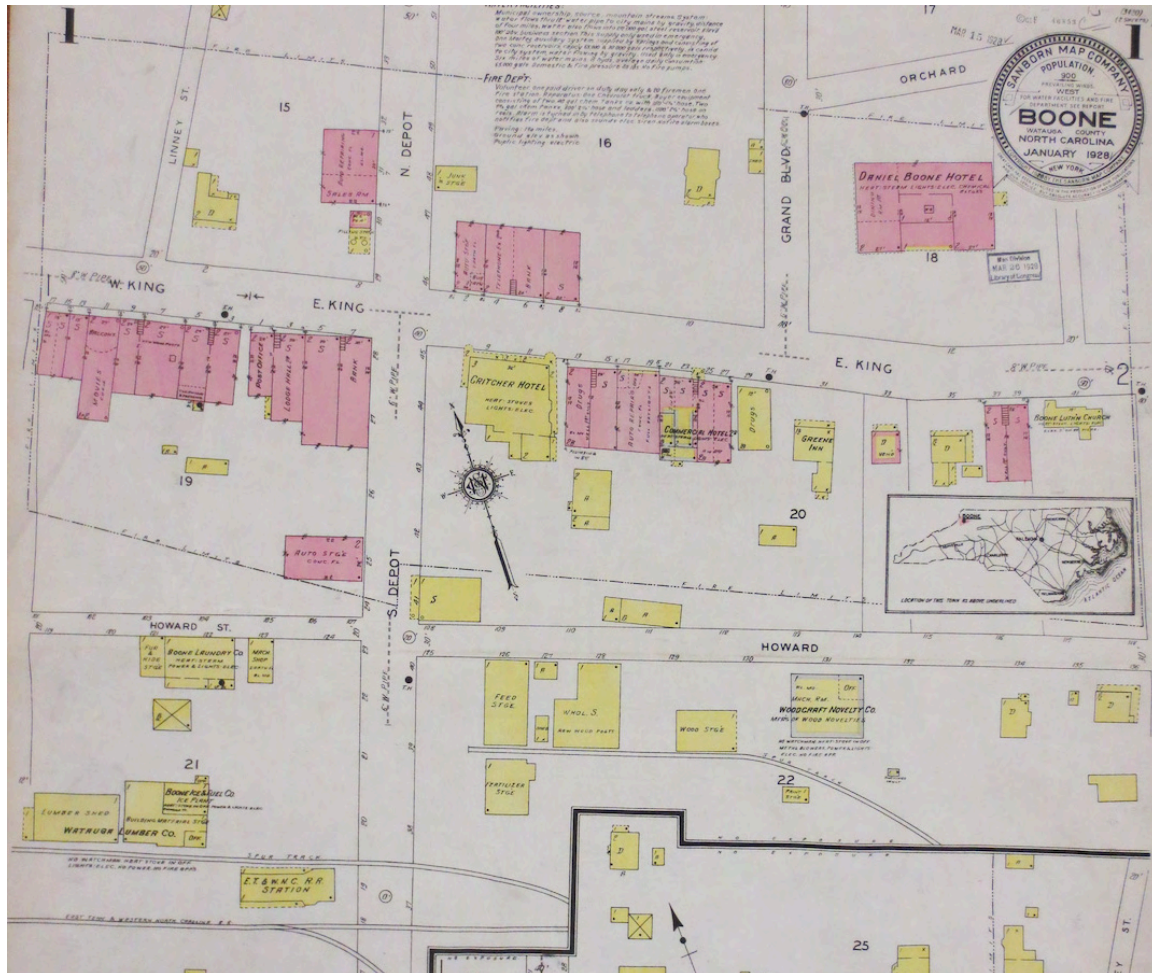
Seen here is the top half of Sheet 1 of the 1928 Sanborn Fire Insurance Company map of Boone, as photographed by the author at the Library of Congress in Washington, DC, showing the east portion of the downtown area. The thick, black boundary at lower right indicates the border of the western portion of town, portrayed on the lower part of the sheet.

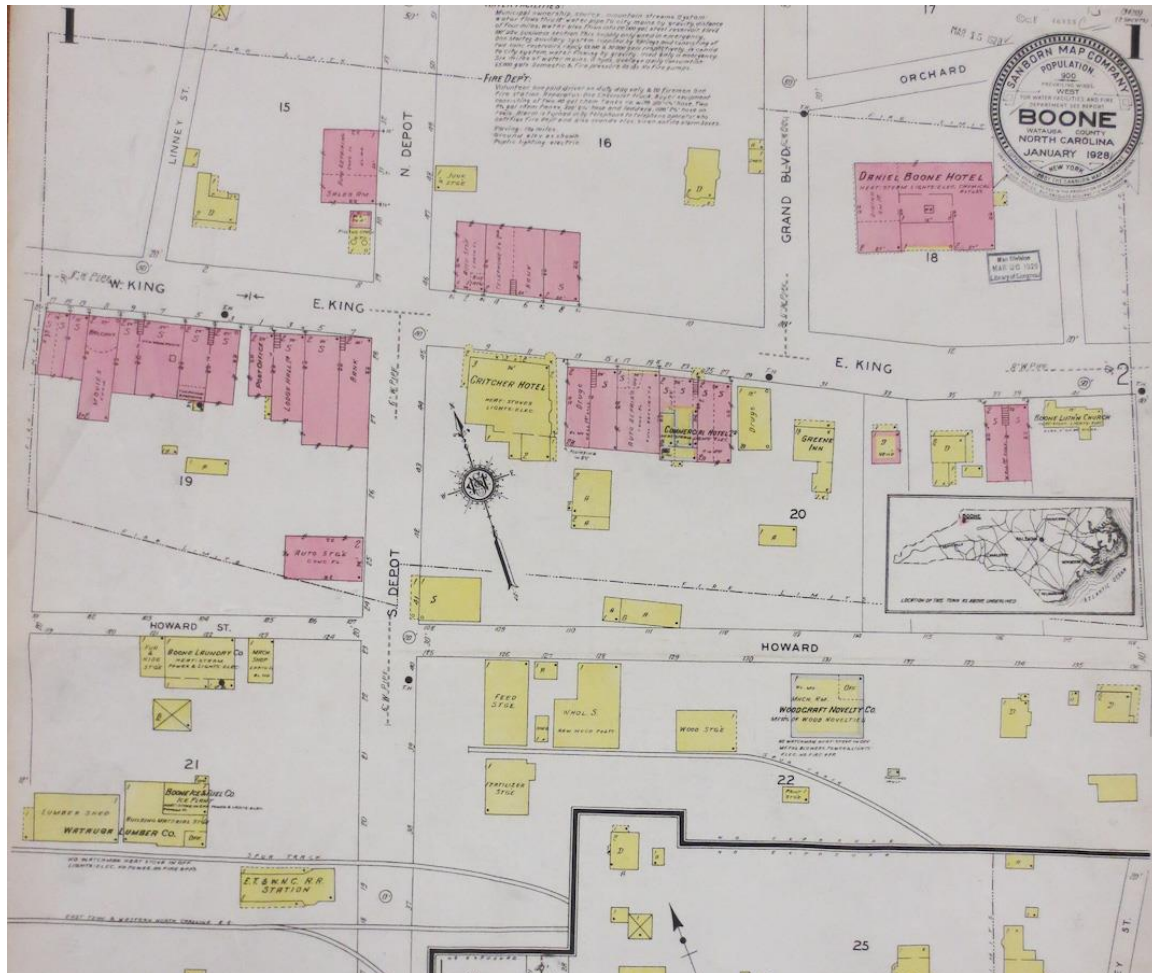
Seen here is the top half of Sheet 1 of the 1928 Sanborn Fire Insurance Company map of Boone, as photographed by the author at the Library of Congress in Washington, DC, showing the east portion of the downtown area. The thick, black boundary at lower right indicates the border of the western portion of town, portrayed on the lower part of the sheet.

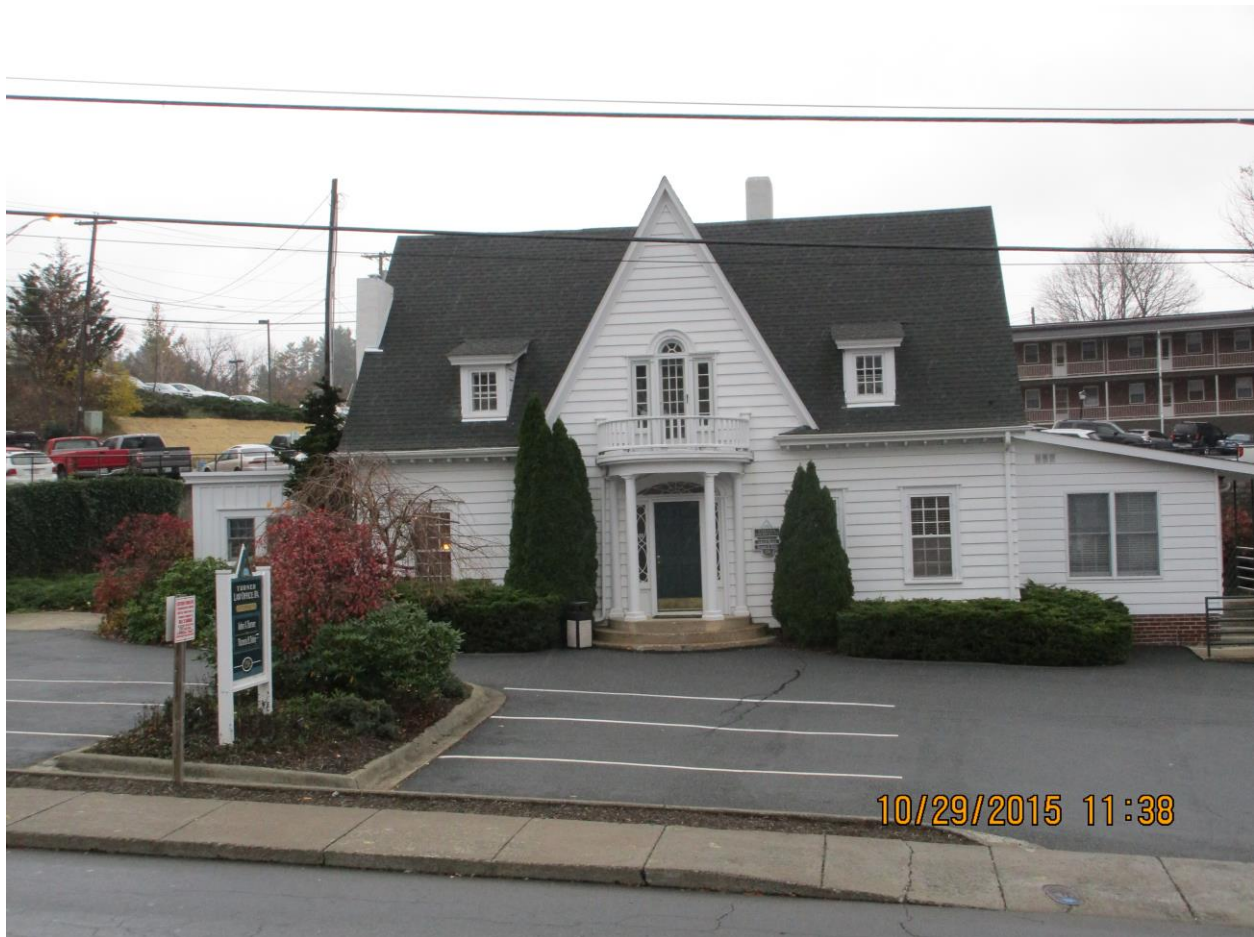
"The Oscar and Suma Hardin House retained many original and architecturally significant features prior to its demolition in January 2021, but later updates removed some original elements and grafted other architectural components (such as vinyl siding) into the mix that did not fit with the original architectural character of the house. Removal of inappropriate new elements and thoughtful restoration of original elements that have disappeared can restore architectural integrity to significant properties within the District. Photo by Nicole Holladay, 2015."

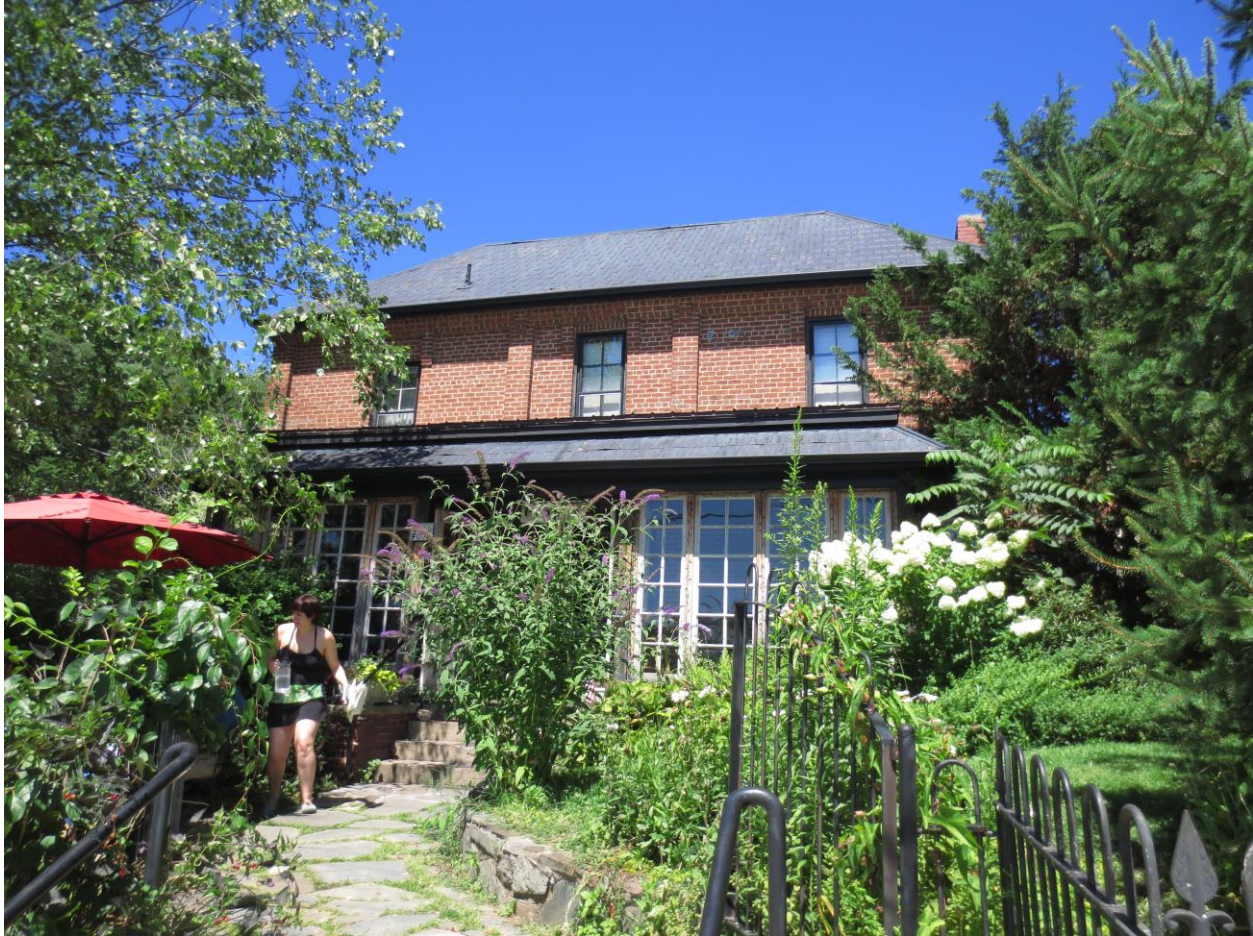
The Watauga County Jail features important masonry details on its primary elevation. Patching of second-floor masonry using Portland cement and other materials mars the historic appearance of the masonry and poses a risk to its stability. Photo courtesy of Eric Plaag, 2015.

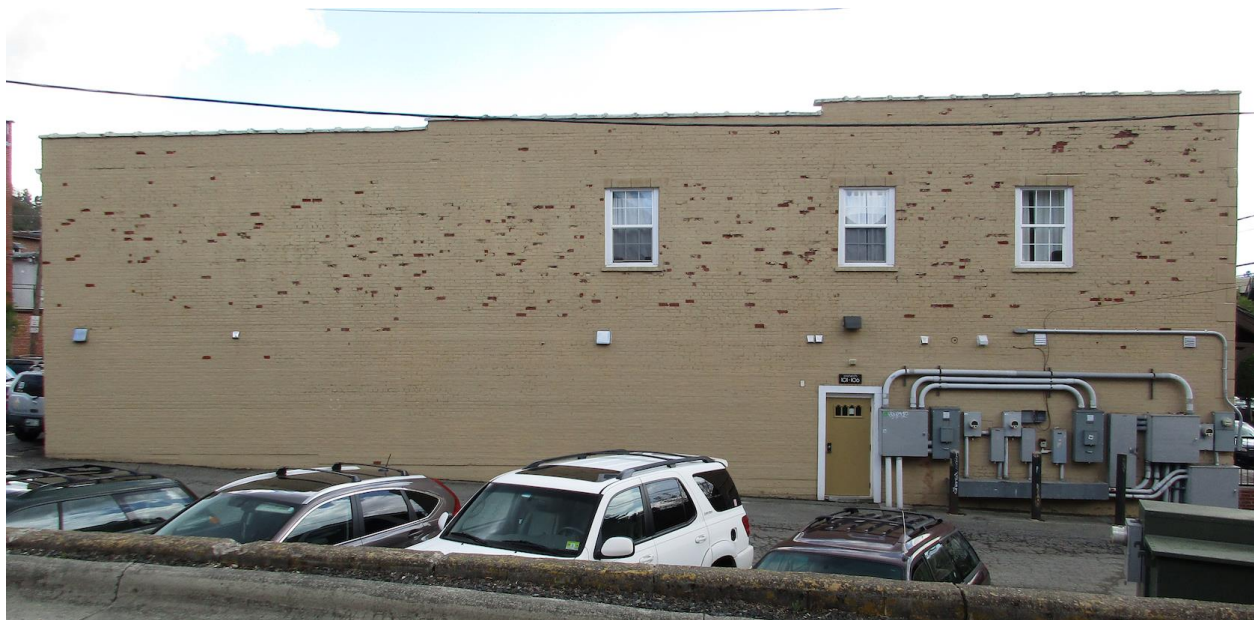
Spalling, as seen on the western wall of this Howard Street building, is often the result of moisture being trapped behind the brick face, freezing, and thus forcing the brick face to pop off. In this particular case, the use of paint to cover the brick wall has likely accelerated the spalling condition. Attempting to cover the spalling through the use of cement infills or other patchwork repairs is not recommended. Image by Paul Fuller, 2016.

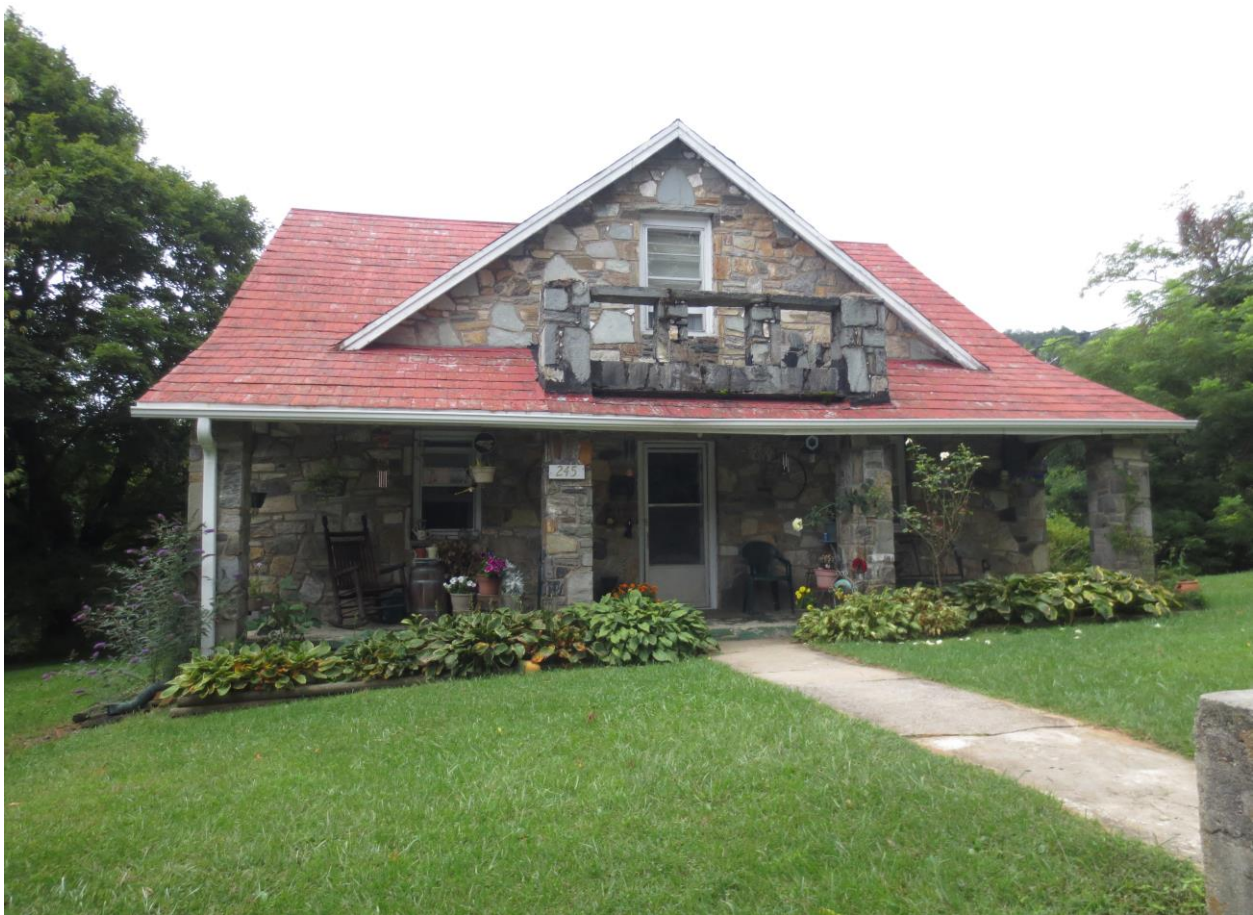
The use of tar as a flashing material, as seen around the second story porch of this historic and otherwise very attractive Boone residence, can damage original masonry and is unsightly. Photo courtesy of Eric Plaag, 2013.

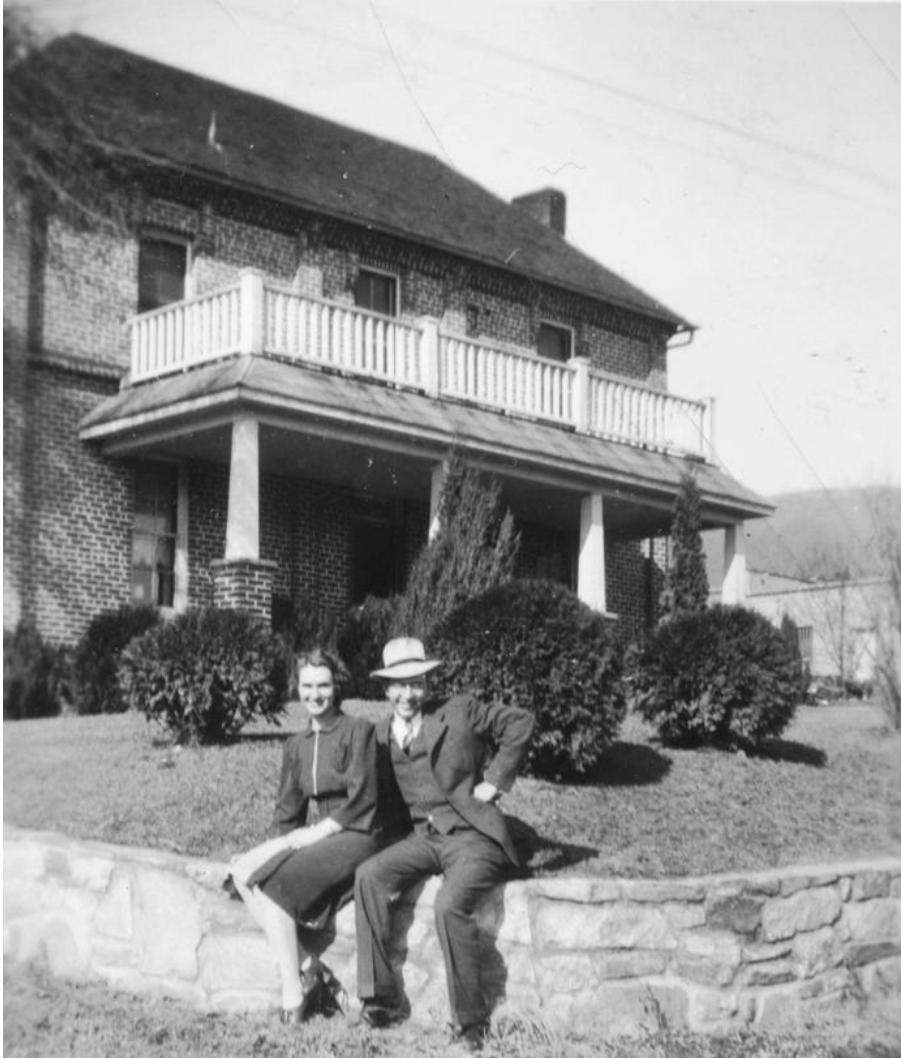
Original entrance configurations and porches should never be closed in or obscured by additions to historic properties. Alterations to the porch of the Watauga County Jail from its appearance in this 1940 image have obscured architectural details and made interpretation of the porch difficult. Image courtesy of the David Wyke Collection, Digital Watauga Project.

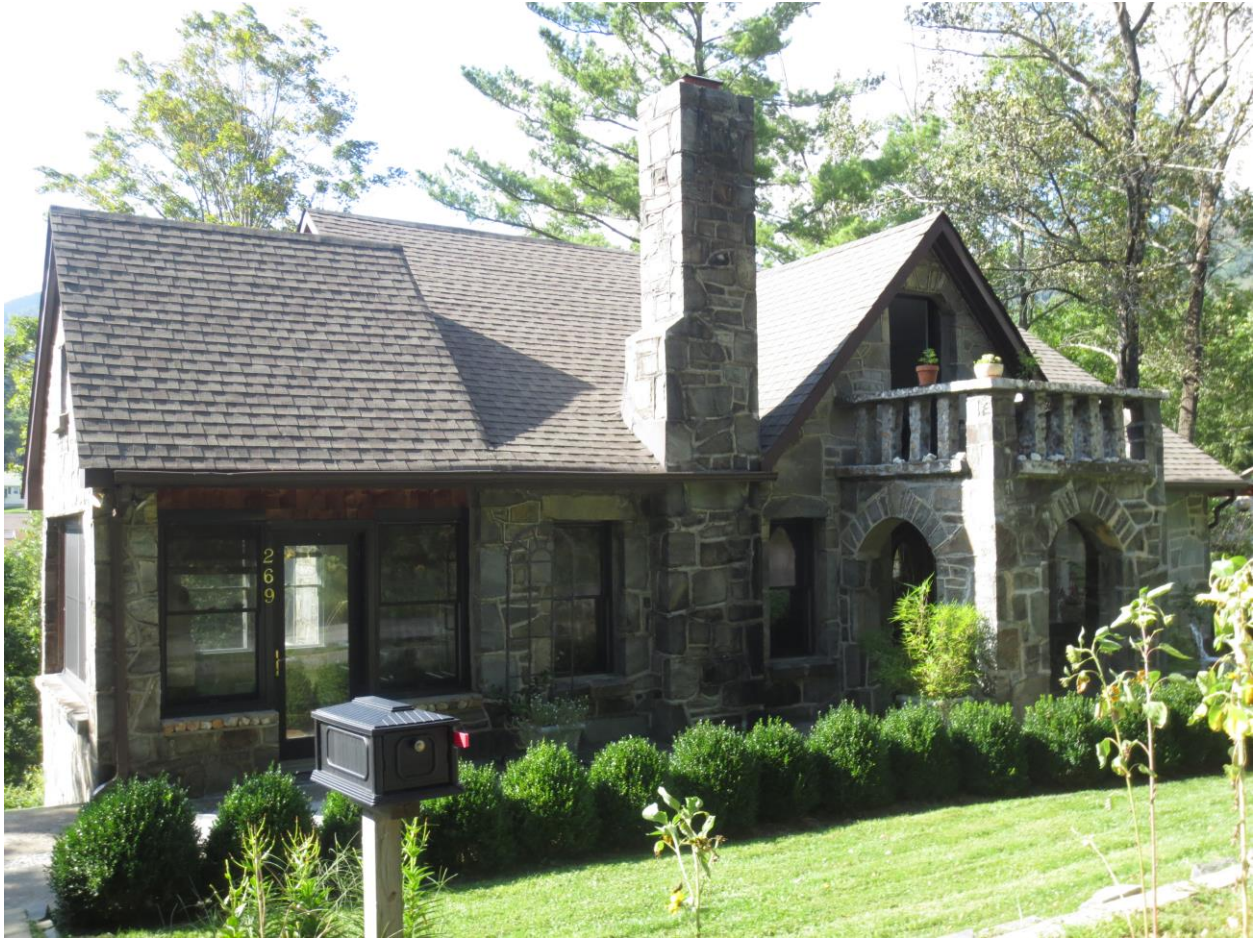
Additions like the one shown on the left side of this Grand Boulevard home should incorporate their own architectural style while also remaining harmonious with the historic part of the building. The use of a roofline distinction can also help communicate that the addition was not part of the original house without distracting from the architectural character of the original section. A lower roof pitch in the addition here, rather than the higher pitch selected, would have helped to further mute the overall impact of the addition on the rest of the property. Photo courtesy of Eric Plaag, 2013.

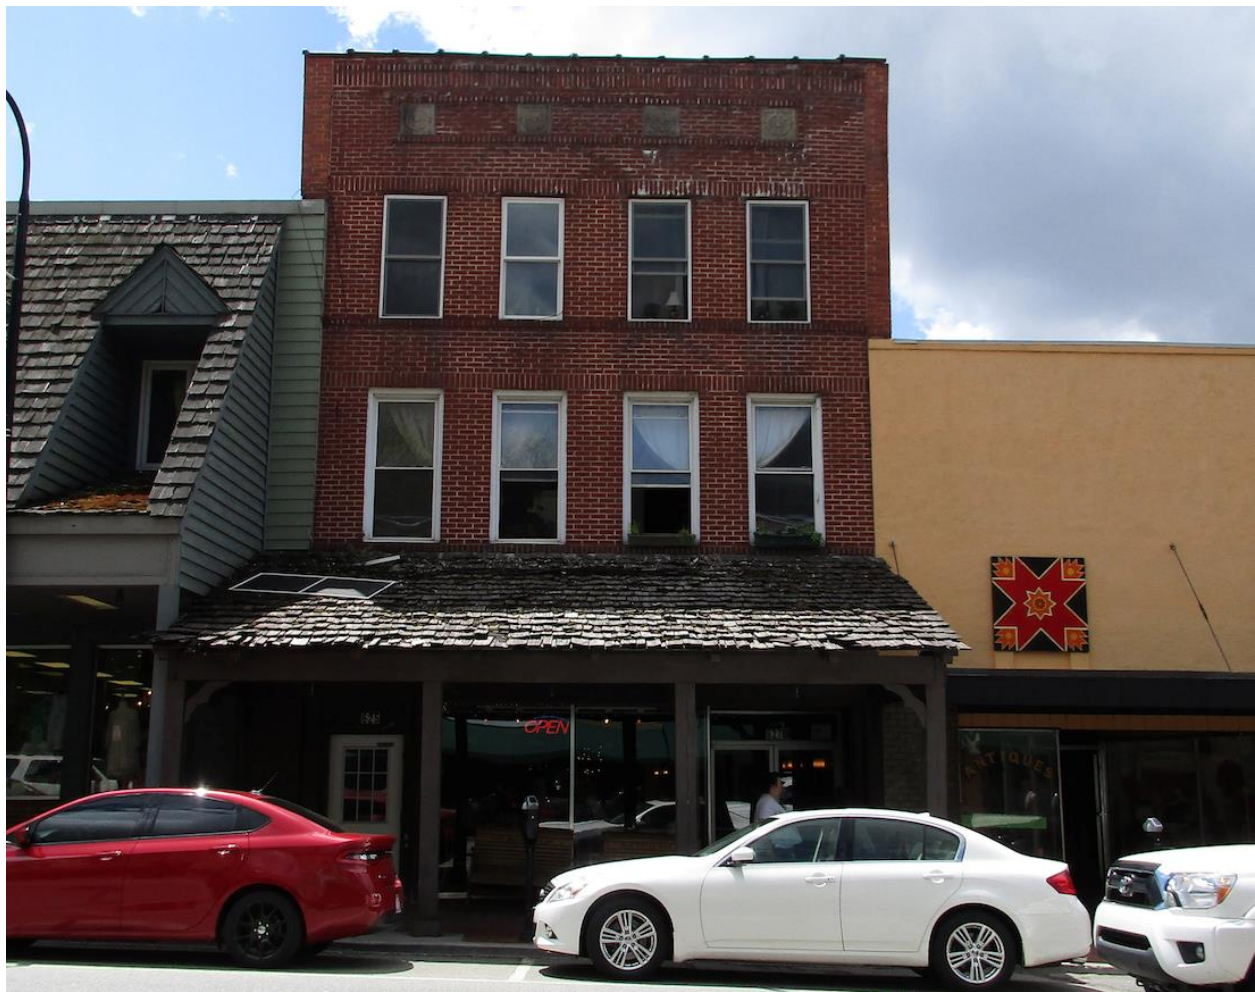
“Mountain village” porch coverings like this one on King Street are never historically appropriate to the District and should be removed in favor of historically documented metal-frame or cable-hung awnings as part of facade rehabilitation efforts. Hidden historic architectural elements, such as clerestory windows and transoms, should also be uncovered and restored. Photo by Paul Fuller, 2016.

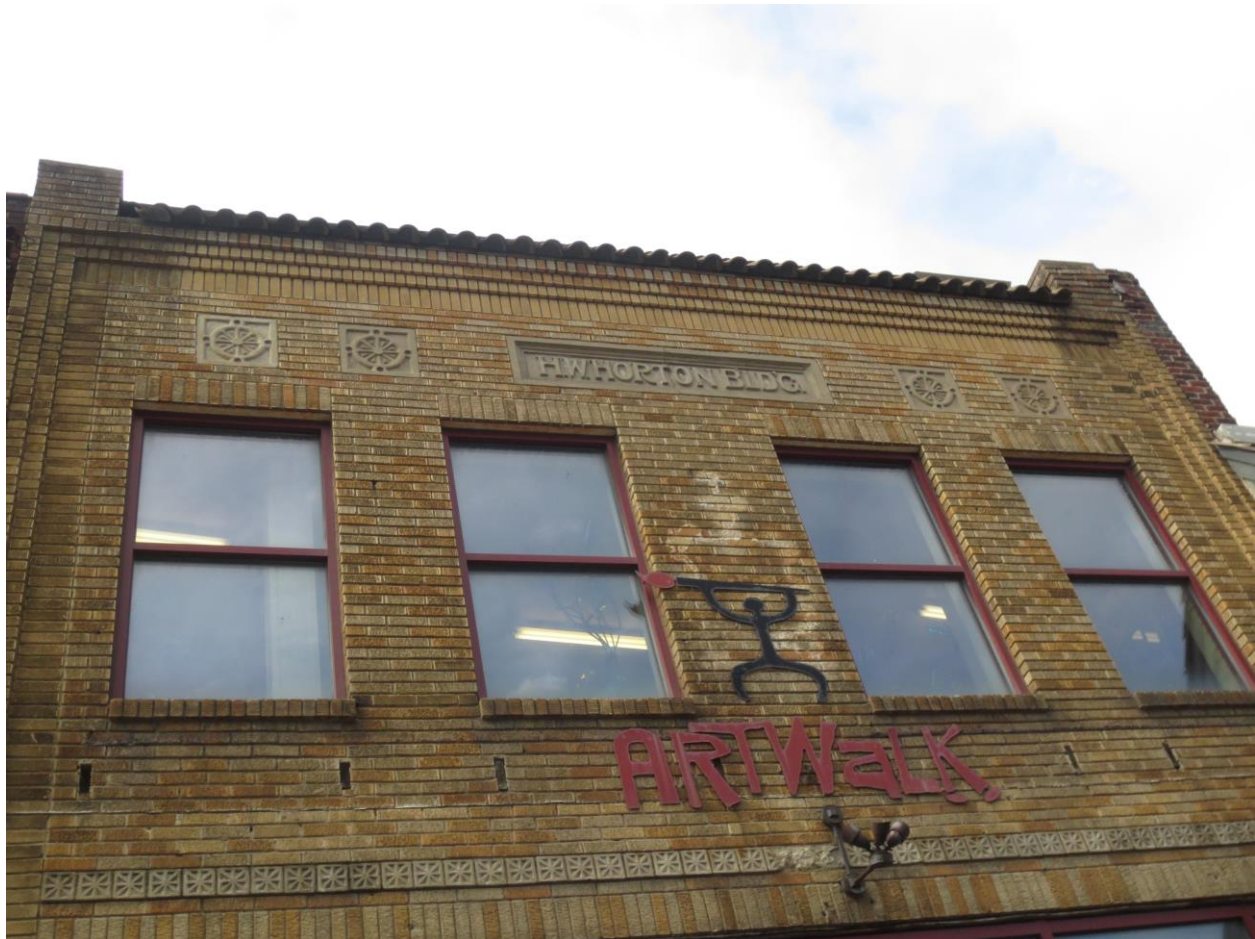
This building on West King Street is an example of both “good” and “bad” preservation decisions made in 2004. While much of the original brick detailing, corbelling, and ornamentation of the façade has been preserved, this upper façade’s windows were replaced with modern materials, and the prominent, ornate cartouche that once appeared between these windows was removed in favor of modern signage. Another renovation in 2018-19 added a rooftop bar structure that adversely impacts the historical integrity of the building as well as the District as a whole. Photo courtesy of Eric Plaag, 2013.

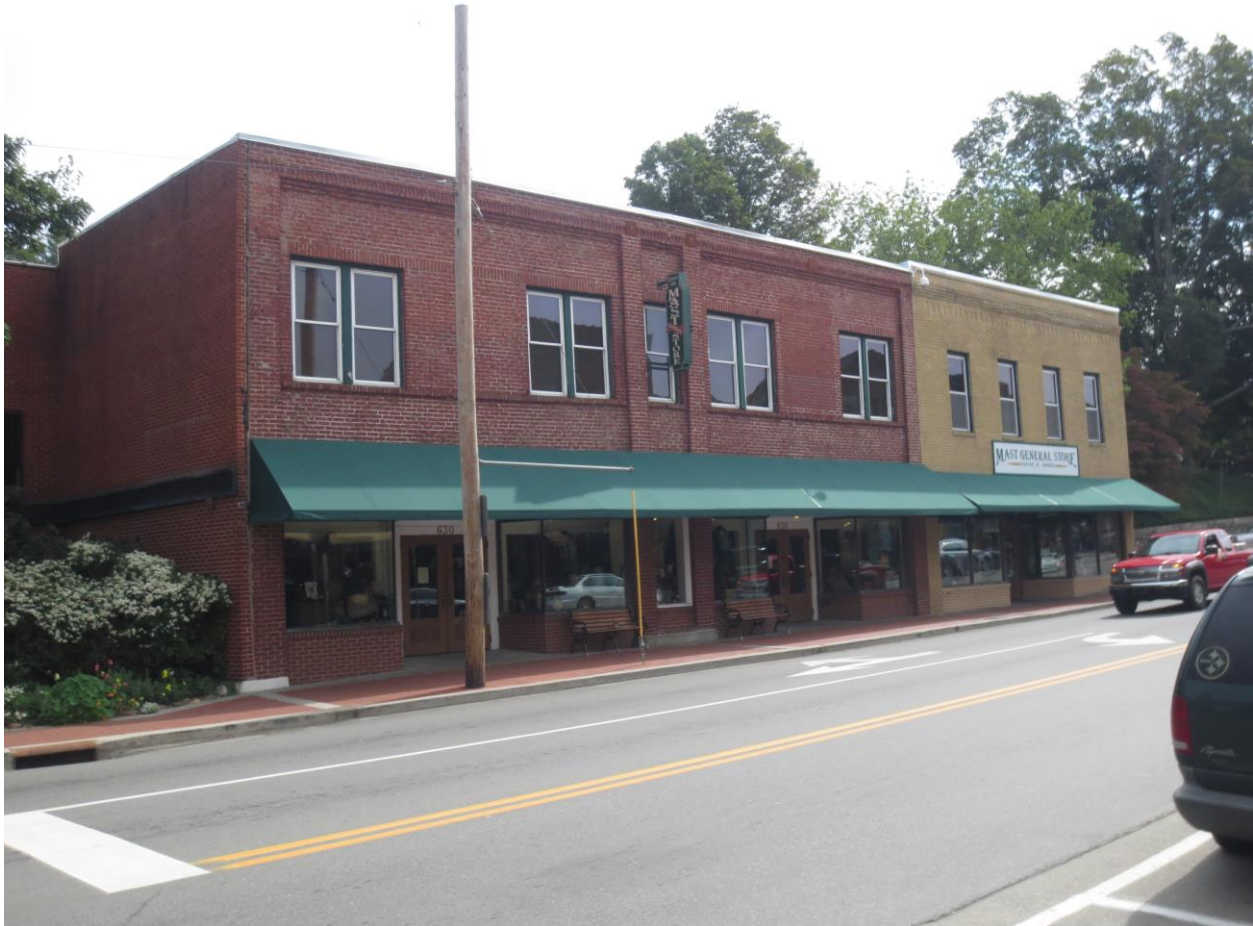
Retaining original masonry configurations, patterns, and detailing is essential to preserving the architectural character of the District. Veneer walls used to obscure original details, like the one on the left side of this complex that covers original masonry and a ghost ad, are always inappropriate. Photo courtesy of Eric Plaag, 2013.

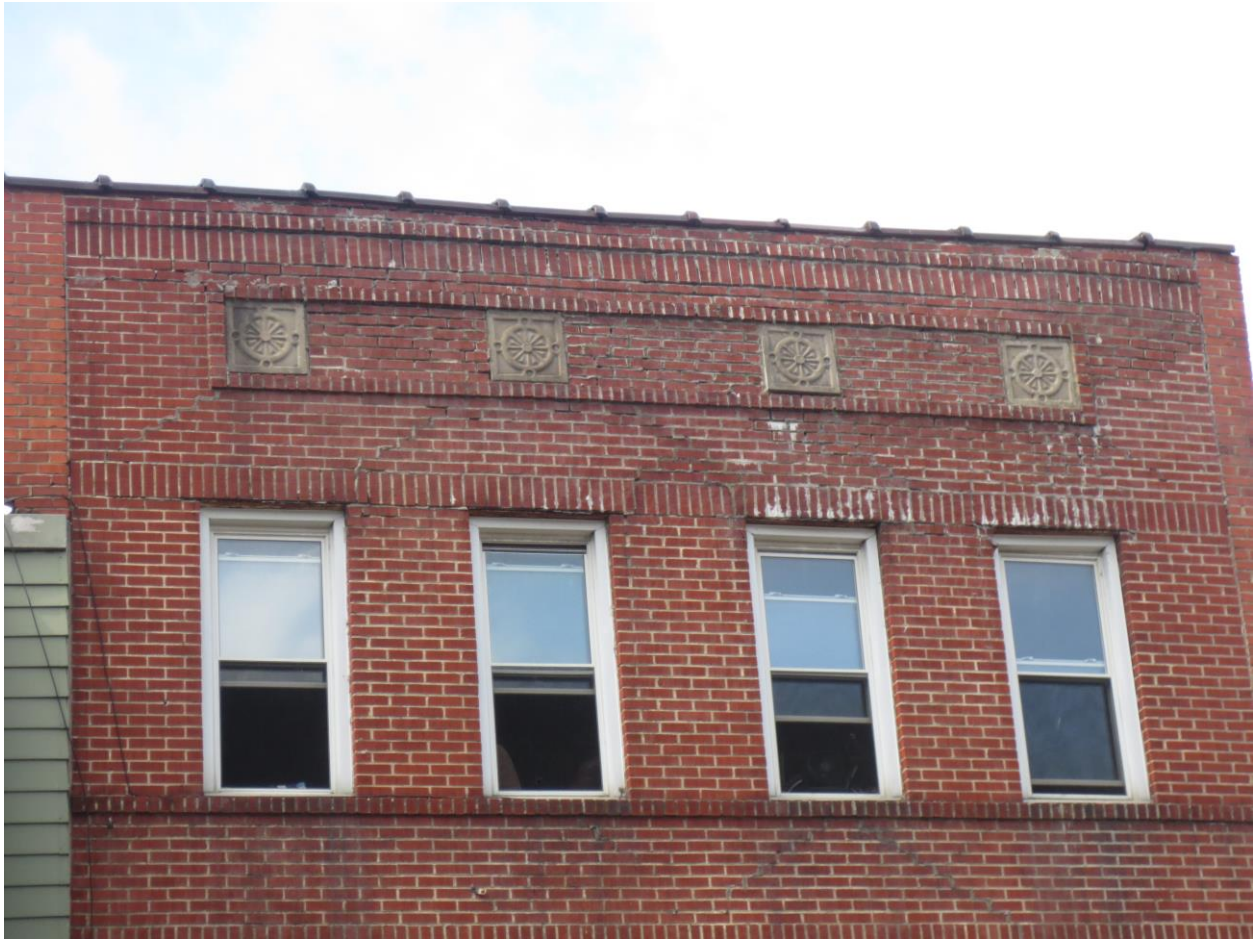
This West King Street property has suffered from poor attempts at re-pointing the masonry between the roofline and upper story windows. Photo courtesy of Eric Plaag, 2013.

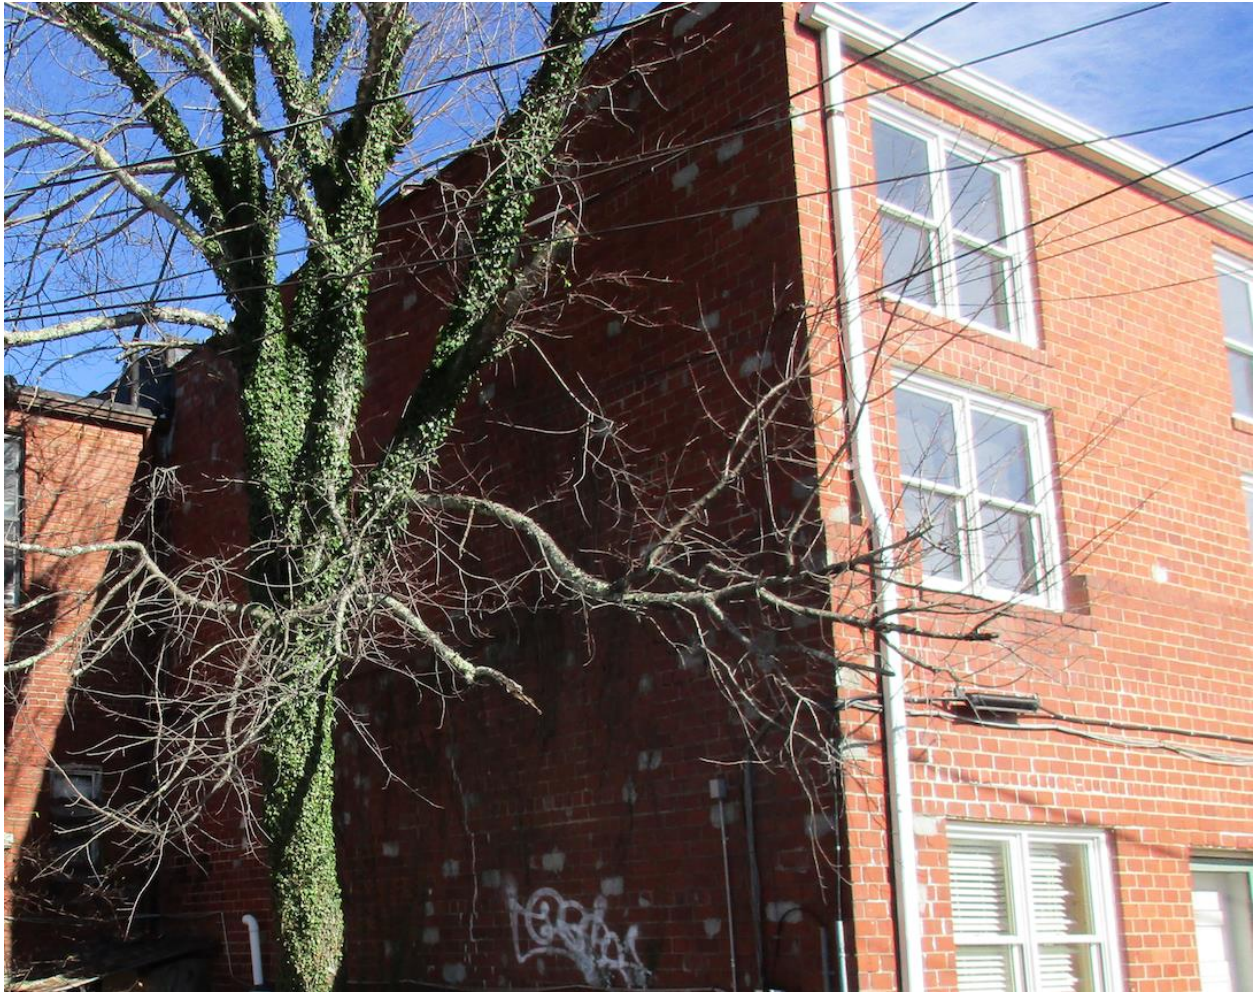
Spalling, as seen on the western wall of this King Street building, is often the result of moisture being trapped behind the brick face, freezing, and thus forcing the brick face to pop off. Attempting to cover the spalling through the use of cement infills or other patchwork repairs, as seen here, actually amplifies the spalling issue, damages surrounding brick, and degrades the historical integrity of the building. It is not recommended. Photo by Eric Plaag, 2015.

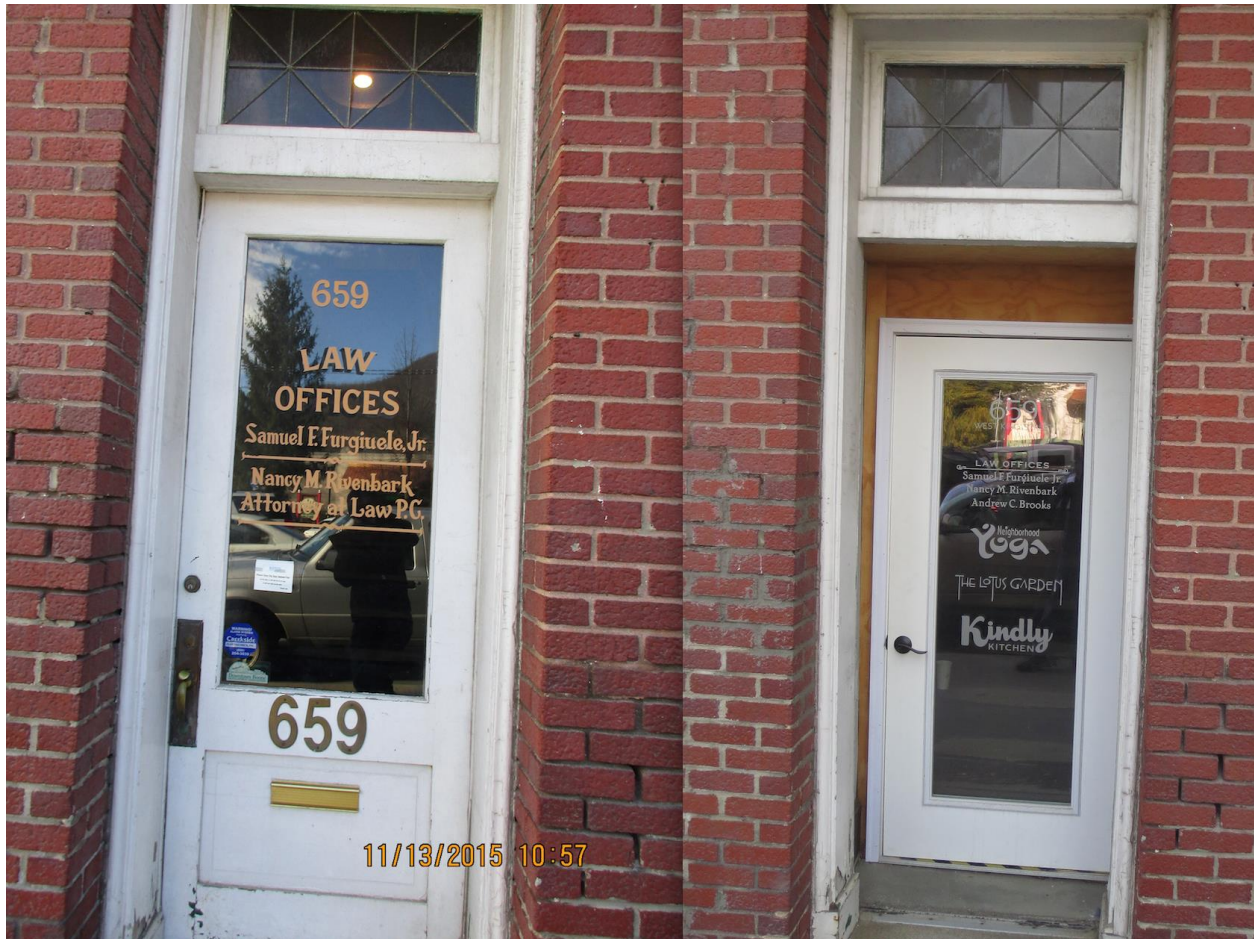
Original door configurations, like the one seen at left in November 2015, should never be abandoned for modern, historically inappropriate treatments like the one seen in the same doorway at right in January 2019. Images by Paul Fuller (left) and Eric Plaag.

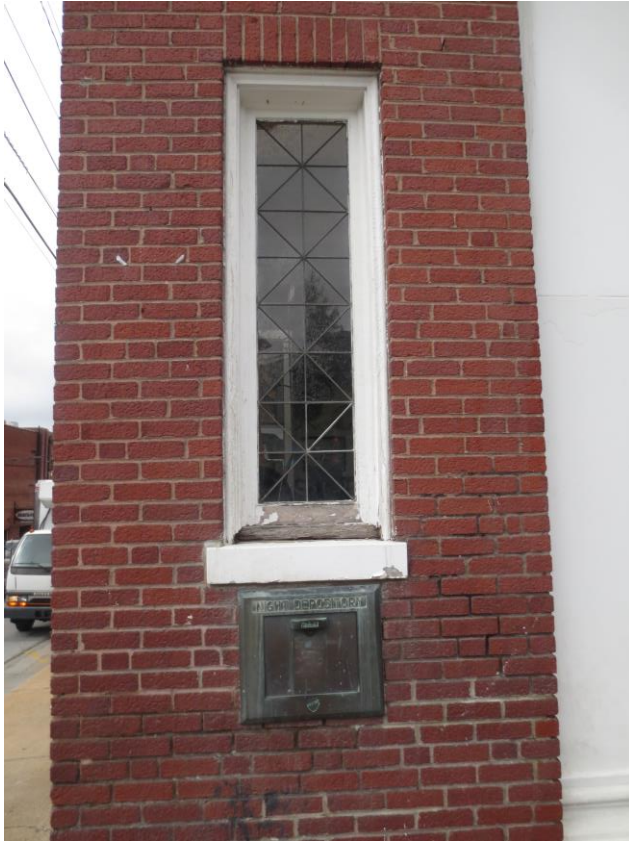
Historic window patterns, like those found here on the Watauga County Bank building, should always be repaired and preserved rather than replaced. Architectural flourishes, like the night depository door below the window, which is no longer used, should be retained, as they help tell the story of an historic property's function and importance to the District. Photo courtesy of Eric Plaag, 2013.

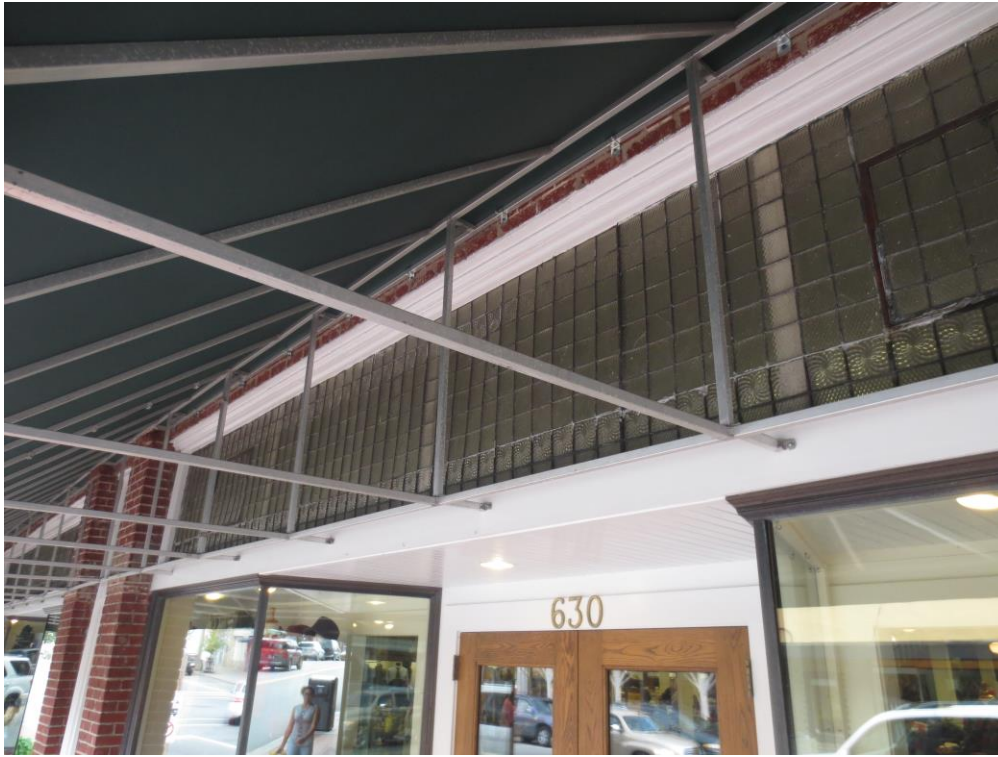
Original clerestory windows, like these found on one West King Street property, contain elaborate details that contribute to the character, appearance, and integrity of the downtown historic district. Photo courtesy of Eric Plaag, 2013.

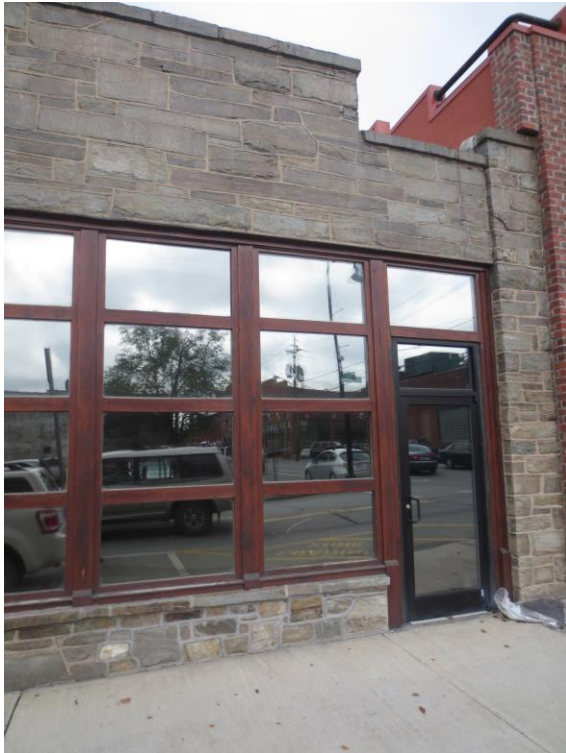
Reflective glass, like the kind found on this Depot Street property, is not historically accurate to the District and should never be used if visible from the street or public rights of way. Photo courtesy of Eric Plaag, 2013.

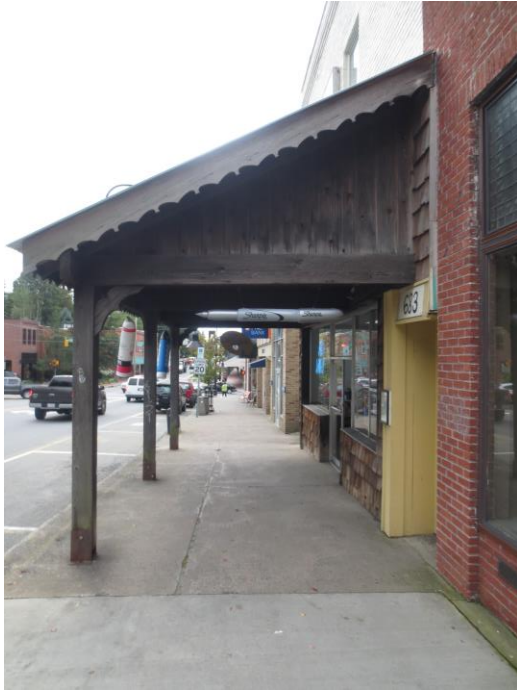
Shed roof porticoes like this one on West King Street attempt to create a “mountain village” appearance but are not historically appropriate to the District and damage the integrity of the District. Photo courtesy of Eric Plaag, 2013.

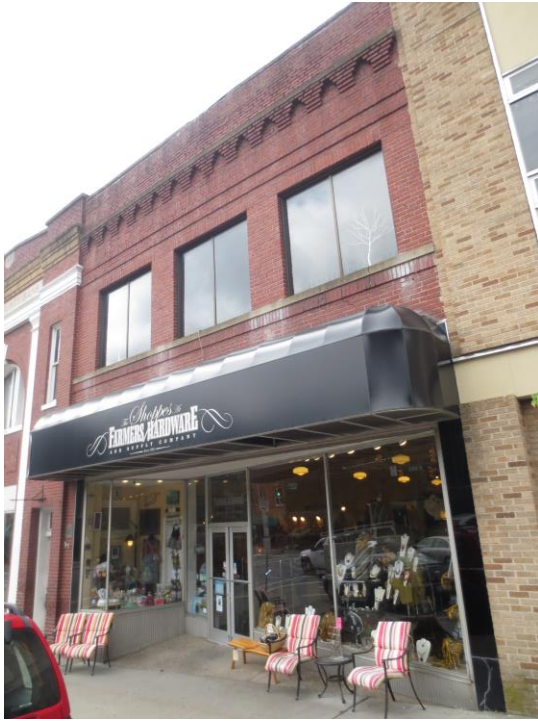
Awnings should be historically appropriate to the buildings they are attached to, and they should never obscure historic architectural features. This awning on West King Street, for example, is stylistically inappropriate to the building and almost entirely covers the structural glass that was once visible above this storefront. Photo courtesy of Eric Plaag, 2013.

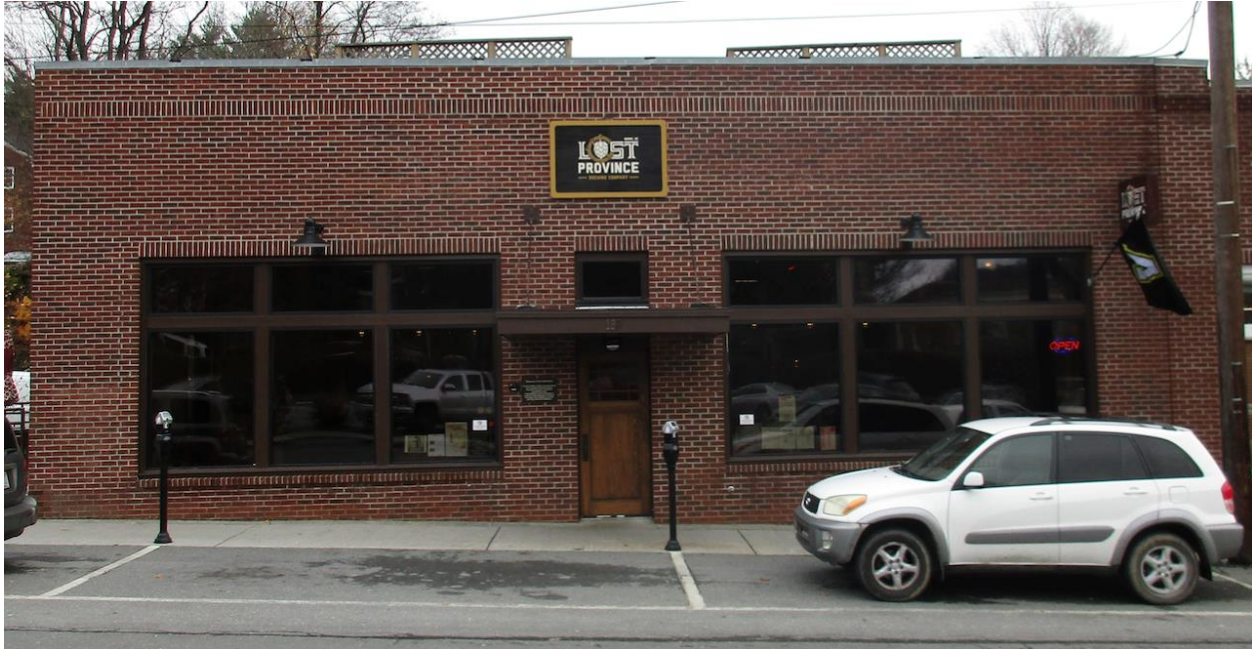
Rooftop screening materials should never be erected on top of a roof to obscure mechanical elements. Instead, strategic positioning of such elements and the use of existing parapet walls is the preferred method for obscuring such features. Image by Eric Plaag, 2015.
